ROOF ASSESSMENT REPORT

TURNERS FALLS MUNICIPAL AIRPORT
HANGAR BUILDING
42 INDUSTRIAL BOULEVARD
TURNERS FALLS, MA 01376

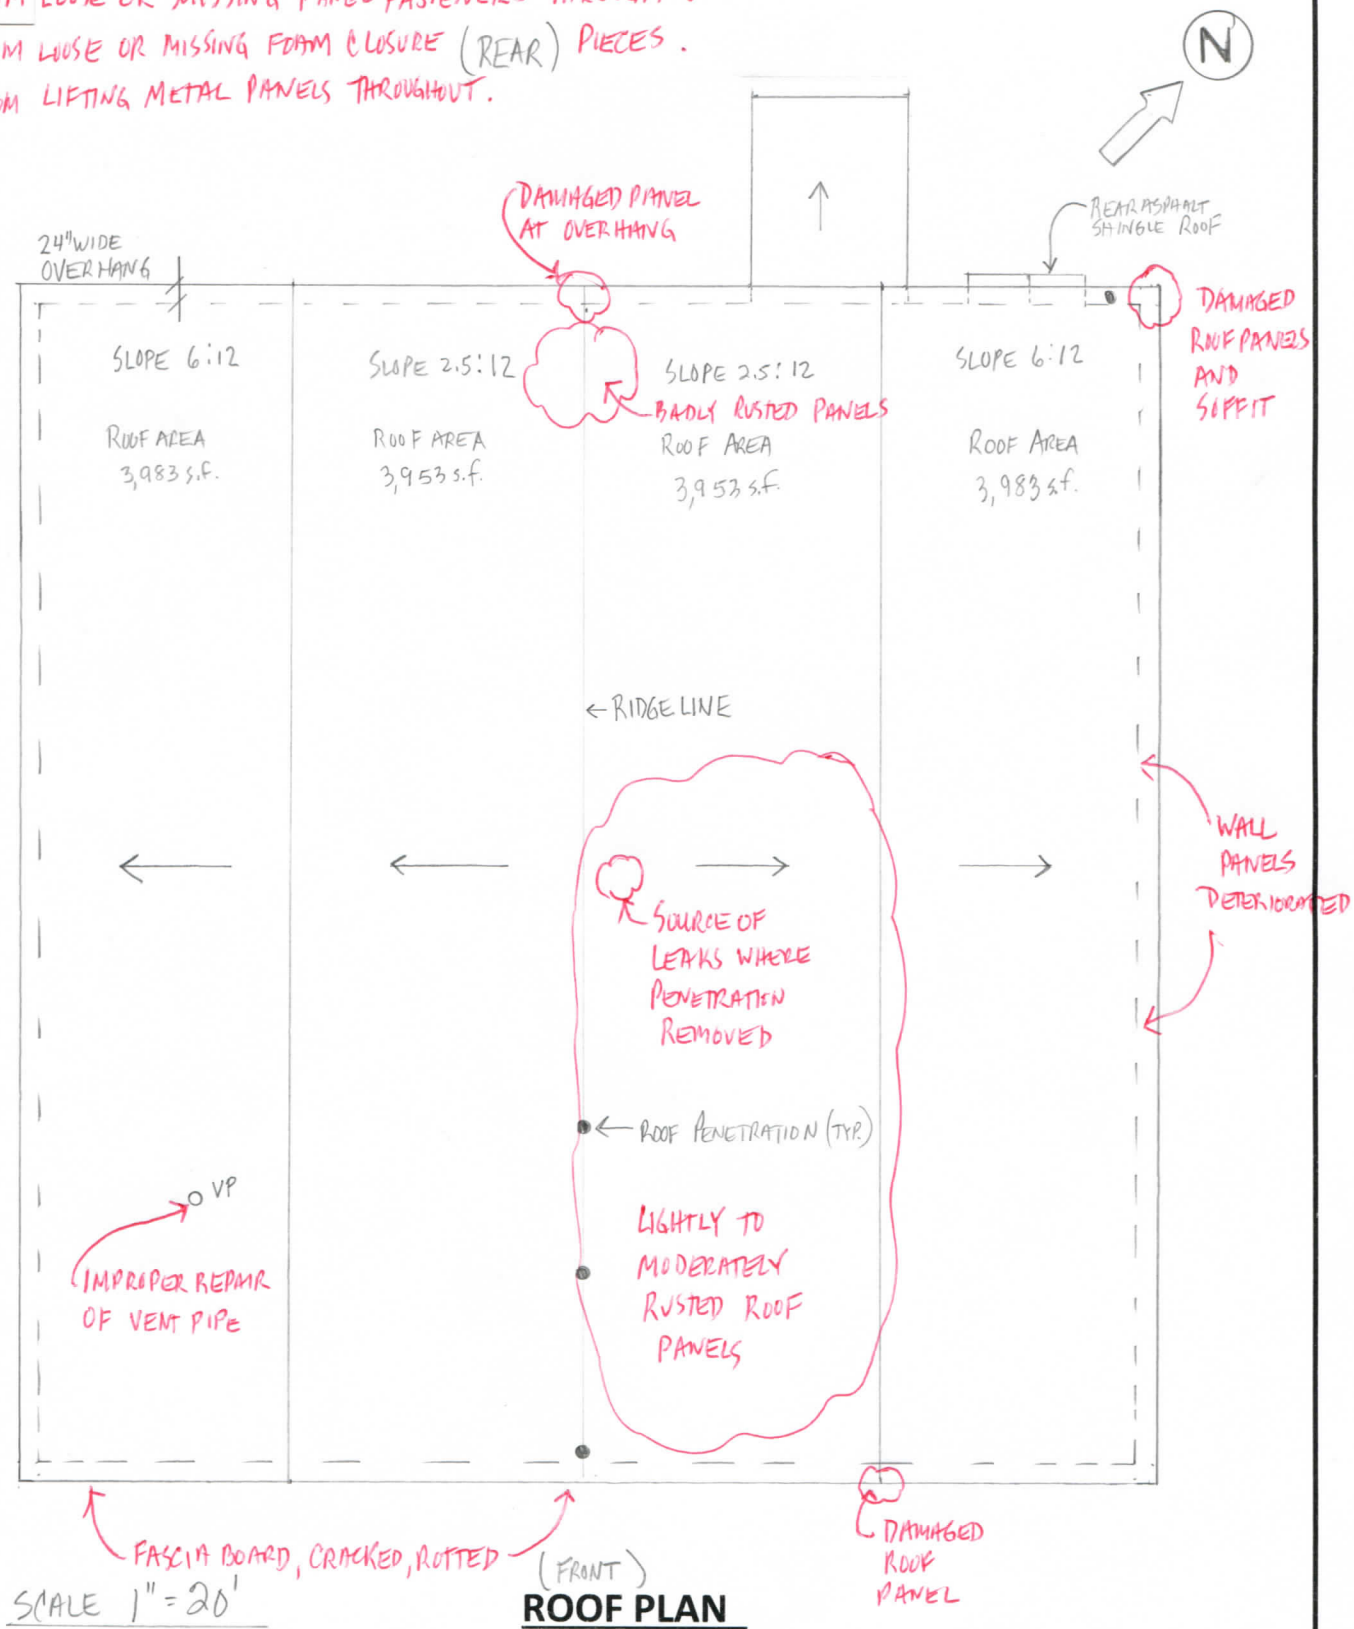
- RANDOM LOOSE OR MISSING PANEL FASTENERS THROUGHOUT.
- RANDOM LOOSE OR MISSING FORM CLOSURE (REAR) PIECES.
- RANDOM LIFTING METAL PANELS THROUGHOUT.

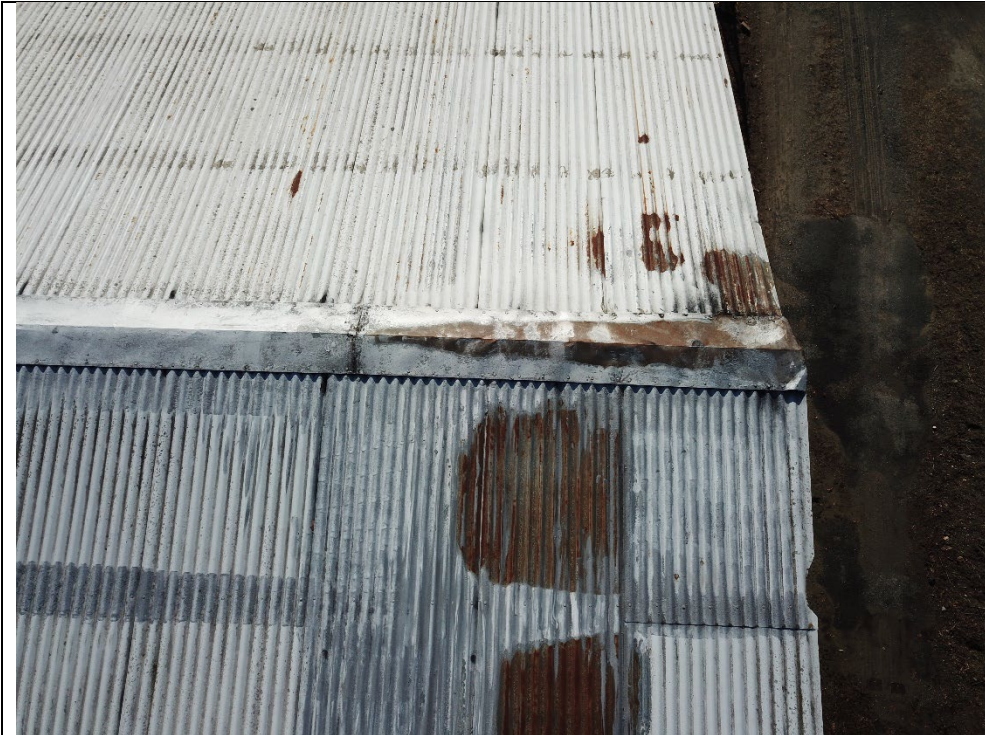
ROOF ASSESSMENT REPORT
AIRPORT HANGAR, 42 INDUSTRIAL BLVD., TURNERS FALLS, MA
(Photo Documentation)

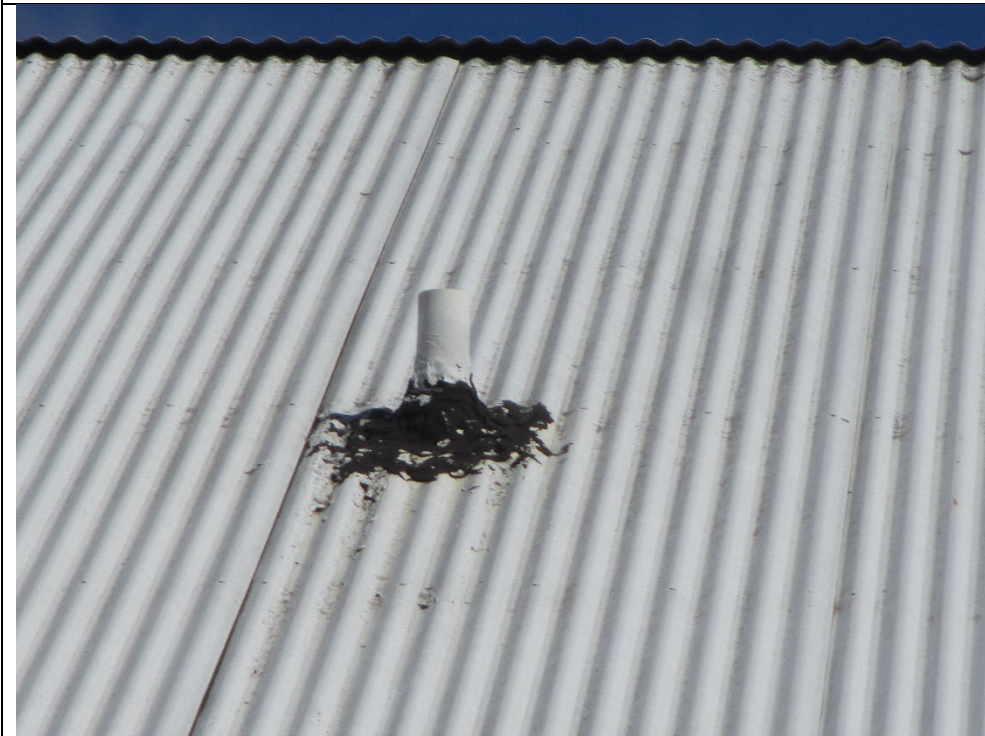
Description:
View of damaged ridge closure piece. Adjacent panels were found to be the most rusted areas of the roof.

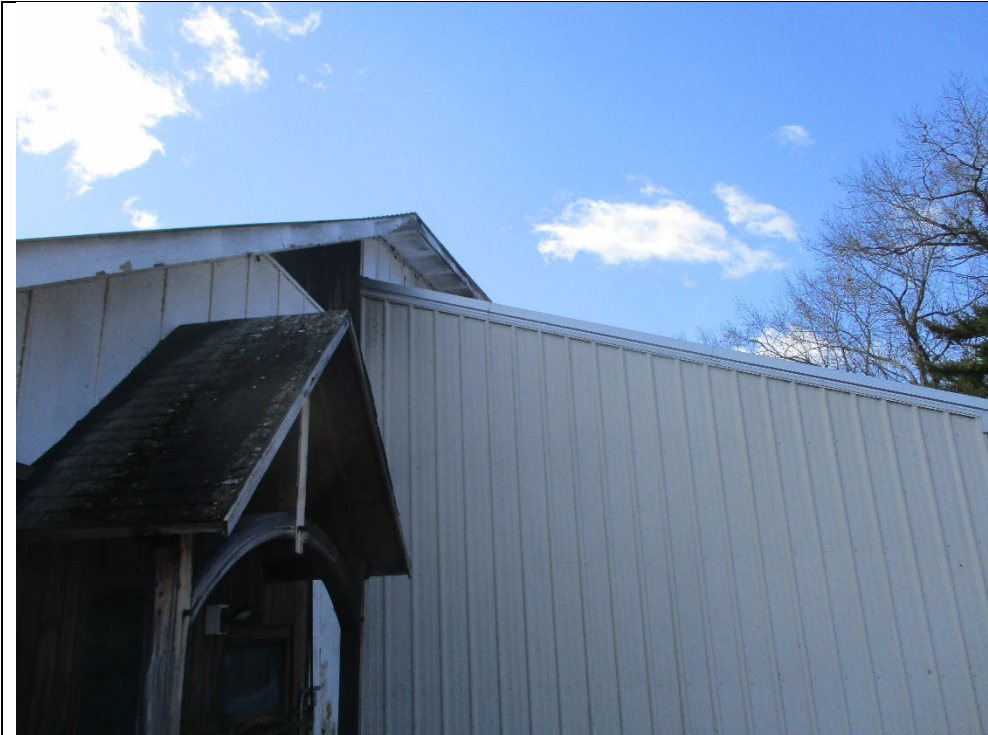
ROOF ASSESSMENT REPORT
AIRPORT HANGAR, 42 INDUSTRIAL BLVD., TURNERS FALLS, MA
(Photo Documentation)

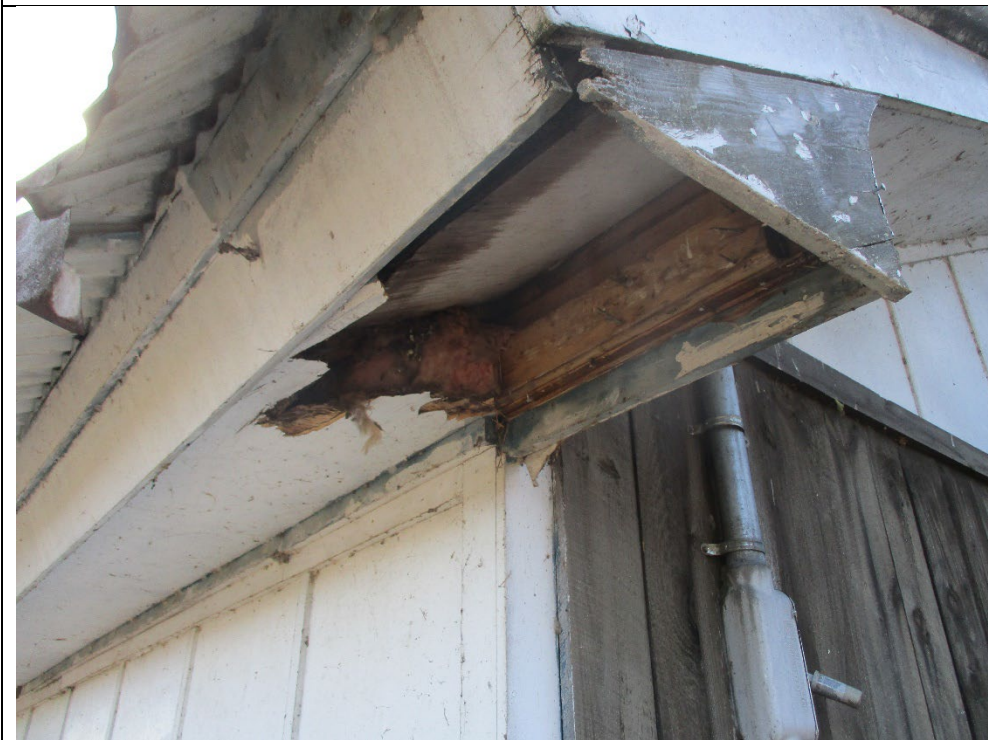
Description:
View of rear entrance overhang covered with asphalt roof shingles in fair condition.

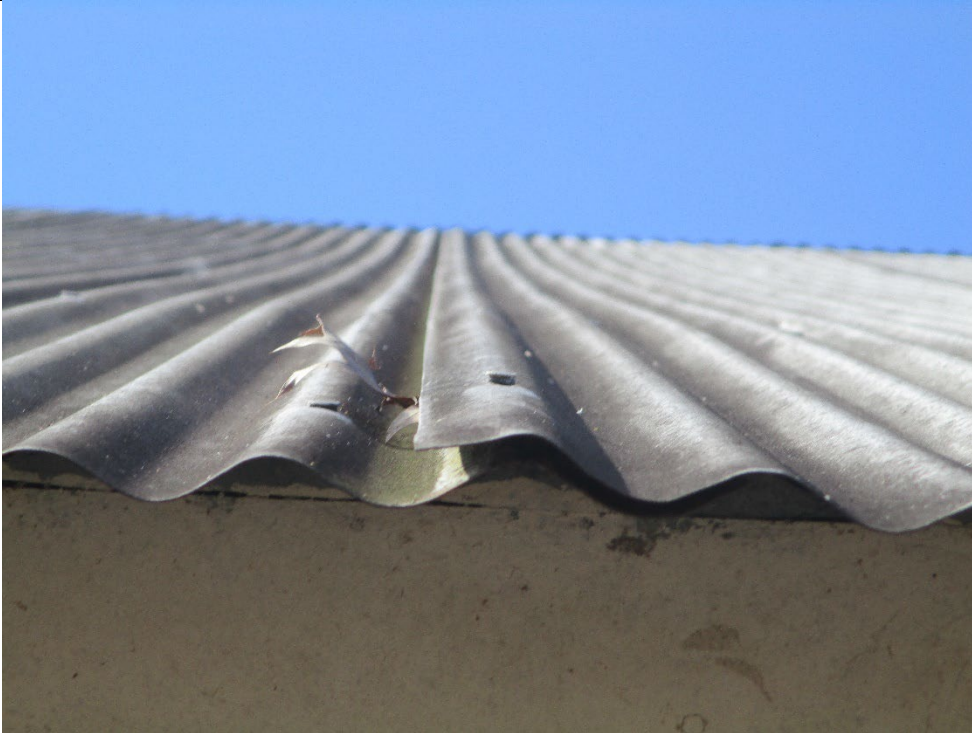
ROOF ASSESSMENT REPORT
AIRPORT HANGAR, 42 INDUSTRIAL BLVD., TURNERS FALLS, MA
(Photo Documentation)

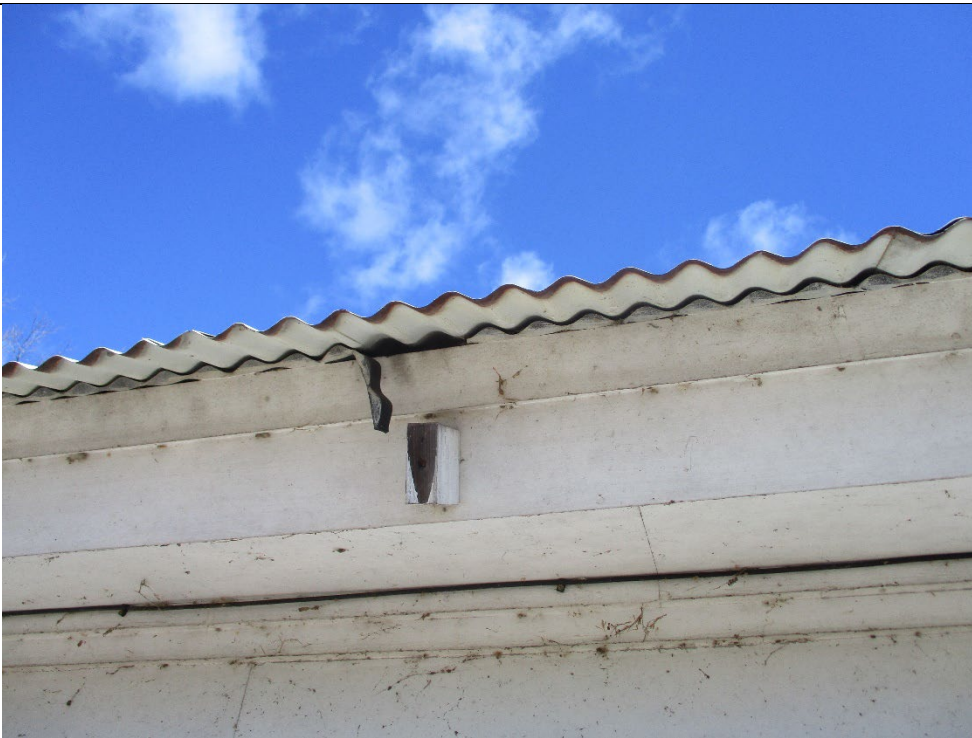
Description:
Previous repairs to
repair hole(s) in
wood fascia at
ridge area.

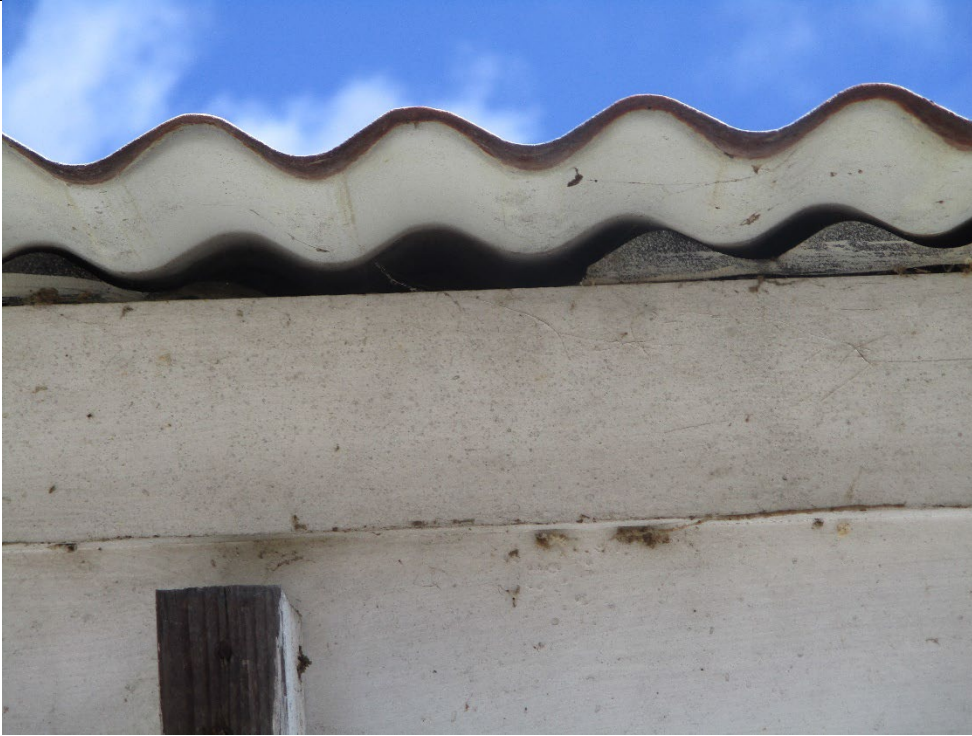
ROOF ASSESSMENT REPORT
AIRPORT HANGAR, 42 INDUSTRIAL BLVD., TURNERS FALLS, MA
(Photo Documentation)

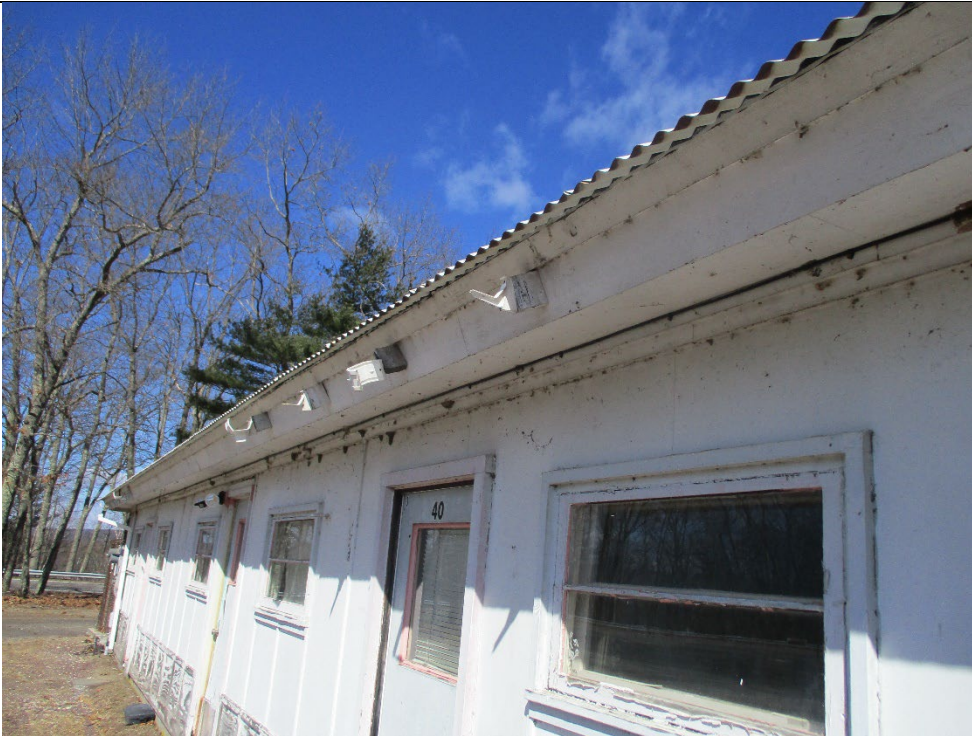
Description:
Missing foam closure piece under edge of metal panels.
