Appendix F Turners Falls Technical Memo – Field Investigations

Date: **3/3/2023**

Project No.: **21005**

Subject: Turners Falls, Lake Pleasant, and Montague Center Wastewater Collection System Study - FINAL

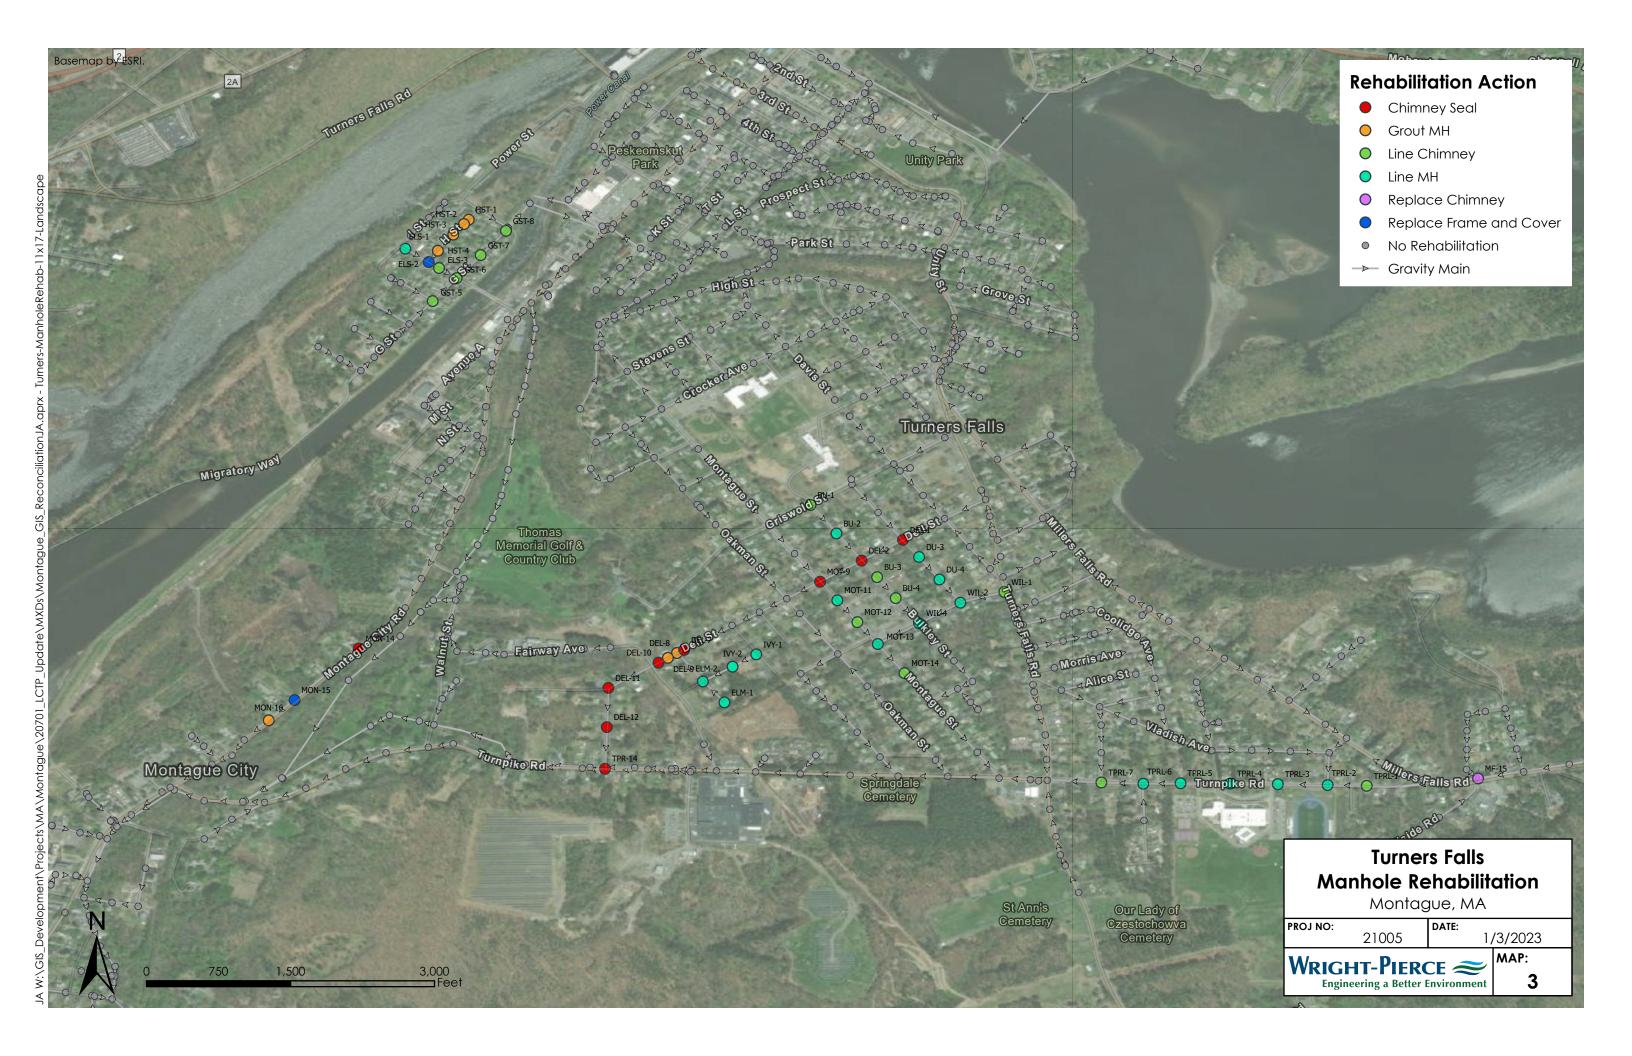
The results from the manhole inspections are summarized in **Table 9.** Most manholes have an LoF of 3 and the highest LoF is 5. Inspected manholes and their rehabilitation recommendations are depicted in **Map 3**.

Likelihood of Failure (LoF), Rounded	Number of Manholes
0	0
1	0
2	0
3	28
4	20
5	3
6	0
Total	51

Inspected manholes and their rehabilitation recommendations are depicted in **Map 3**. Inspected pipe segments and their rehab recommendations are depicted in **Map 4**.

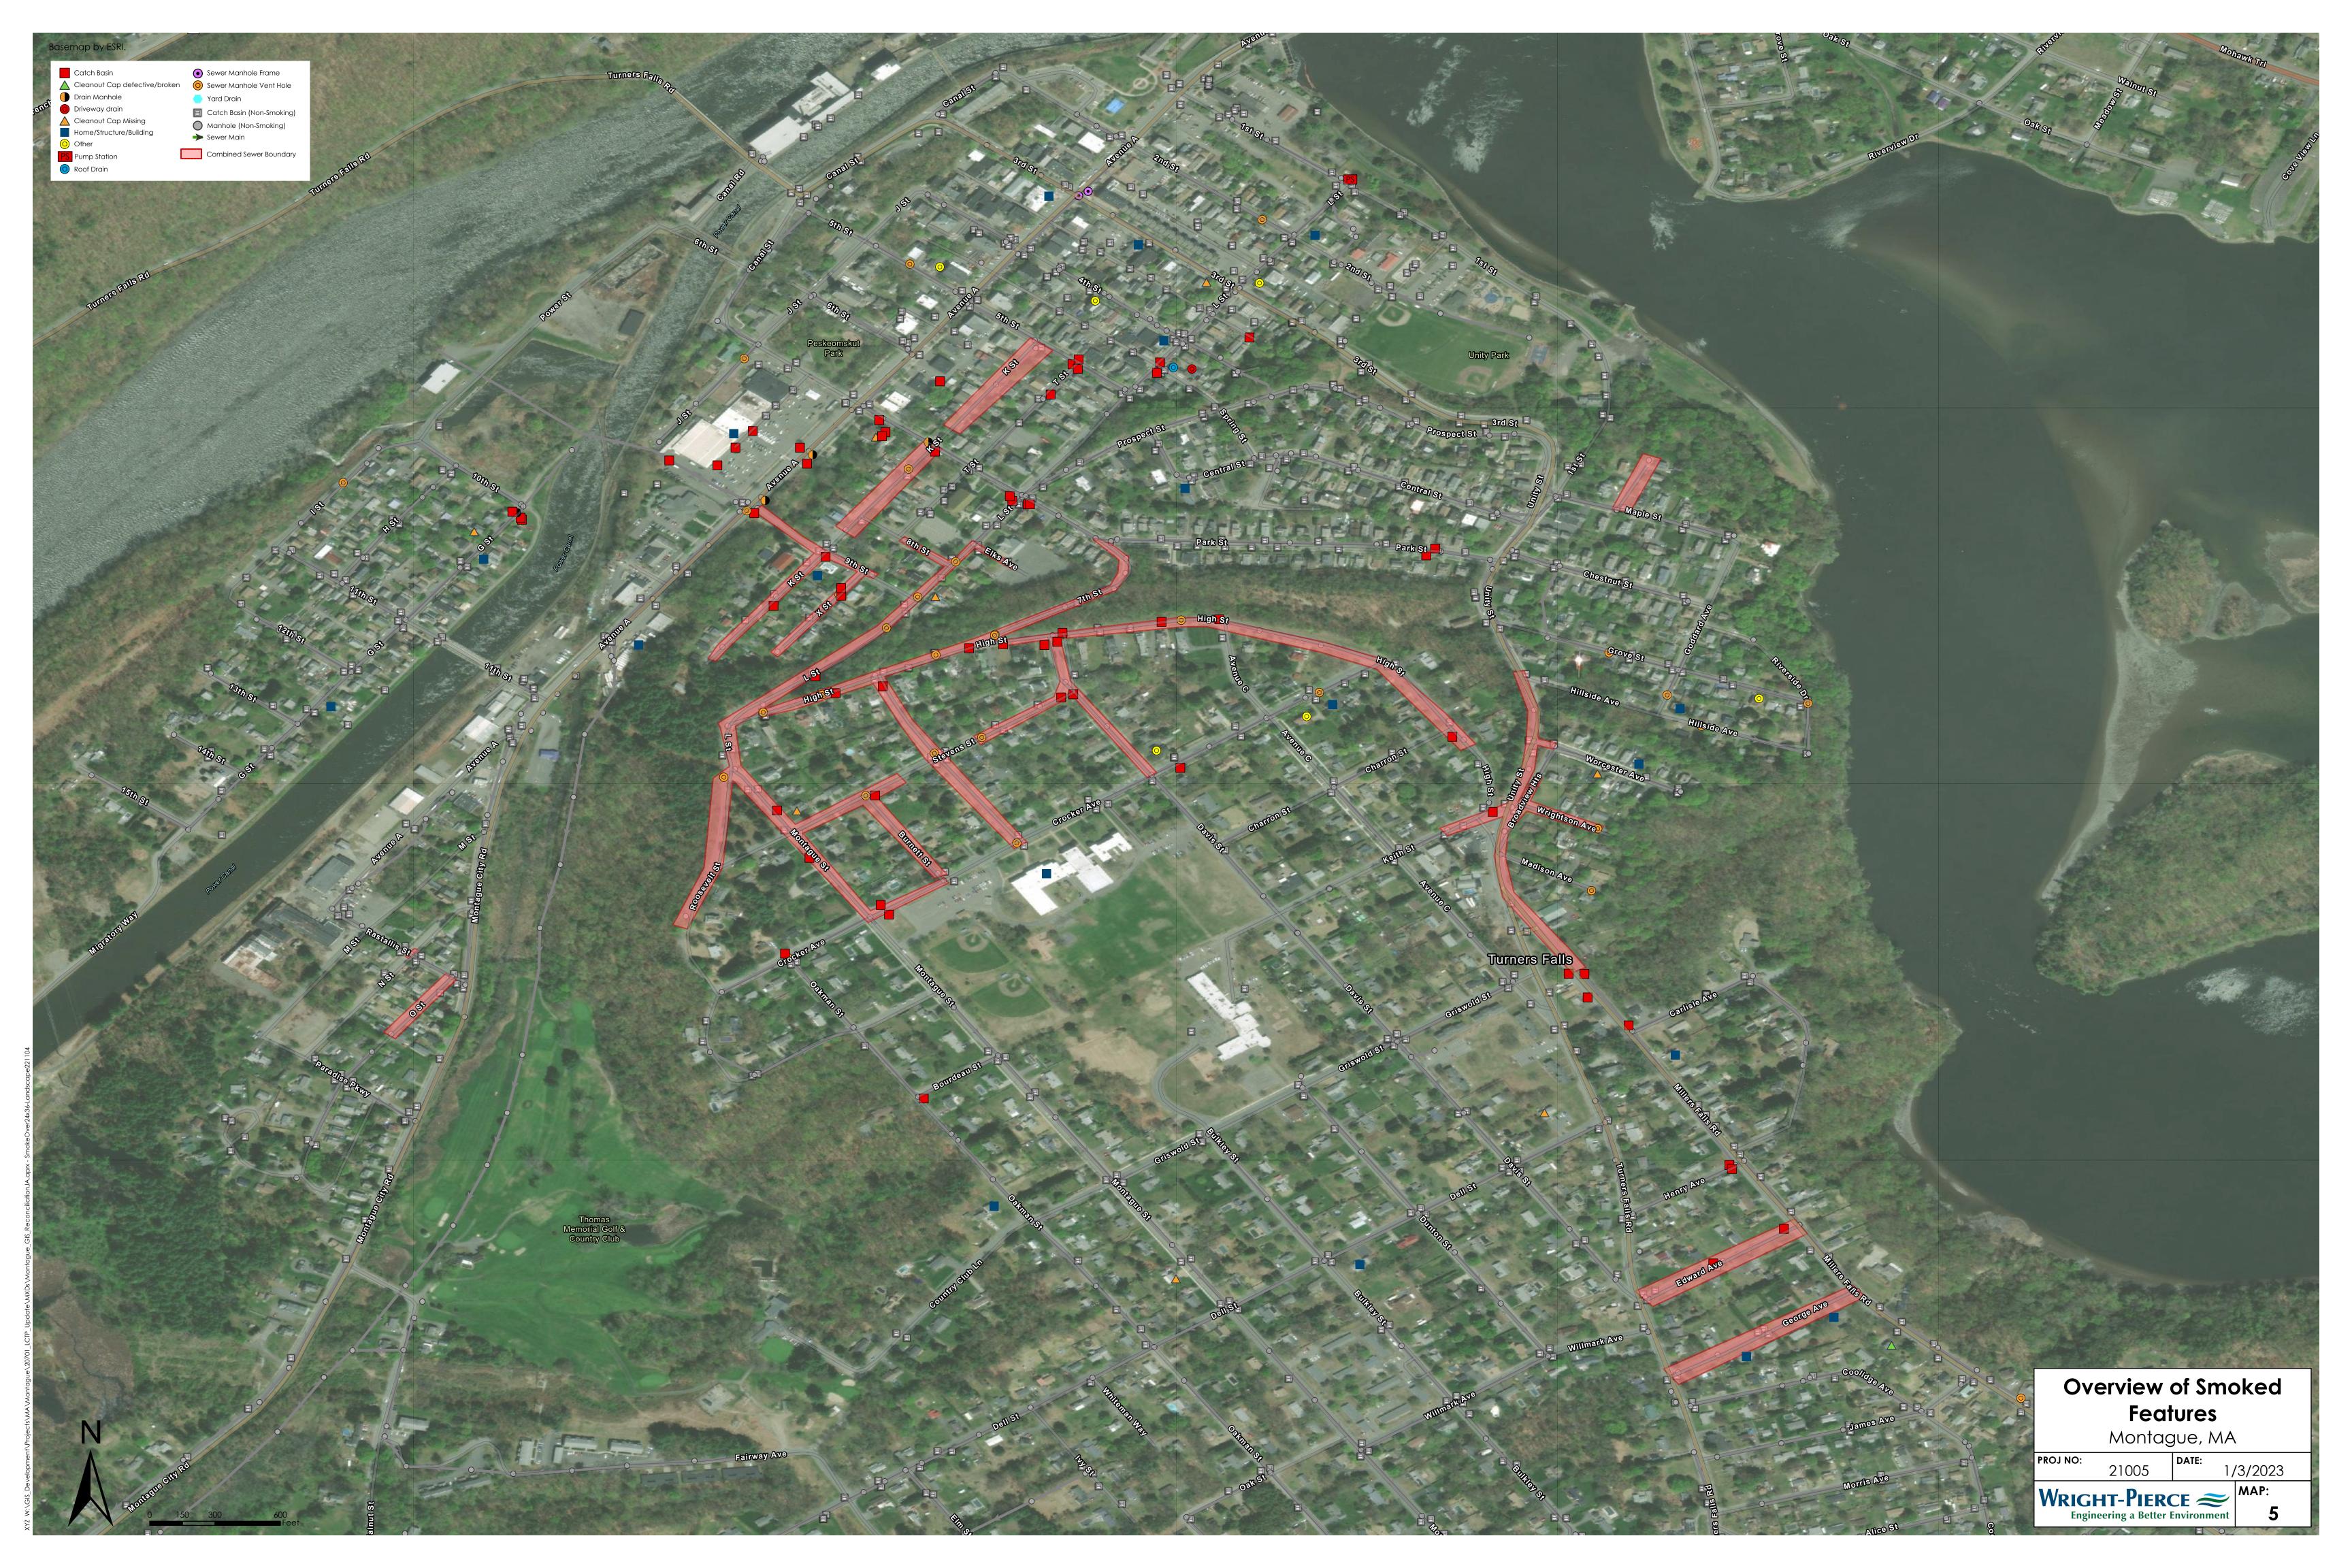
The results of the smoke test survey are summarized in **Table 11**. Mapbooks detailing each observation can be found in **Appendices C** (Inflow-Contributing Defects) **and D** (Non-Defect Observations).

1. Possible defective cover, frame, and/or chimney but probably not a major source of inflow. Further investigation recommended to determine extent of defect.
