ROOF ASSESSMENT REPORT

**CARNEGIE LIBRARY
201 AVENUE A
TURNER FALLS, MA 01376**

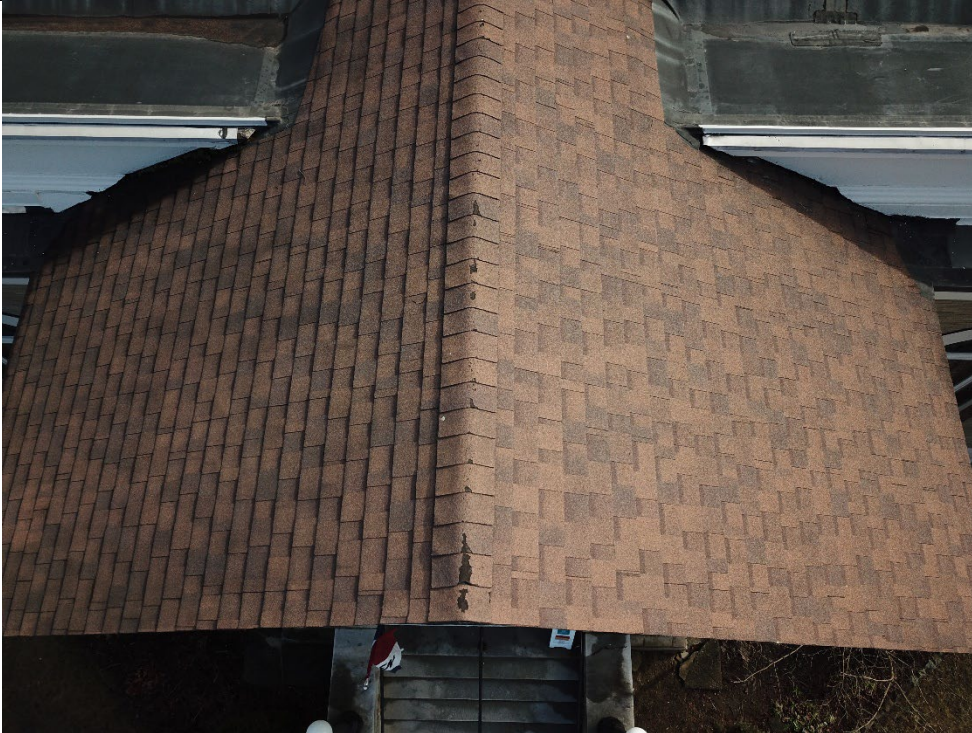
ROOF ASSESSMENT REPORT
CARNEGIE LIBRARY, 201 AVENUE A, TURNERS FALLS, MA
(Photo Documentation)

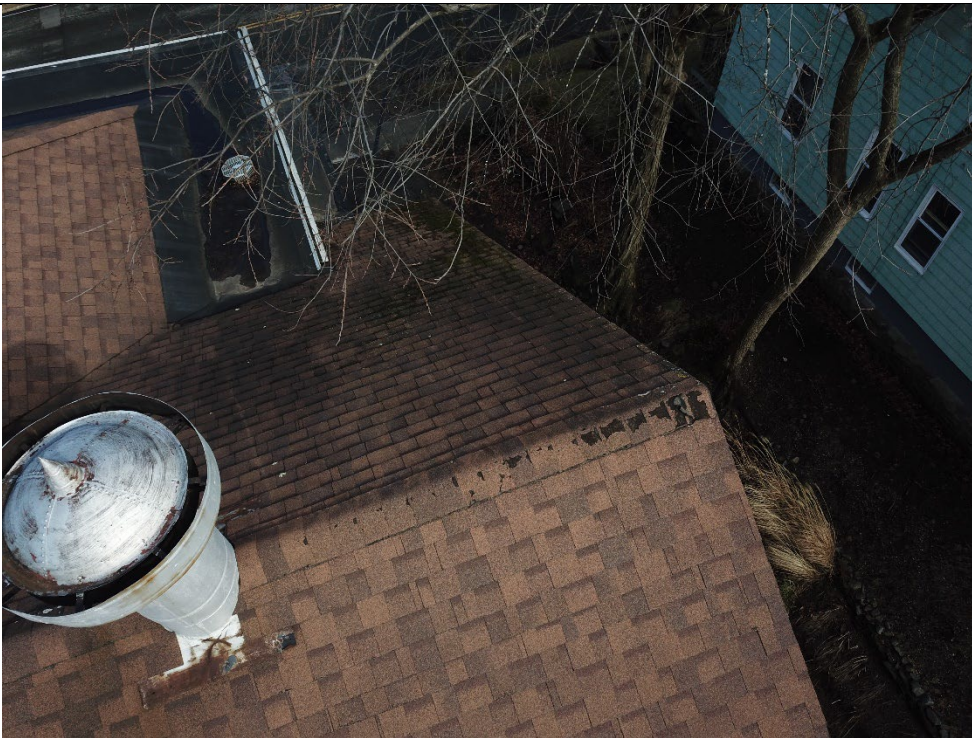
Description:
Deteriorated ridge
cap shingles
showing loss of
protective granular
coating.

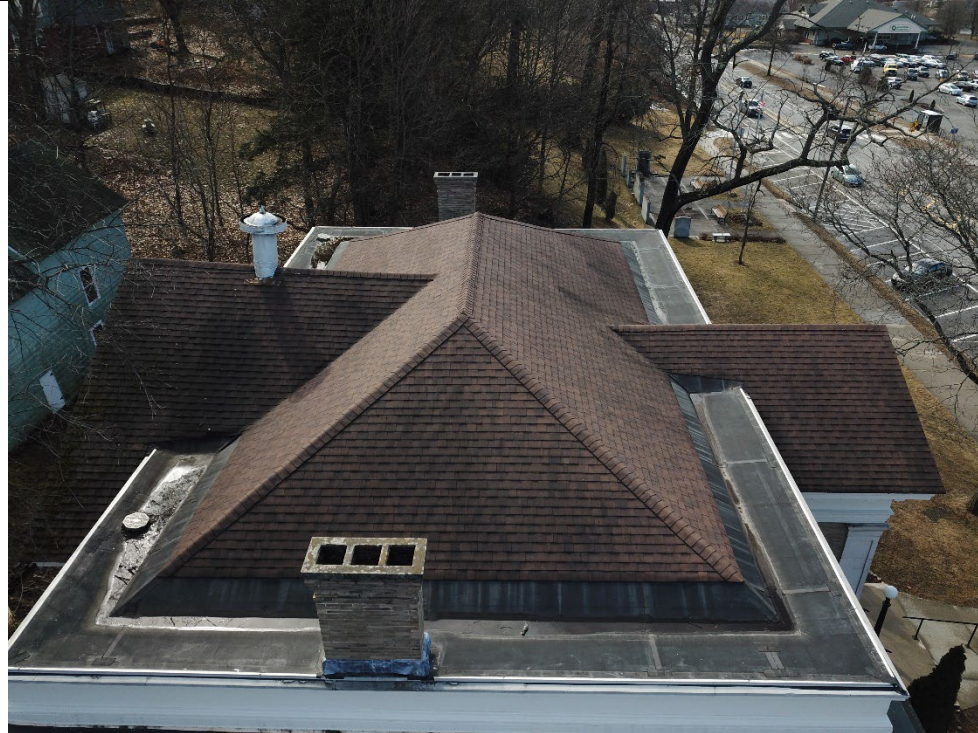
ROOF ASSESSMENT REPORT
CARNEGIE LIBRARY, 201 AVENUE A, TURNERS FALLS, MA
(Photo Documentation)

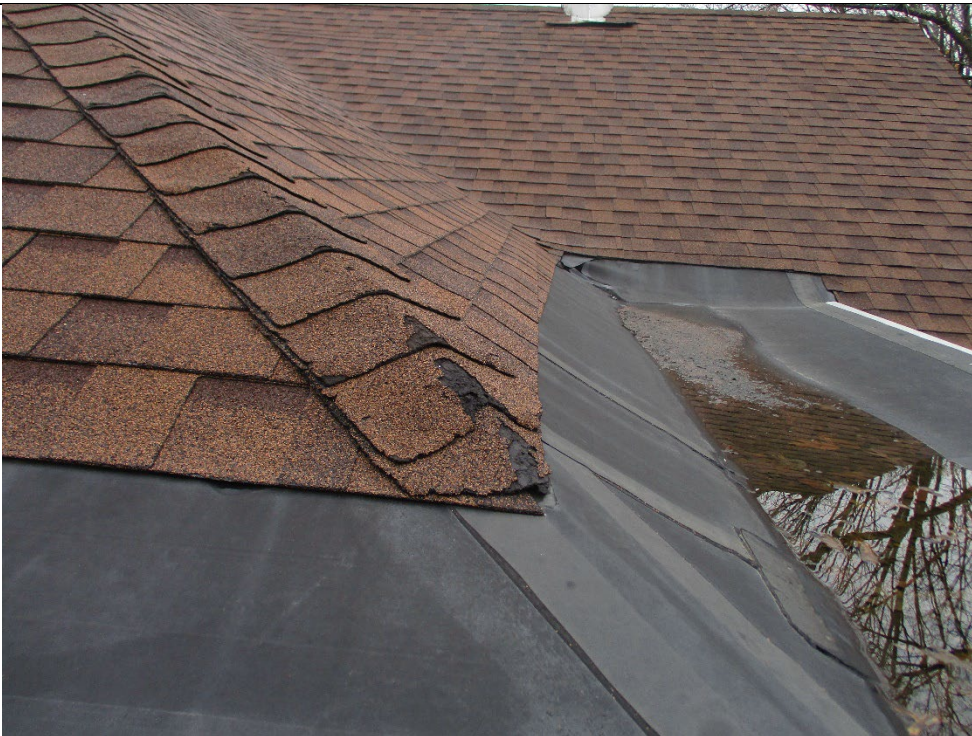
Description:
Existing lead
counterflashing is
deteriorated, loose
and torn.

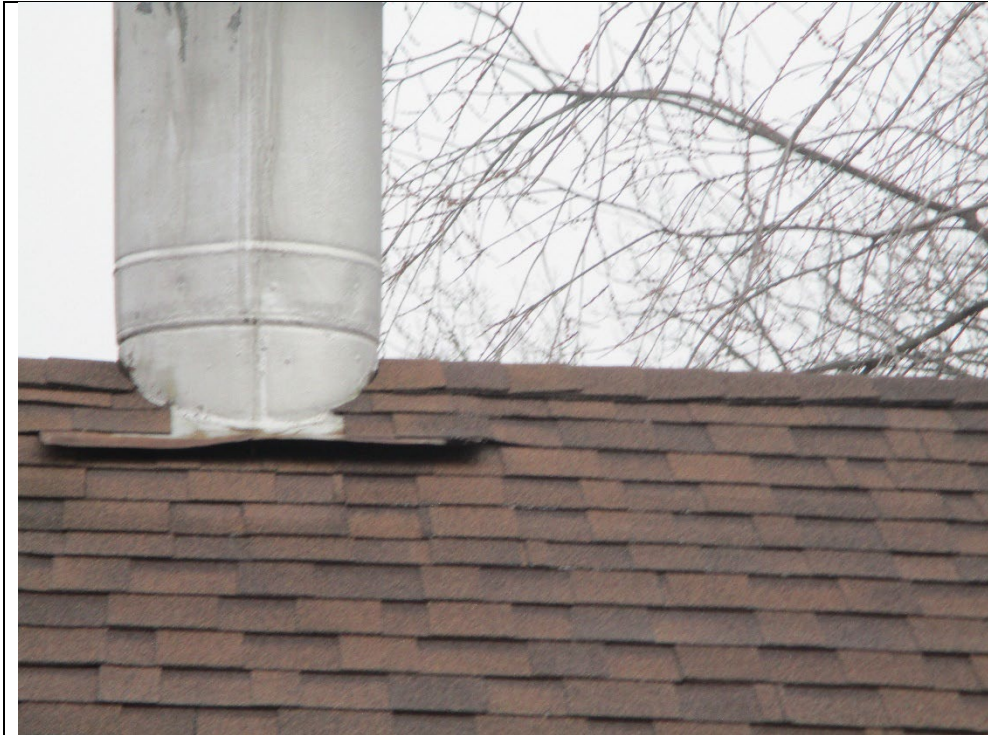
ROOF ASSESSMENT REPORT
CARNEGIE LIBRARY, 201 AVENUE A, TURNERS FALLS, MA
(Photo Documentation)

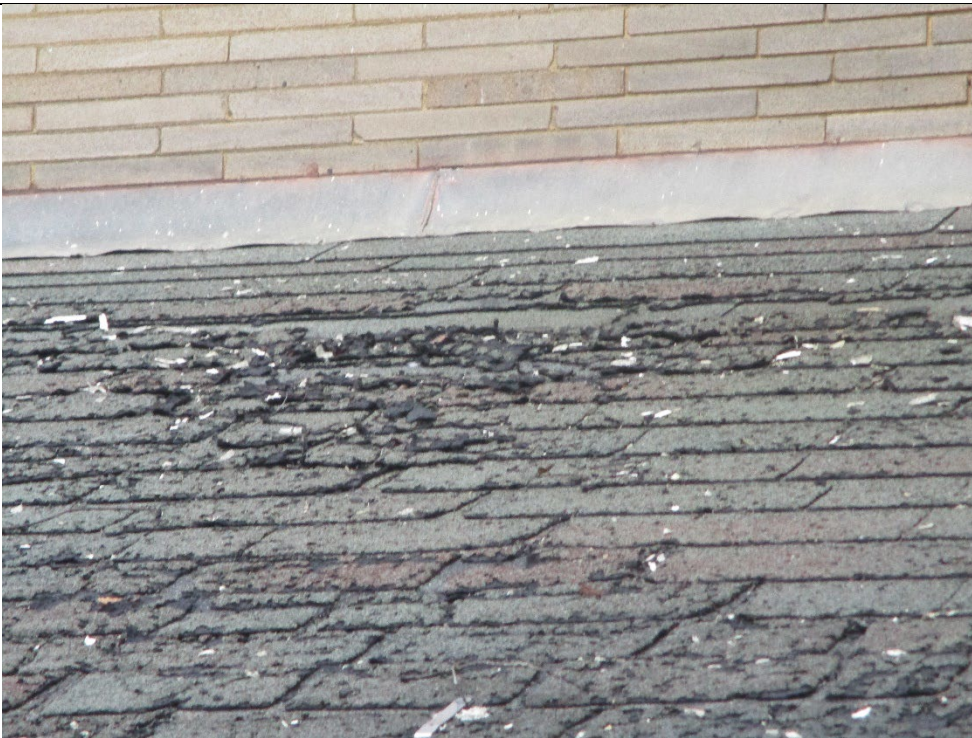
Description:
Existing
deteriorated three
tab shingles in
need of
replacement.
