ROOF ASSESSMENT REPORT

**THE COLLE BUILDING
85 AVENUE A
TURNER FALLS, MA 01376**

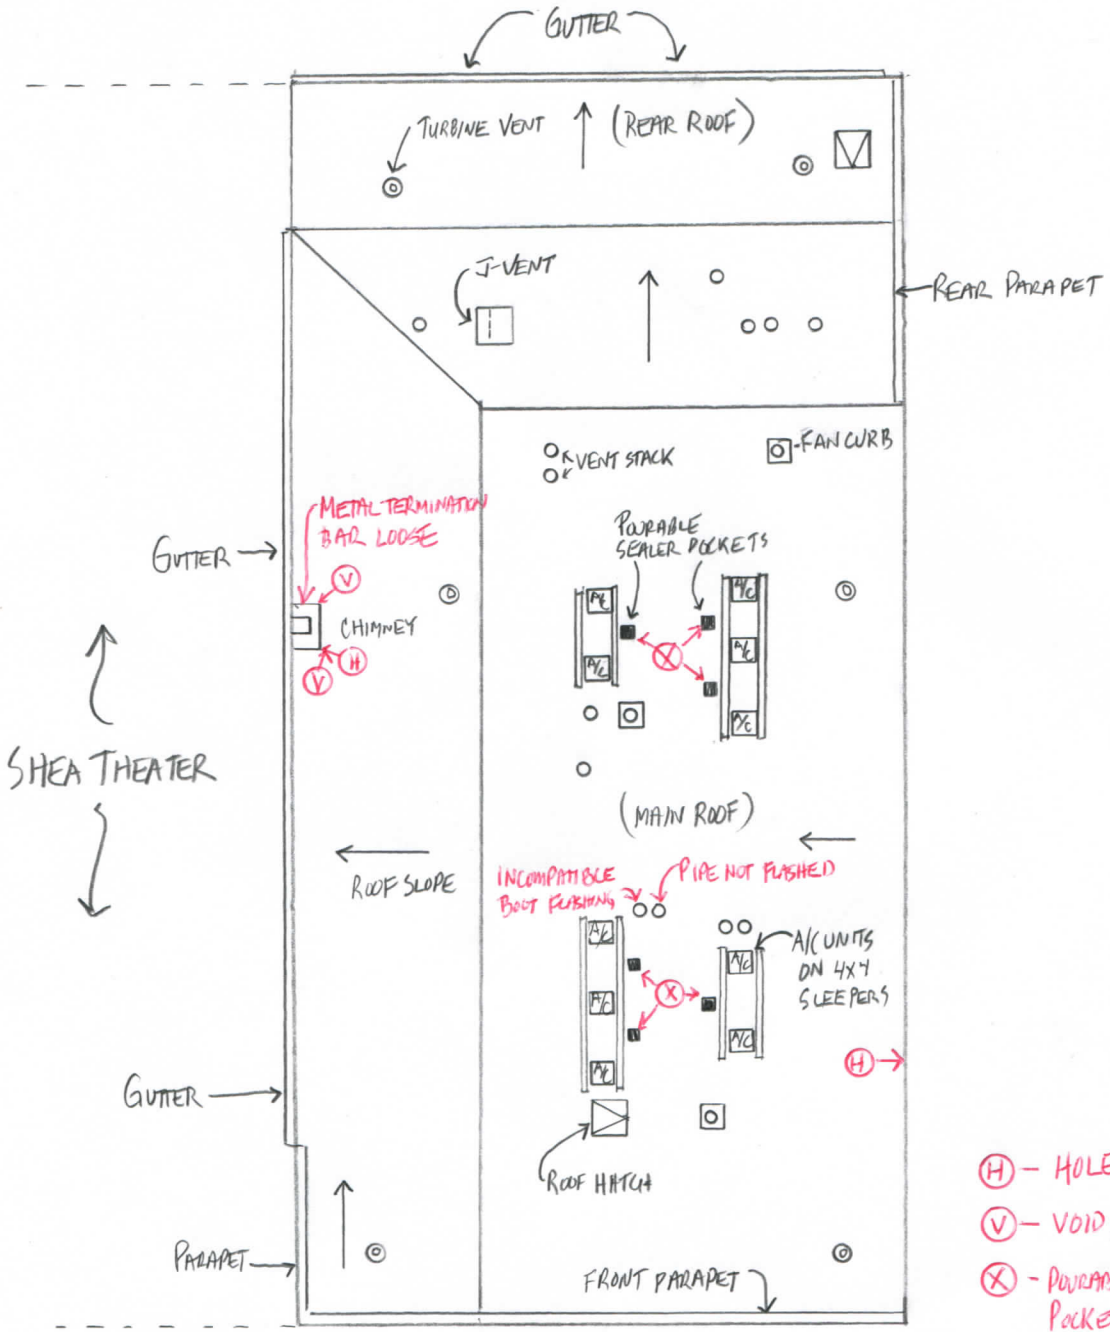
- (H) - HOLE
- (V) - VOID IN LAP
- (X) - DAMAGED SEALER POCKET OPEN IN AREAS

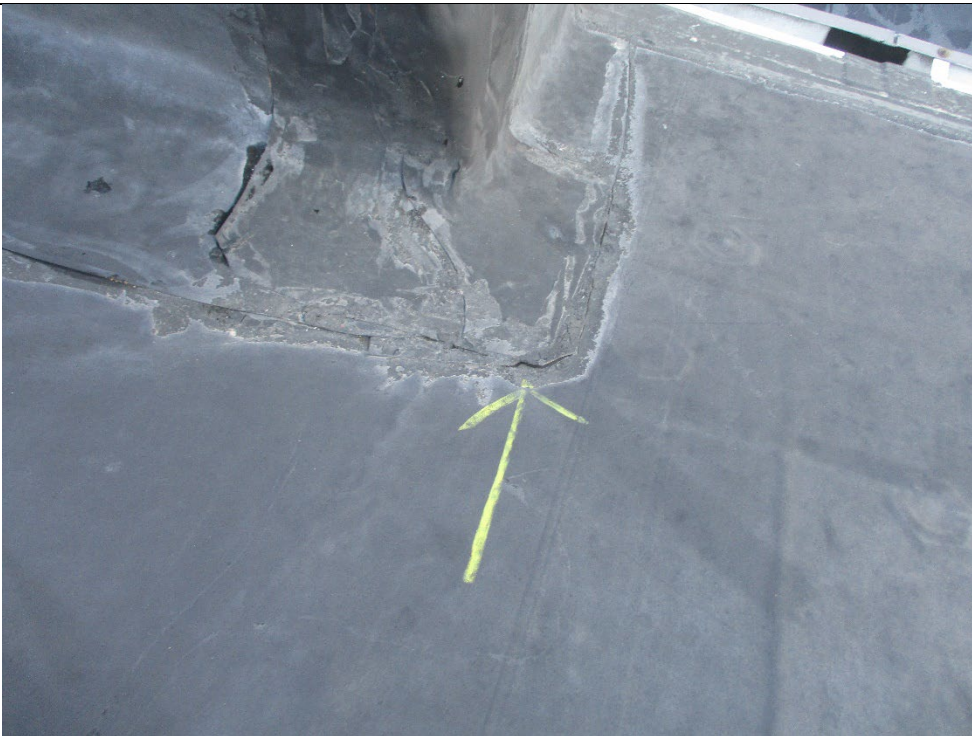
Description:
View of damaged EPDM edge flashing.

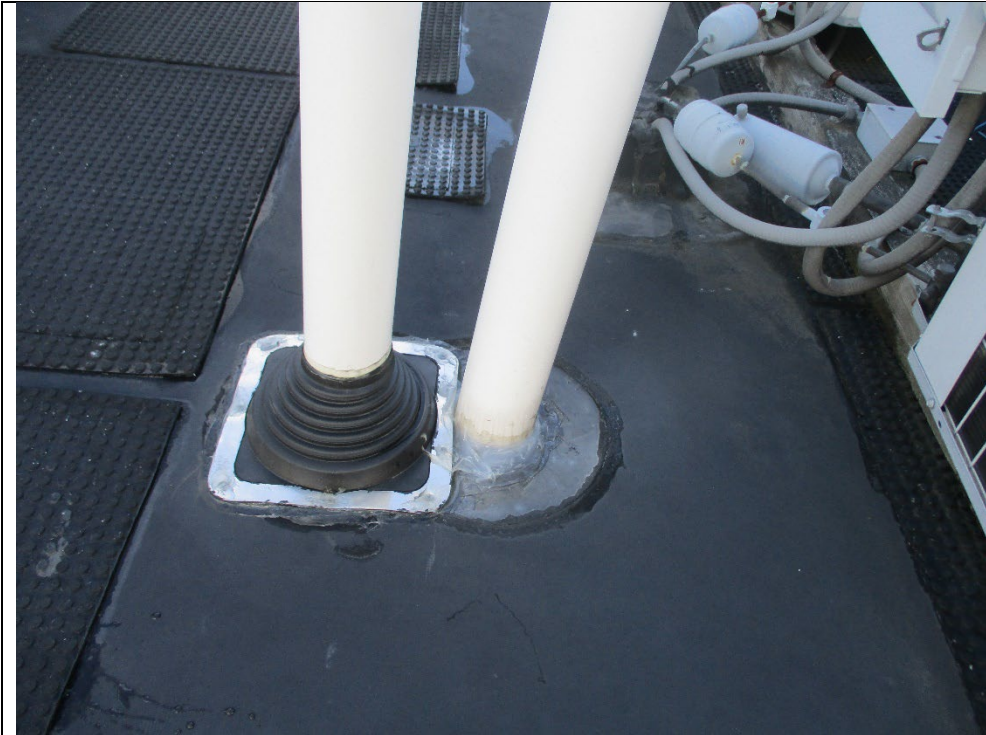
ROOF ASSESSMENT REPORT
THE COLLE BUILDING, 85 AVENUE A, TURNERS FALLS, MA
(Photo Documentation)

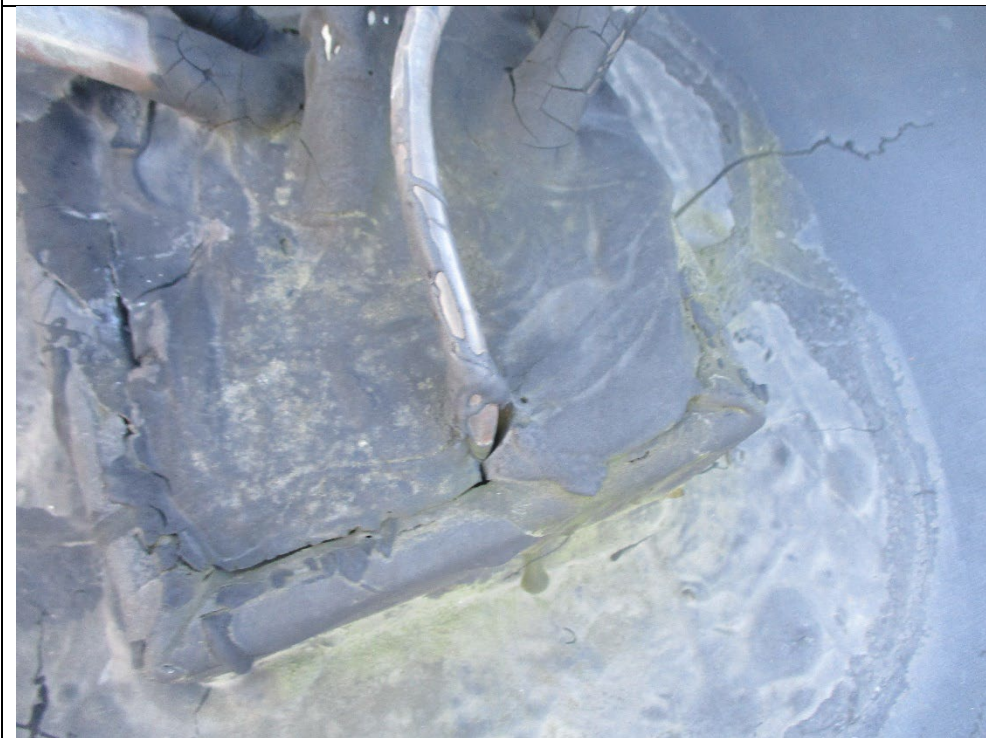
Description:
Two PVC vent stacks on roof. The left vent has an improper pipe boot with no hose clamp, typically used on metal roofs. The right vent has no boot and is relying on clear silicone to seal the base of the pipe.
