Cut and Cap Locations—Photographic Log

Client: Town of Montague	Job Number: 225003.015.01.01
Site: Strathmore Mill Footbridge, Montague, MA

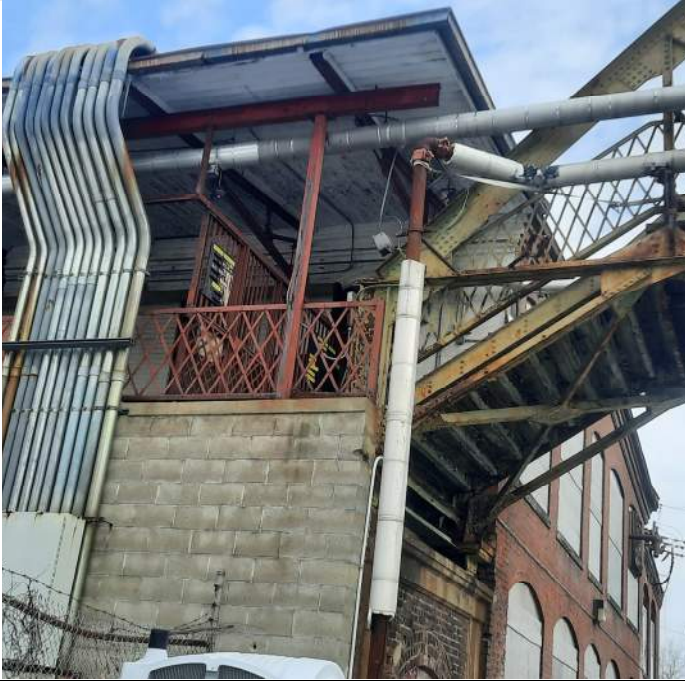
Photograph No.: 1	Date: 3/5/2025	Direction Taken: N/A
Description: Mill side, south side of Footbridge. Cut and cap the two lines in the foreground right under the roof line. Insulation is non-asbestos.

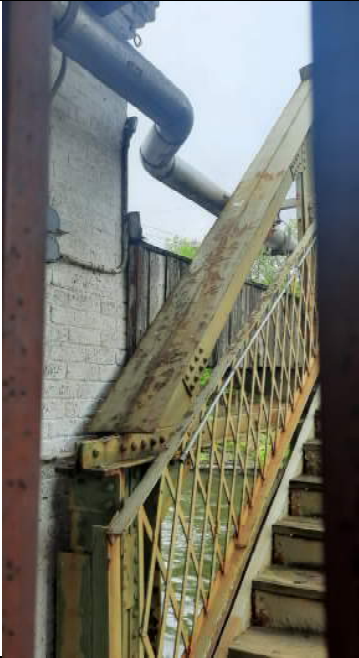
Photograph No.: 3	Date: 5/15/2025	Direction Taken: N/A
Description: Mill side, north side of Footbridge. Cut and cap uninsulated line at or near roof line. Note photo depicts wood box with 8-inch steel pipe within. Remove remnant wood (after abatement of roofing tar from wood) to access pipe and cut close to flush at wall where it enters the building.

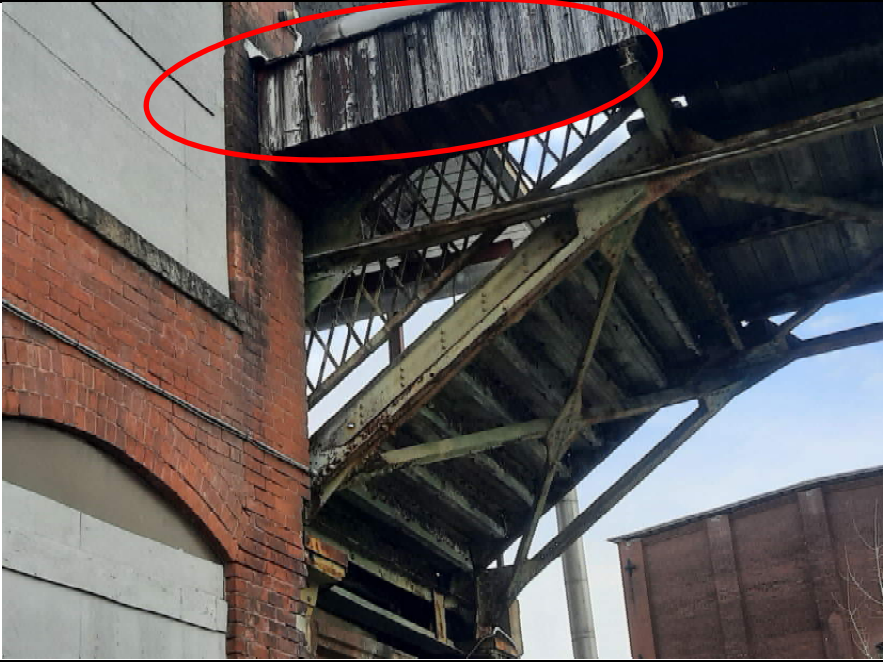
Photograph No.: 4	Date: 3/4/2025	Direction Taken: N/A
Description: Mill side, north side of Footbridge. Photo depicts the same two lines shown in Photo No. 3, one of which is contained within a wooden box requiring partial demolition to access the interior pipe (within red oval).

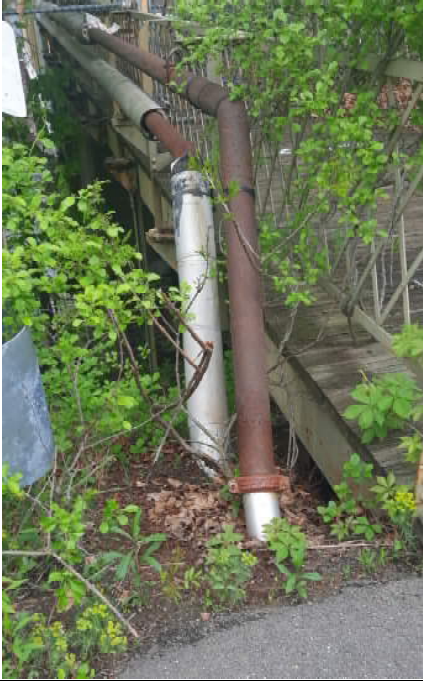
Photograph No.: 5	Date: 5/15/2025	Direction Taken: N/A
Description: Street side, south side of Footbridge. Cut and cap two lines below grade.
