Date: 4/14/2023

Project No.: 21005

To: Town of Montague, MA

Subject: Millers Falls Wastewater Collection System Study - FINAL

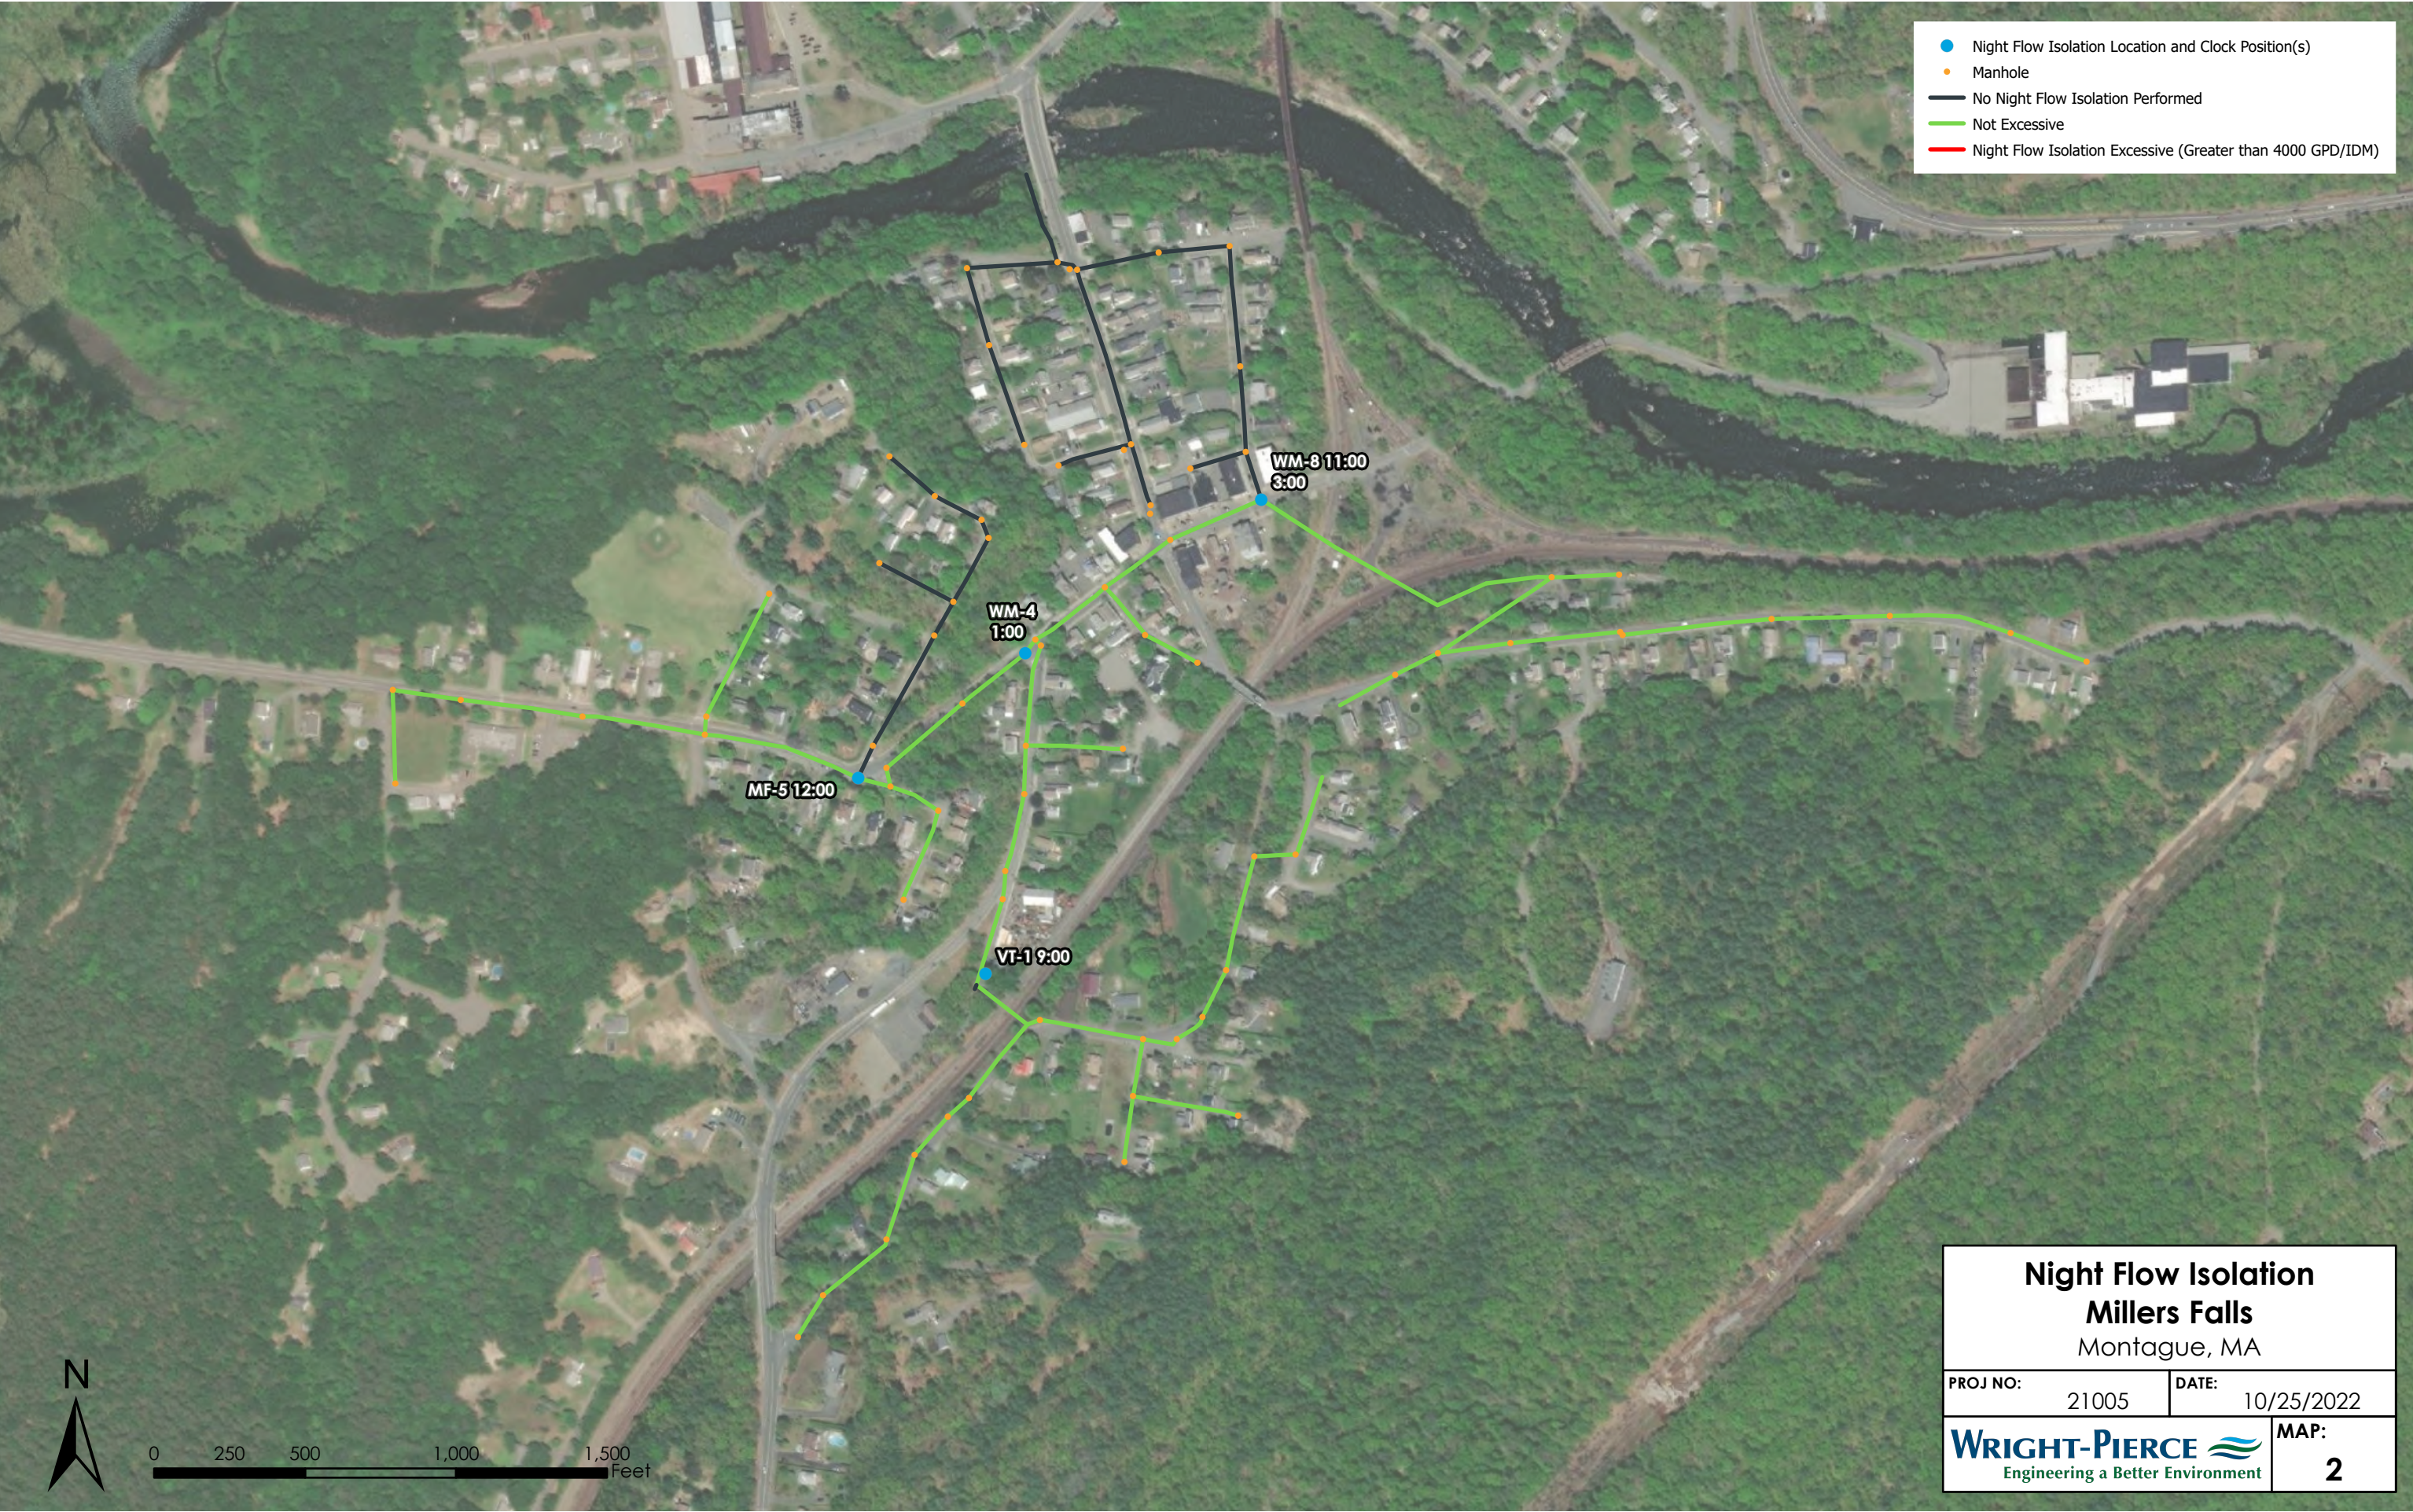
<b>Night Flow Isolation</b>	
<b>Millers Falls</b>	
Montague, MA	
PROJ NO: 21005	DATE: 10/25/2022
<b>WRIGHT-PIERCE</b> <small>Engineering a Better Environment</small>	MAP: <b>2</b>

Map 2 shows the areas targeted for NFIs and the infiltration rate results. Table 3 contains the results of the NFIs, ranked according to the net infiltration rate of the isolation area. None of the isolation areas in Millers Falls were found to be excessive for infiltration.

Night flow isolations were also completed to pinpoint smaller areas of high BI within the meter basins and to collect flow information in areas that were not metered. A summary of the excessive night flow measurement was provided in Table 3. None of the isolation areas in Millers Falls were found to be excessive for infiltration.

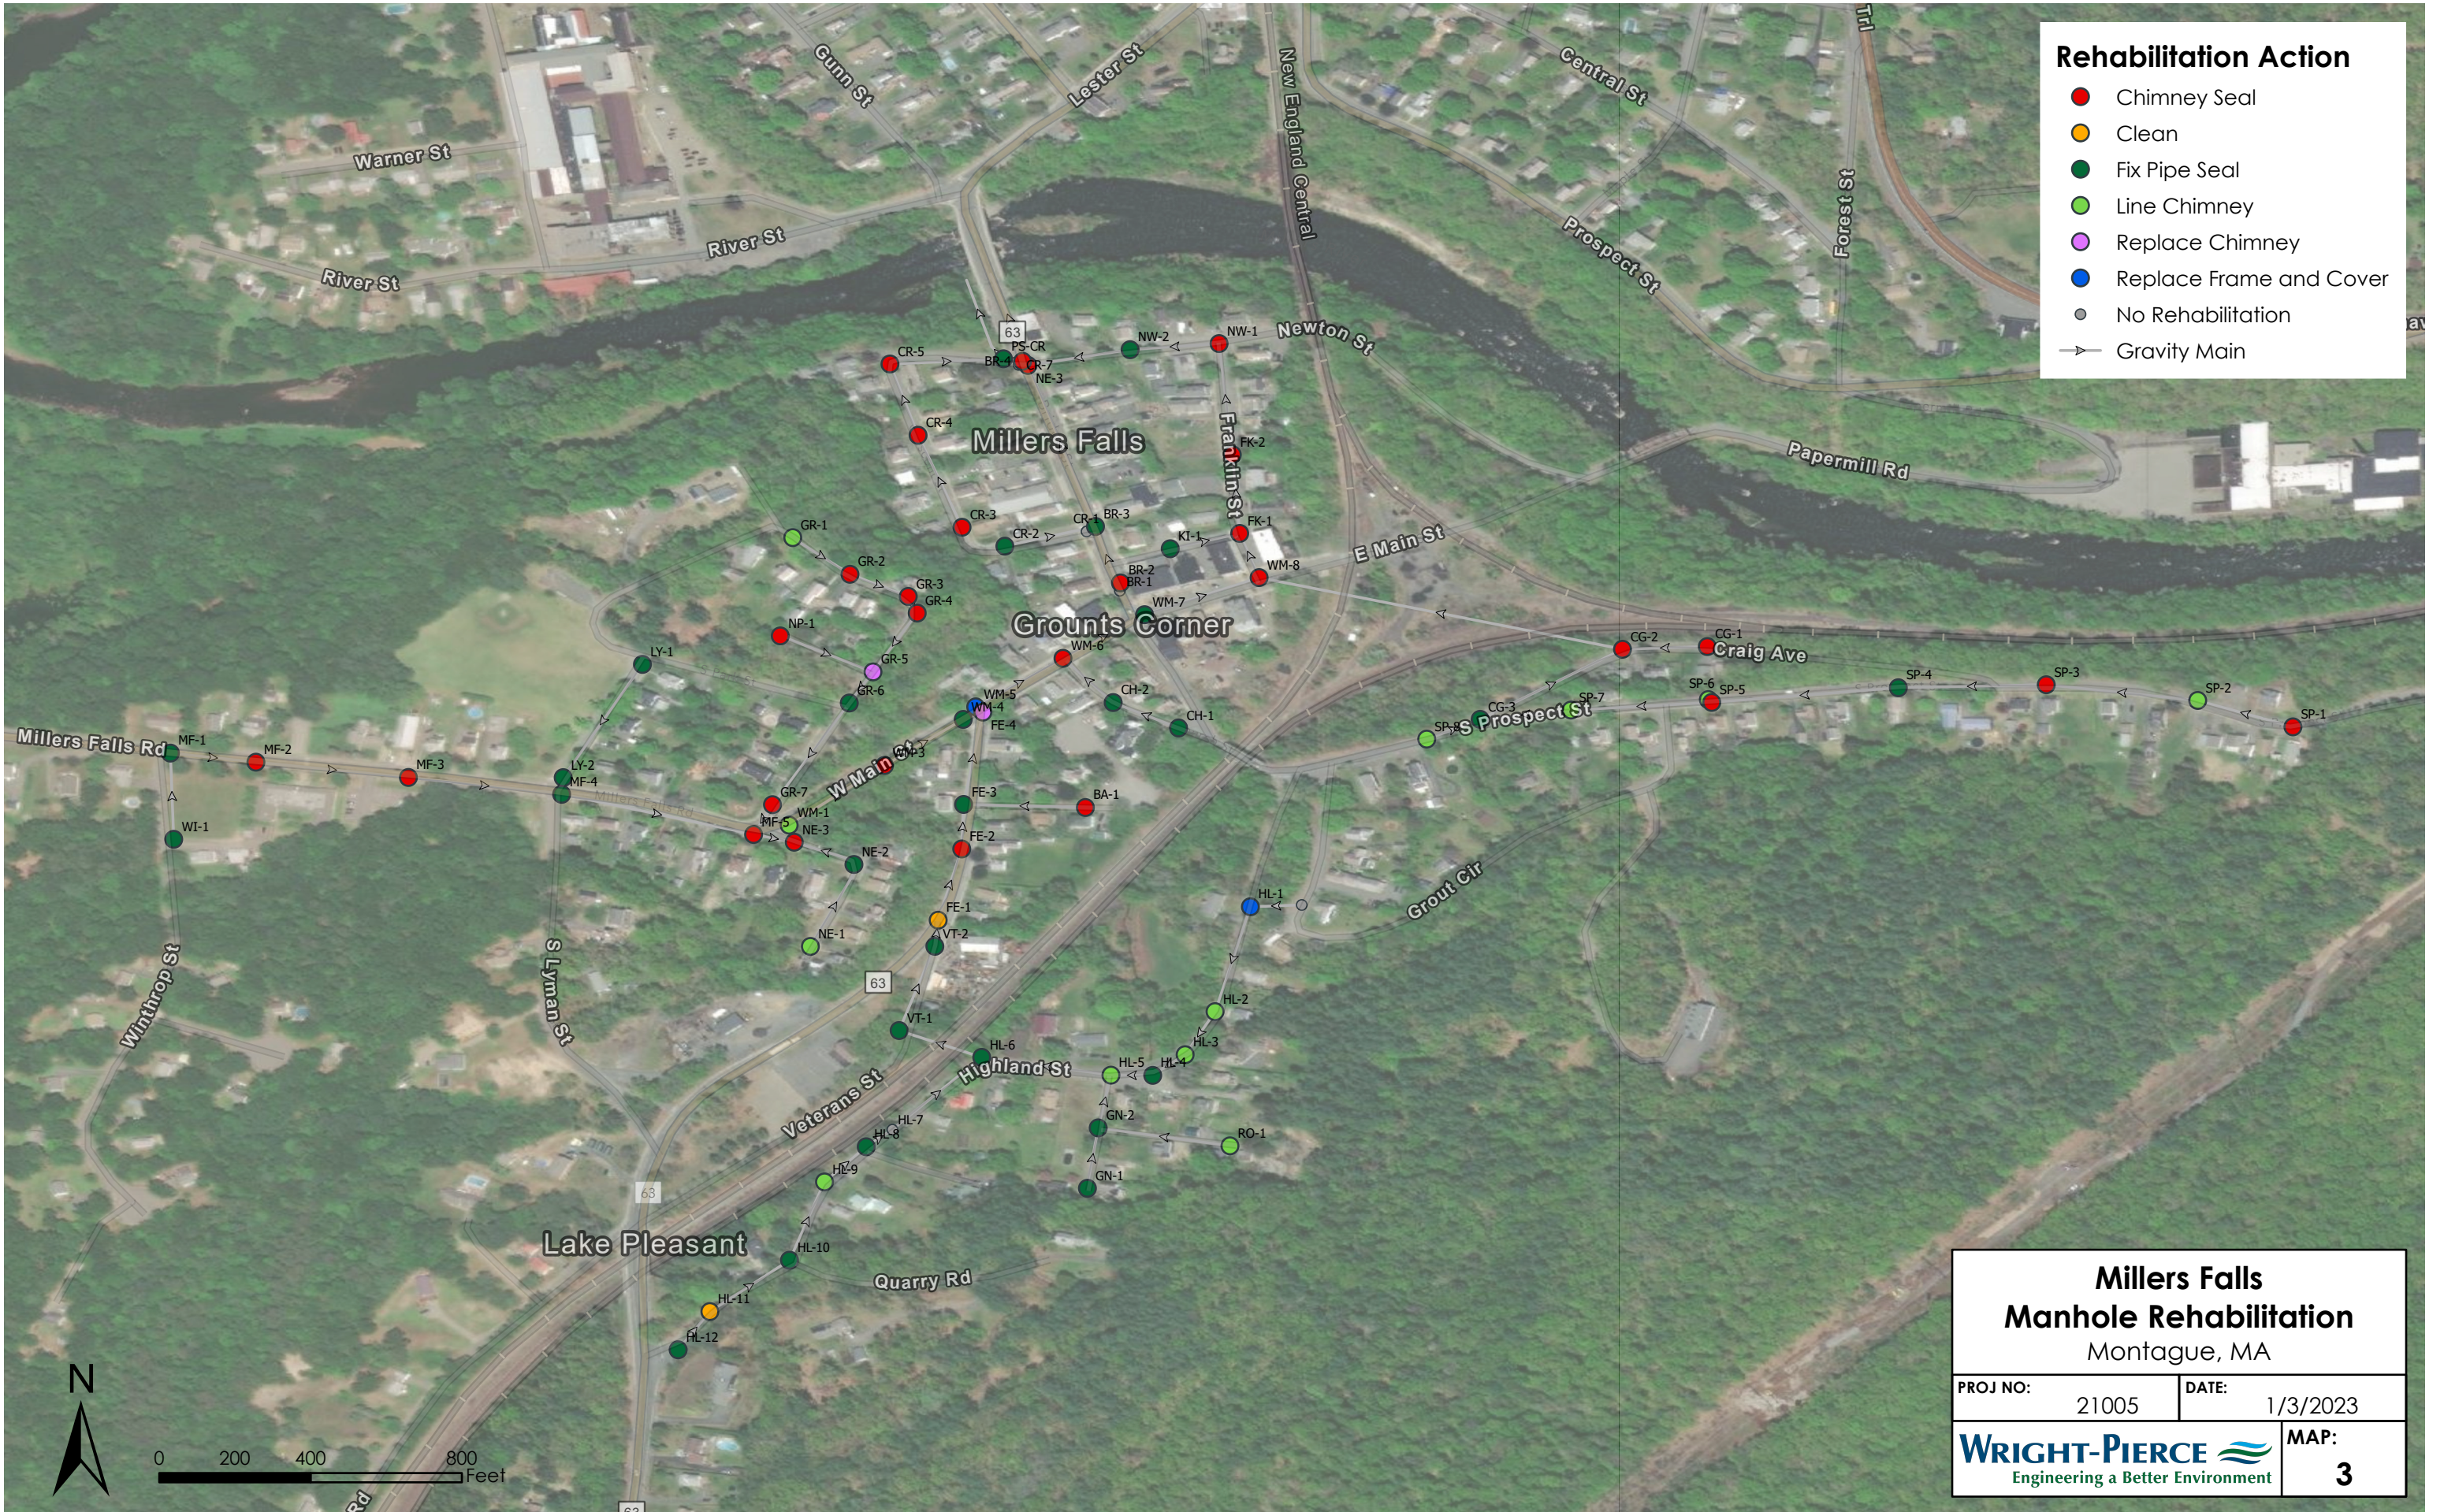
<b>Millers Falls Manhole Rehabilitation</b> Montague, MA	
PROJ NO: 21005	DATE: 1/3/2023
<b>WRIGHT-PIERCE</b> <b>MAP: 3</b>	
Engineering a Better Environment

Inspected manholes and their rehabilitation recommendations are depicted in Map 3. Inspected pipe segments and their rehab recommendations are depicted in Map 4.

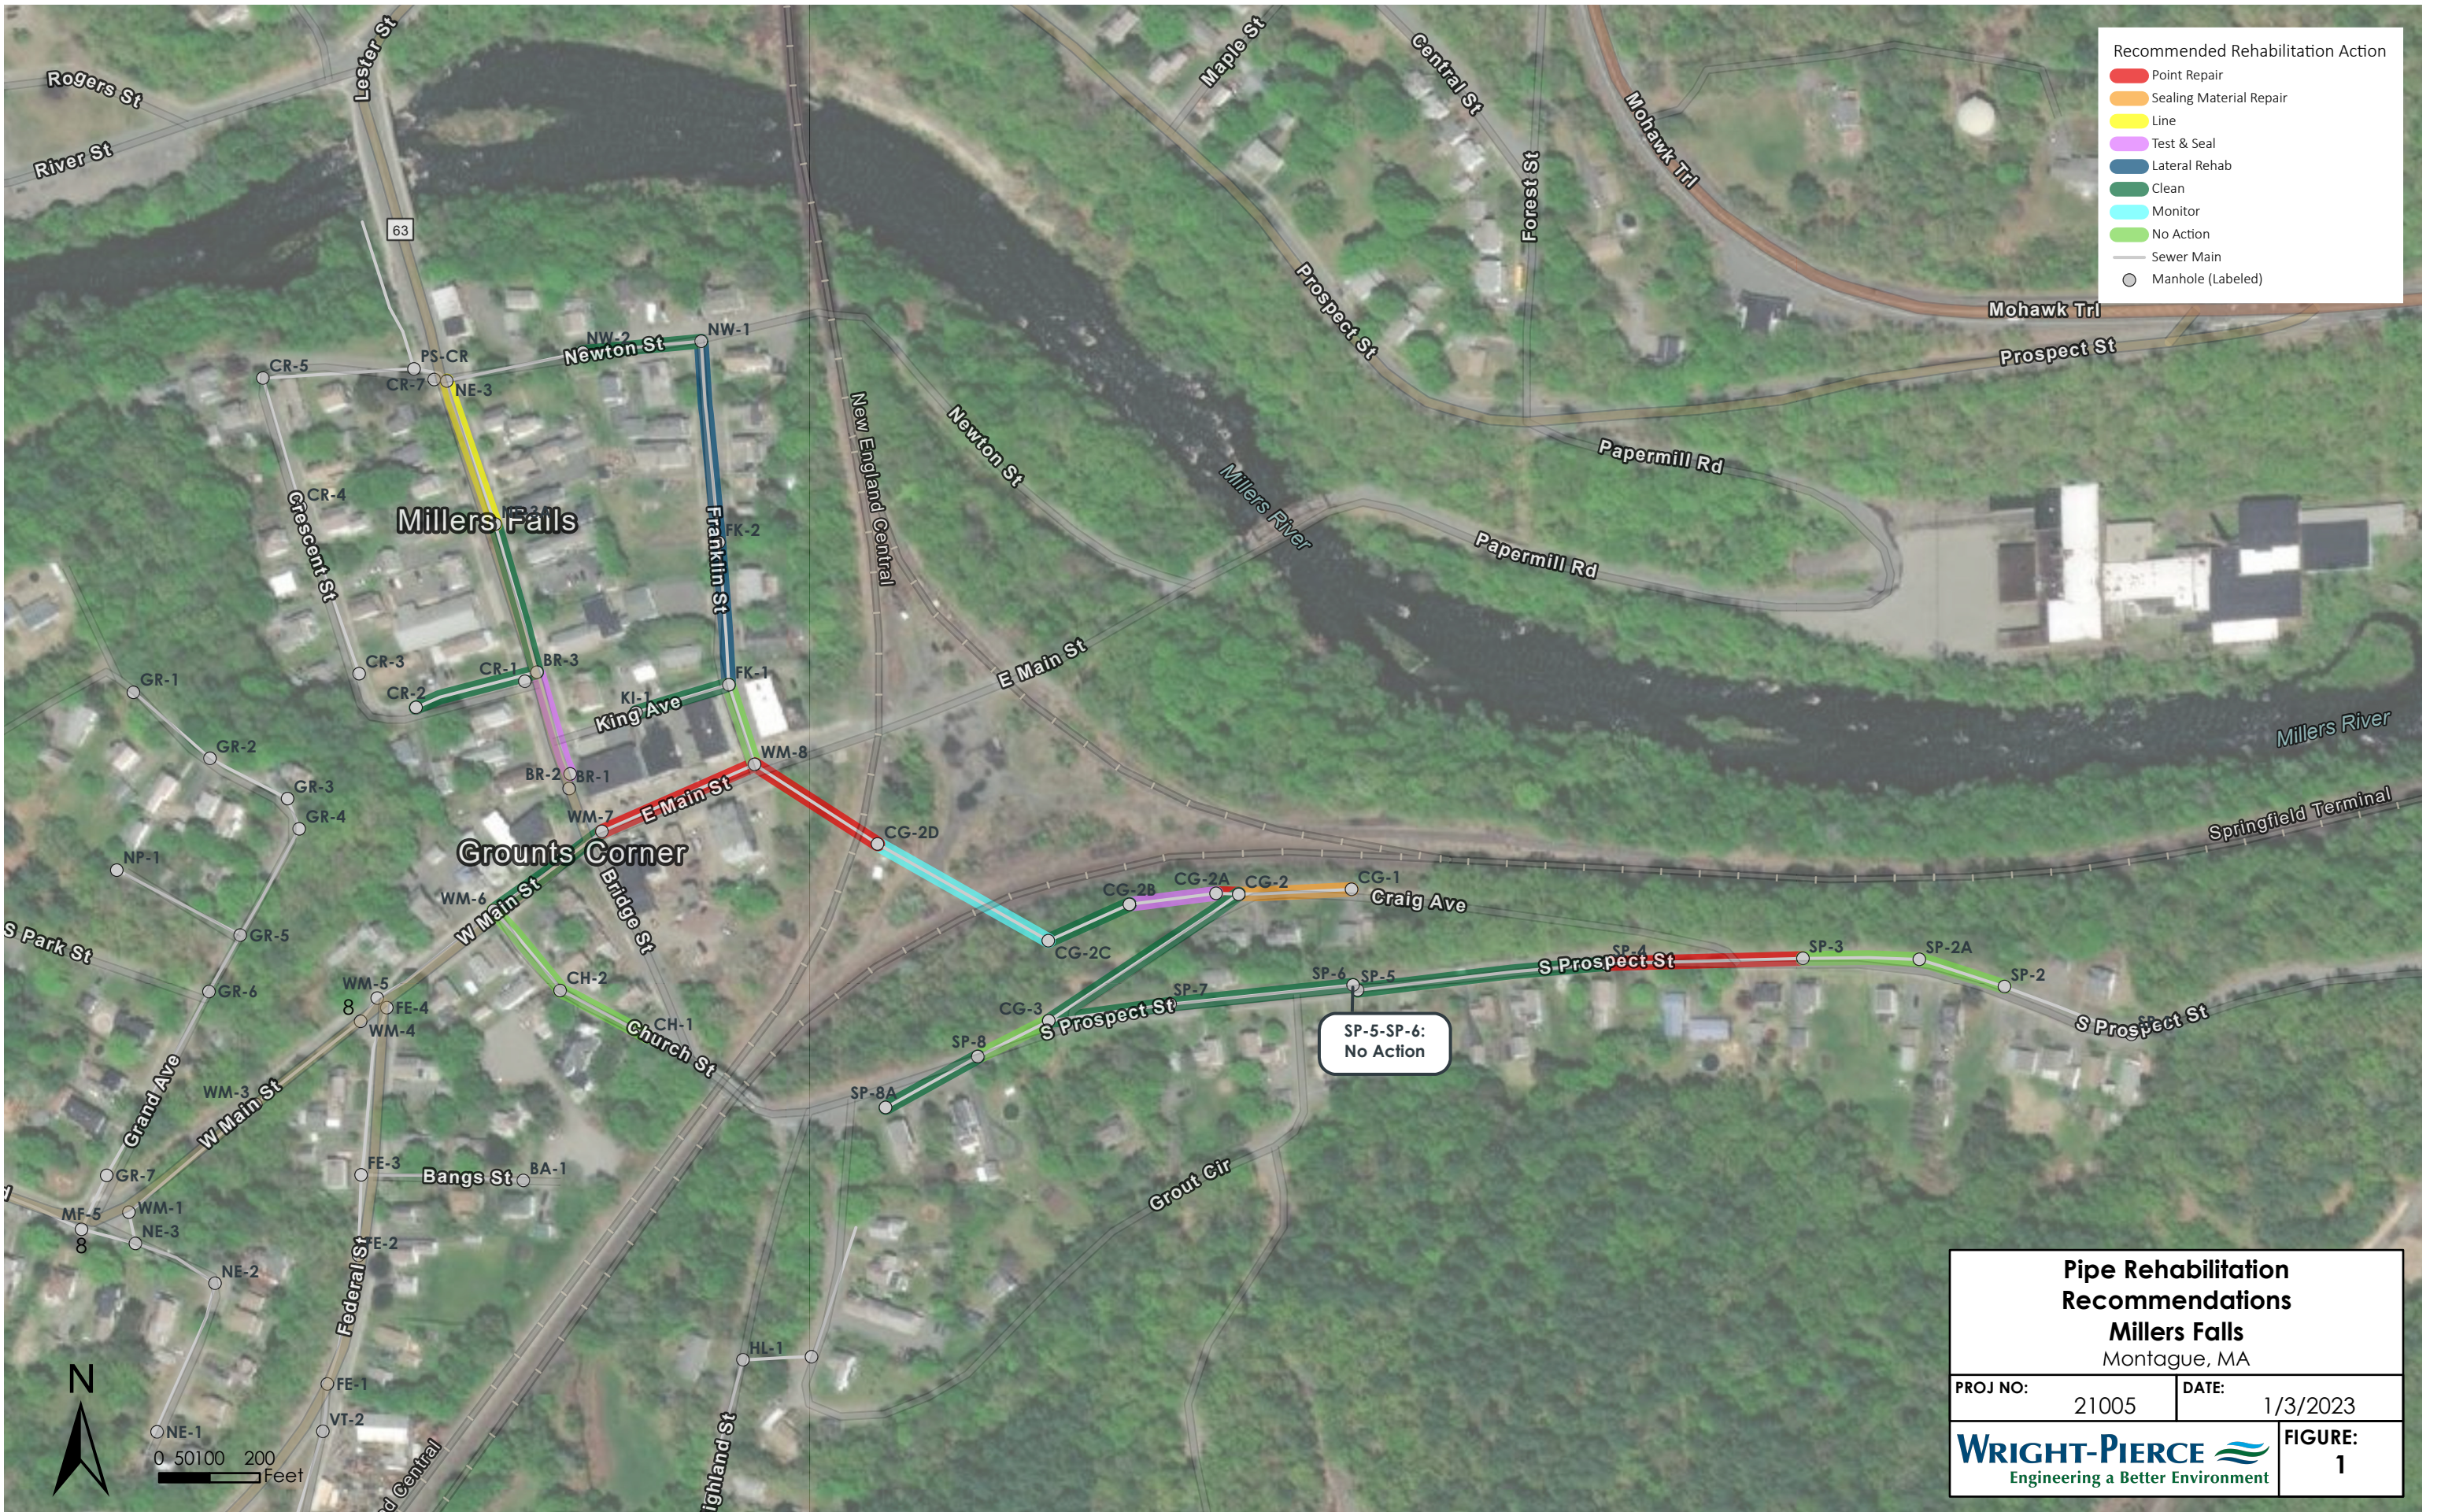
<b>Pipe Rehabilitation Recommendations</b>	
<b>Millers Falls</b>	
Montague, MA	
PROJ NO: 21005	DATE: 1/3/2023
<b>WRIGHT-PIERCE</b>	
Engineering a Better Environment	
<b>FIGURE: 1</b>

Pipe inspections were conducted by flushing the sewer pipes between manholes using a high-pressure jetter to loosen any debris and provide a clear view of the infrastructure. A camera was then run through the pipe, so the operator could see the entire pipe above the water line from the inside. The camera is mounted to a robotic vehicle, which can navigate through the sewer pipes and can rotate to almost any angle to get a closer look at any defects seen by the operator. The entire inspection was recorded on video for review. Any defect in the pipe was noted as well as the distance of the defect from the camera launching manhole. A Wright-Pierce NASSCO PACP certified engineer then performed an independent review of twenty percent of the reports and videos to provide quality control for the pipe inspections. The CCTV inspection reports are included in Appendix B. Inspected pipe segments and their rehab recommendations are depicted in Map 4.
