Property Condition Assessment

Millers Falls Library
23 Bridge Street

Millers Falls, MA

January 15, 2021

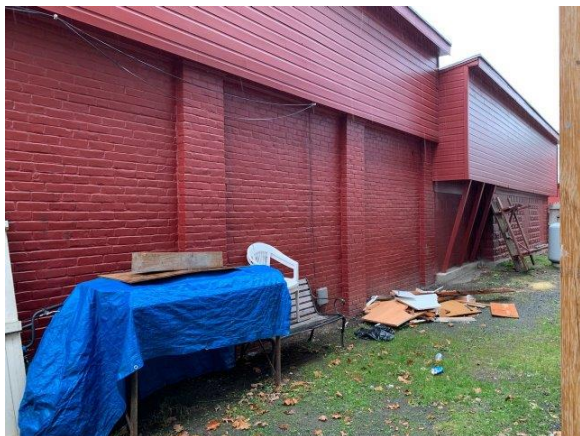
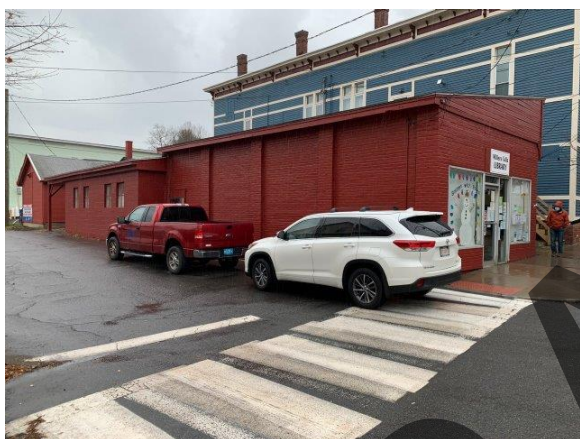
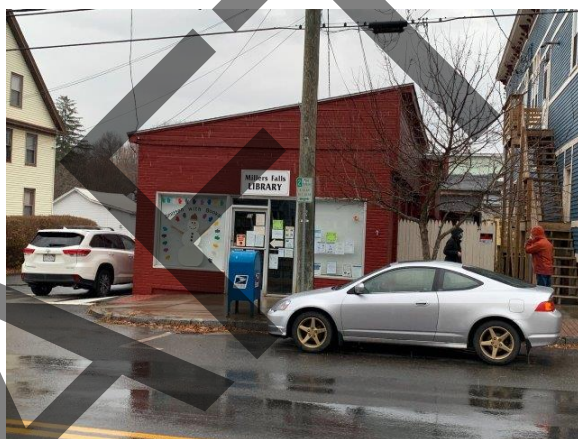
It was observed that at the base of the exterior walls along the north elevation of the rear section of the building and at the west elevation the joint between the exterior wall and the adjacent bituminous paving and cast in place concrete sidewalks was open. This condition will allow water to infiltrate the pave surfaces at the foundation wall. While the rear portion of the north elevation is adjacent to an unfinished crawl space, it was reported by onsite personnel that at the west elevation which is adjacent to the full basement there is an ongoing issue with water infiltration.

5.1 Site & Features at Grade							
Observation/Issue/Recommended Correction				Estimated Cost, Category and Year			
Item	Qty	Unit	Unit Cost	Total Cost	Cat	Year	
1. Remove debris from sided yard	1	LS	\$100	\$100	CE	1	
Clean and caulk pavement to base of exterior wall rear section North	100	LF	\$10.00	\$1,000	CE	1

5.1 Site & Features at Grade						
Observation/Issue/Recommended Correction			Estimated Cost, Category and Year			
Item	Qty	Unit	Unit Cost	Total Cost	Cat	Year
3. Clean and caulk pavement to base of exterior wall West elevation	40	LF	\$10.00	\$400	CE	1
4. Contingency		10.0%		\$150	CE	
Total				\$1,650

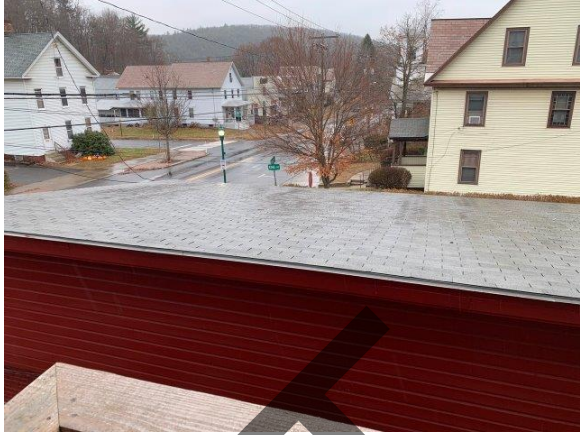
Roofing

The roof over the front section of the Property appeared in good condition, consistent with its reported age. The asphalt shingles roof over the rear section were observed to exhibit early signs of cupping and/or curling. Cupped and/or curled shingles are most often an indication of the advanced age of an asphalt shingle roof, although it can also be caused by extreme weather or issues with attic ventilation.

At the interior, it was observed that there were water stains on the acoustic ceiling tile located just beneath the transition of the two roofs. On site personnel stated that there had been a leak at the transition, however it repairs were made to the flashing of the transition and they were not aware of any active leaking.

Given the prior history of leaks at the transition between the front and rear roofs, it is recommended that the flashing and sealants at the transition be inspected and repairs made as required.

The roof over the rear section was observed to be cupping and/or curling which is an indication of age and potential failure. The roof over the rear section will require replacement in early in the evaluation period.

The roof over the front section was reported to be 10-15 years old and appeared in good condition. Asphalt shingle roof systems have an expected useful life ("EUL") of 20-25 years. At the end of the evaluation period the roof on the front section will be 25-30 years old and should be replaced.

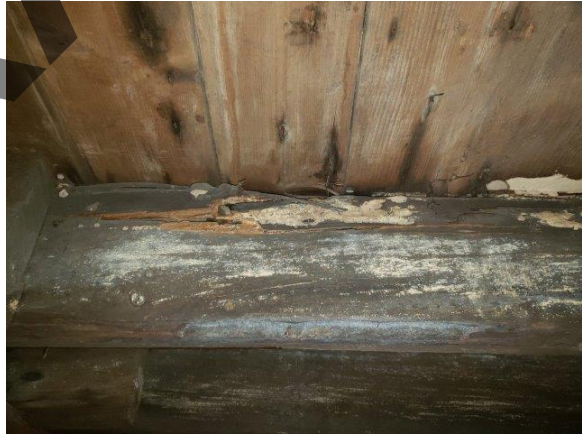
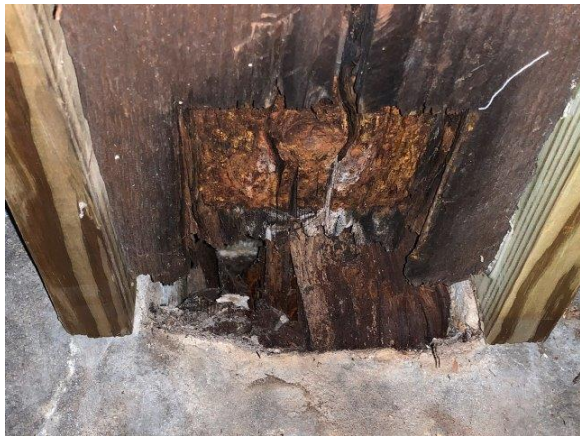
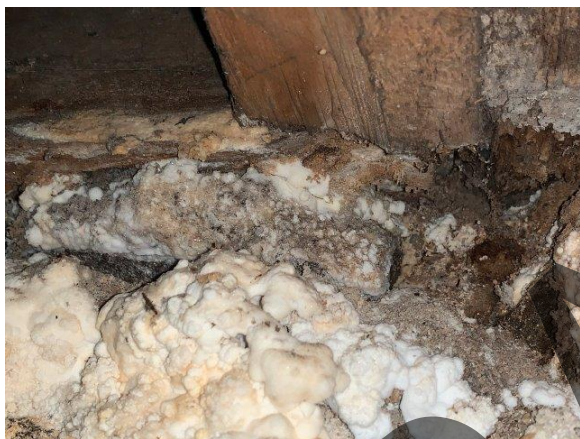
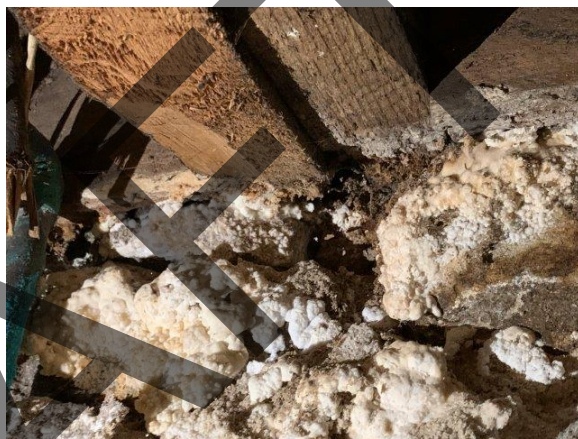
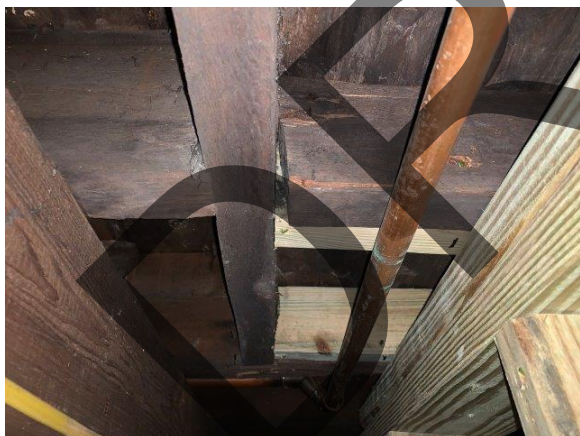
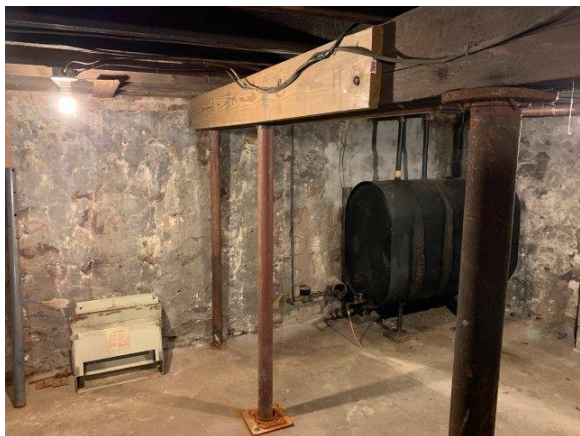
Structural System

In general, the building structural systems appeared to be in fair condition, with no apparent indications of deflection or settlement. It was observed that several of the wood timber beams supporting the floor joists above had been recently reinforced by the addition of sister joists and the installation of new additional steel lally columns.

It was observed that some of the wood timber beams were completely rotted away at the beam pockets and that some of the wood timber beams exhibited evidence of past pest infestation and/or rot. It appears that the addition of the sister joists and new lally columns were a remedial effort to address these conditions.

It was observed that the sister joists were face nailed into the wood timbers and that the sister joists are not continuous for the full length of the beams. While the use of gluing and face nailing is acceptable method of sistering a structural member in this condition, the overall appearance of the repairs raises questions about the quality and adequacy of the repair.

It was reported that the basement has had issues with water infiltration at the foundation walls and possibly through the floor slab. Several of the steel lally columns exhibited advanced corrosion at the base of the columns.

Below the main entrance, new wood shoring was installed to support perpendicular floor framing under the door. The framing is pressure treated lumber, however it bears on the floor slab which has moisture issue that will cause the framing to deteriorate over time

While face nailing sister joists to the original beam using construction adhesive between the two structural members is acceptable it is unknown if adhesive was used in the repair. Sister joists should be continuous for the length of the beam. The existing repairs should be inspected and revised as required to provide proper structural performance.

Past evidence of pest damage and areas of rot were observed that several of the wood timber beams. It is recommended that all wood timber beams be inspected and any additional repairs made as required.

The bases of the steel lally columns were observed to have advanced corrosion. The steel lally columns should be replaced with new columns set on a cast in place concrete footing that will keep the columns up off the wet basement floor.

The base of the chimney was observed to have heavy efflorescence and some deterioration to the brick. It is anticipated that the brick will need to be repaired at the midpoint of the evaluation term.

Replace wood shoring below main entry door with steel lally columns on a formed concrete base.

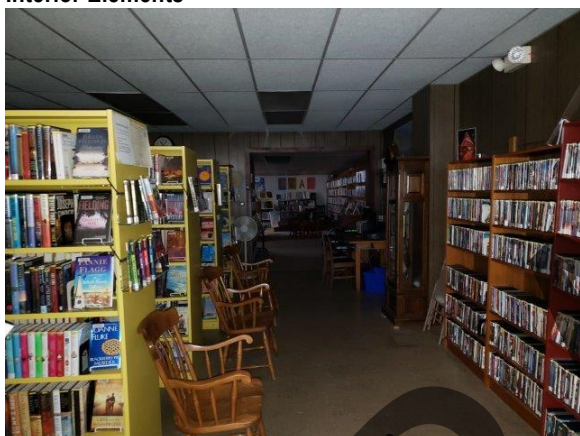
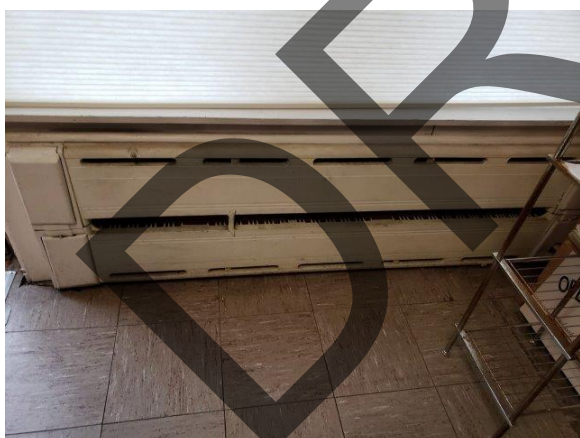
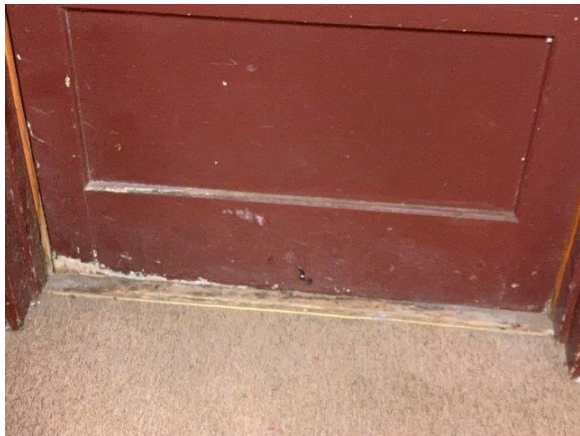
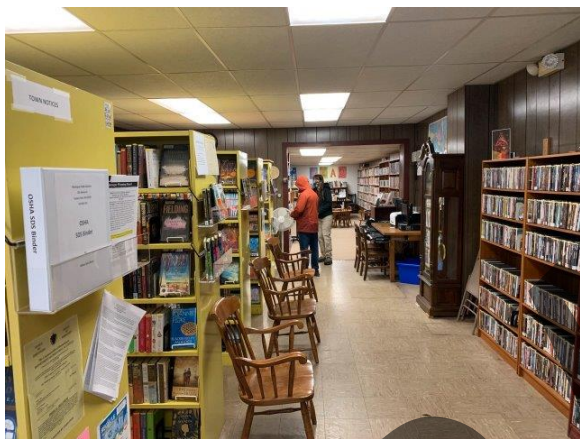
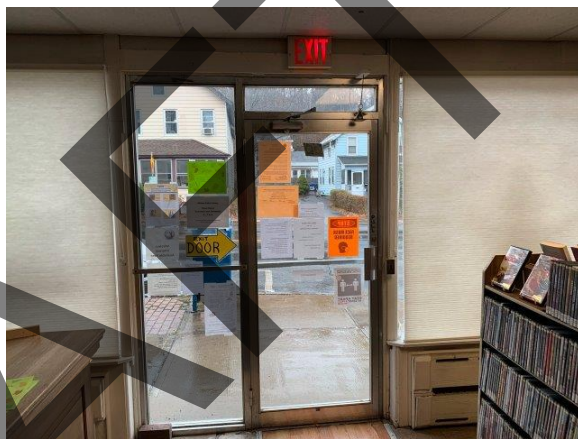
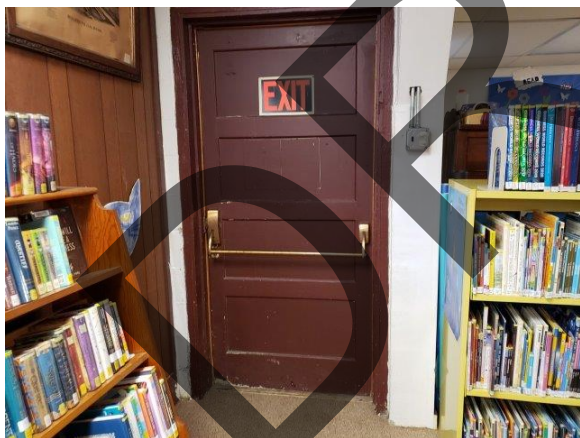
Interior Elements

There is water stained acoustic ceiling tiles located beneath the roof transition. Replace stained ACT tiles.

The wood door to the basement was observed to be in fair condition and should be replaced at the beginning of the midpoint of the evaluation term.

The exterior door at the rear section was observed to be in fair condition and should be replaced at the beginning of the midpoint of the evaluation term.
