# **ROOF ASSESSMENT REPORT**

**MILLERS FALLS LIBRARY ROOF  
23 BRIDGE STREET  
MILLERS FALLS, MA 01349**

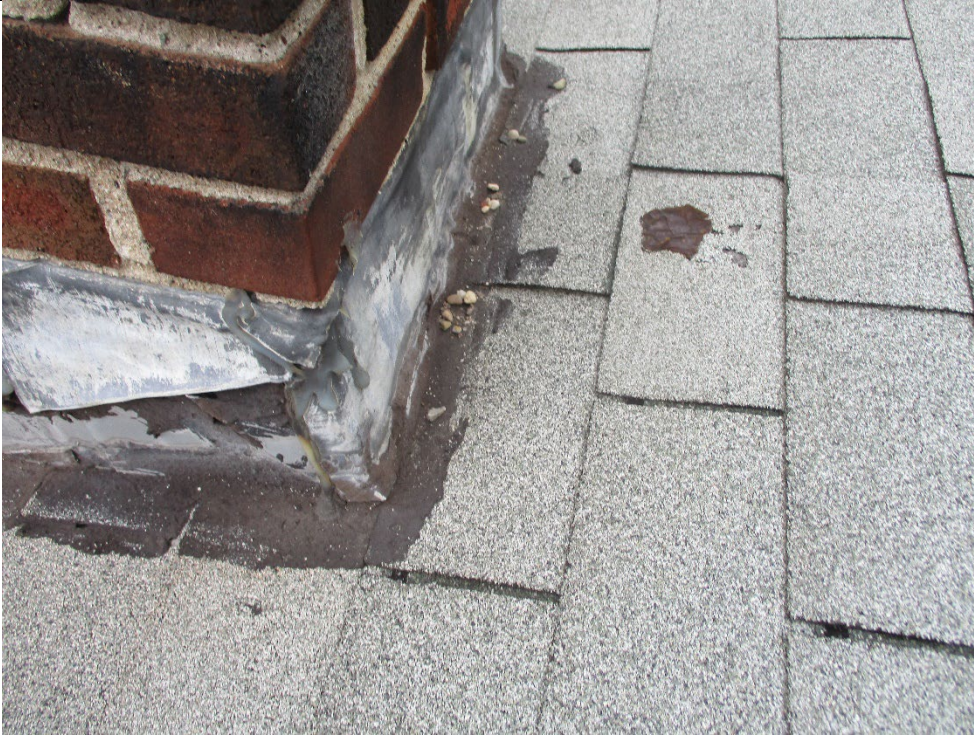
**Photo R5**  
01/06/22

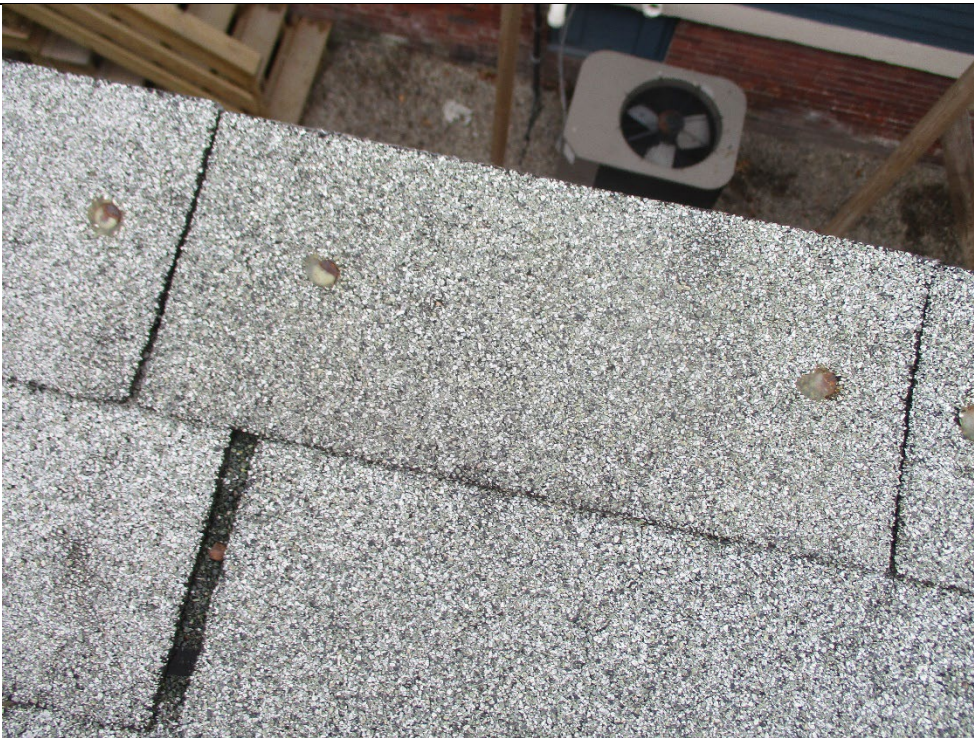
**Photo R6**  
01/06/22
