ROOF ASSESSMENT REPORT
MONTAGUE CENTER LIBRARY
17 CENTER STREET
MONTAGUE, MA 01351

Prepared For:

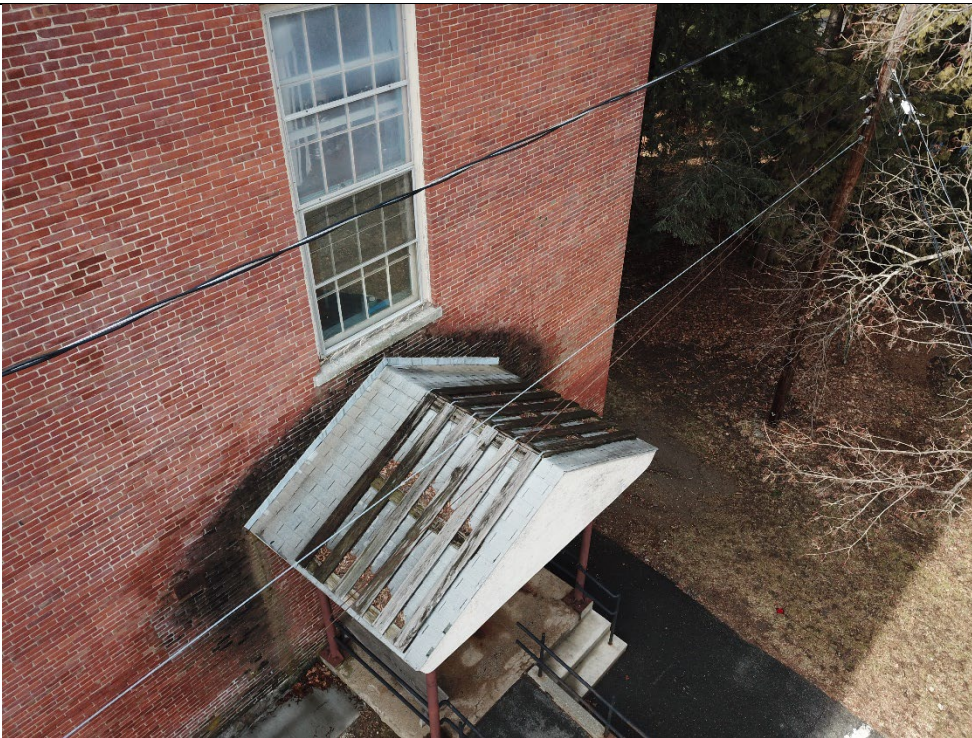
Description:
View of natural slate roof and numerous previous repairs with off colored slate. Note: waves in ridge line.

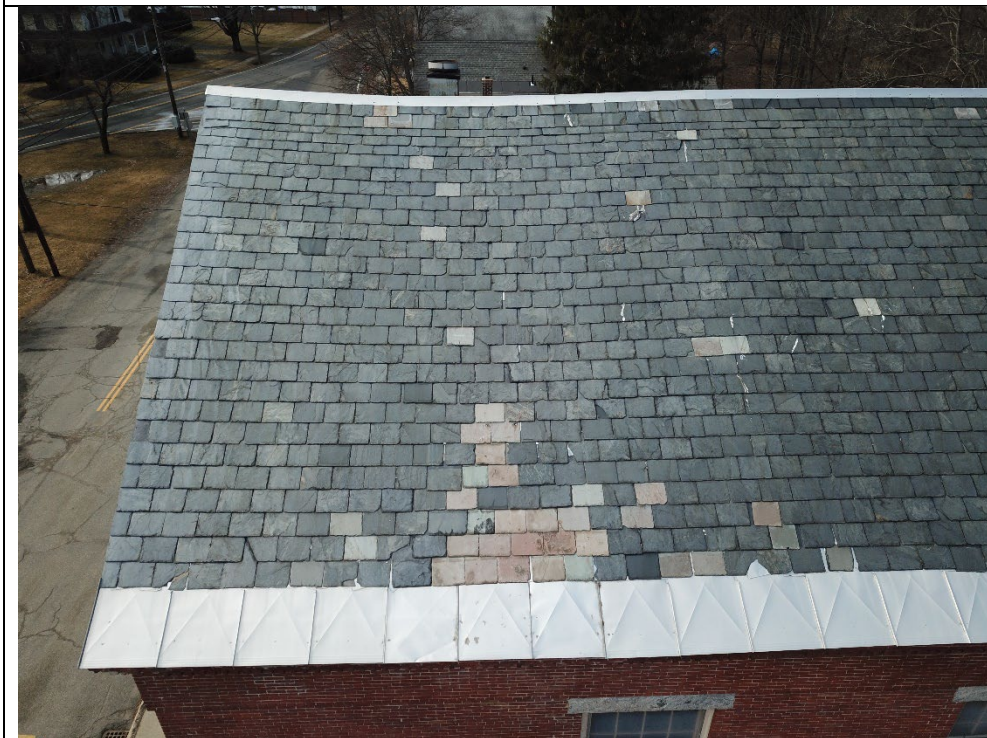
Description:
View of multiple missing slate covered with self-adhering bitumen membrane.

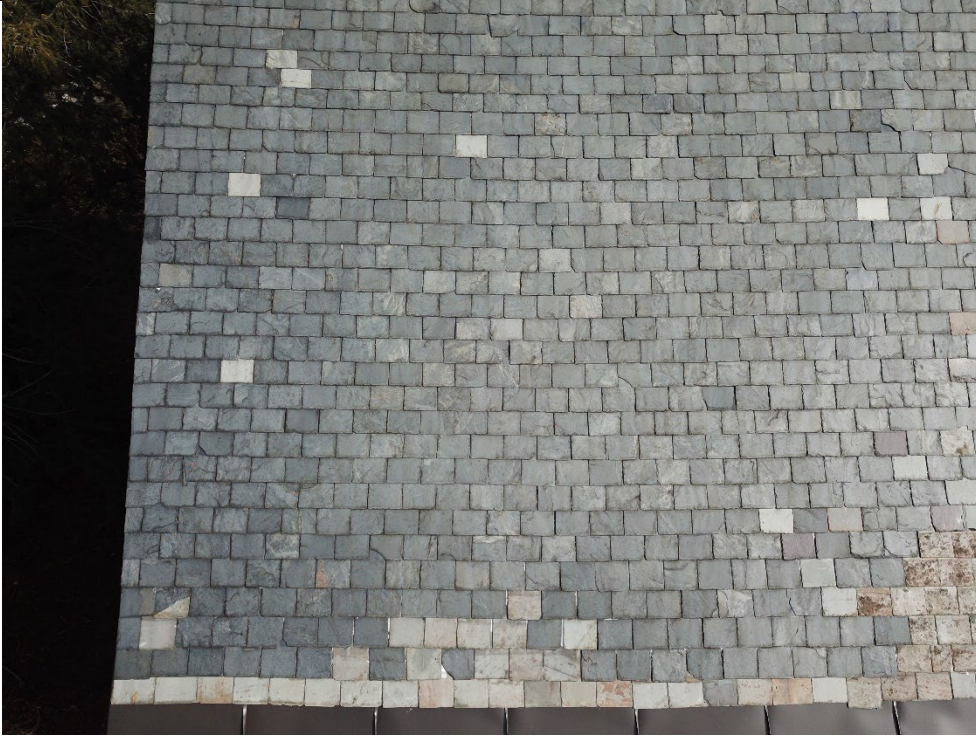
ROOF ASSESSMENT REPORT
MONTAGUE CENTER LIBRARY, 17 CENTER STREET, MONTAGUE, MA
(Photo Documentation)

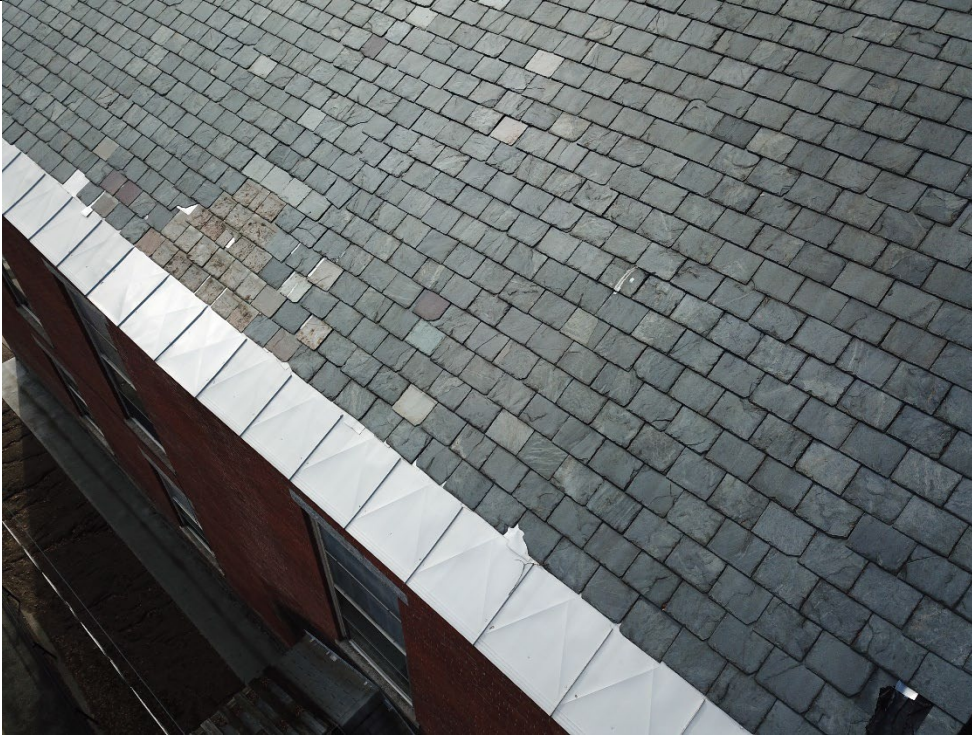
ROOF ASSESSMENT REPORT
MONTAGUE CENTER LIBRARY, 17 CENTER STREET, MONTAGUE, MA
(Photo Documentation)

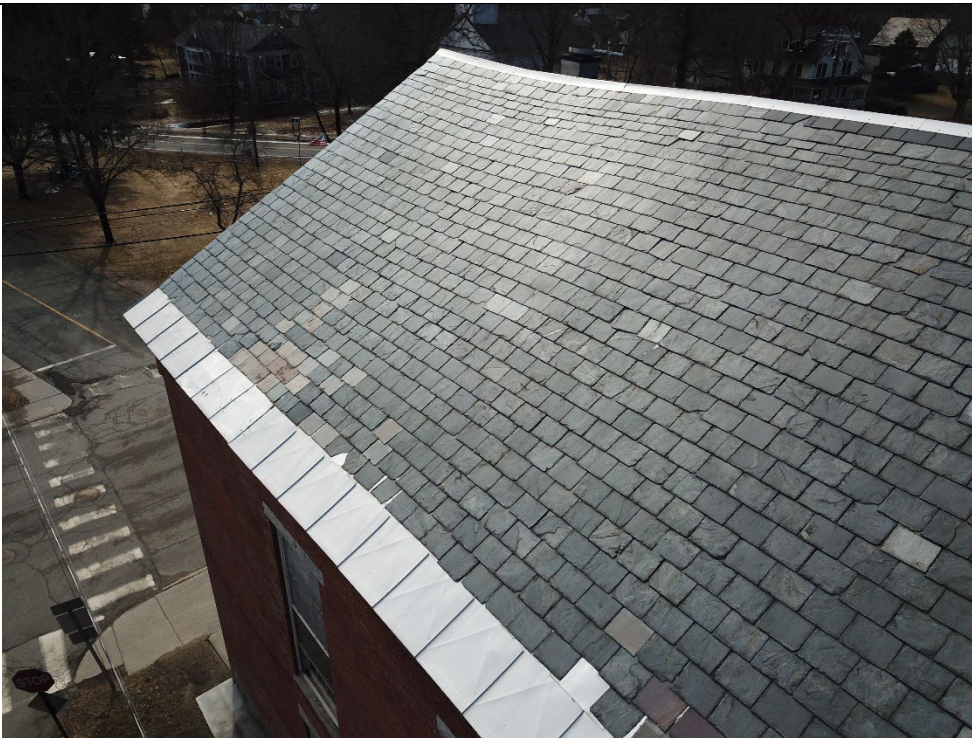
Description:
Metal ice belt appears to be in good condition and functioning as intended.
