STRUCTURAL ENGINEERING REPORT

MONTAGUE CENTER LIBRARY

17 Center Street
Montague, MA

August 12, 2021

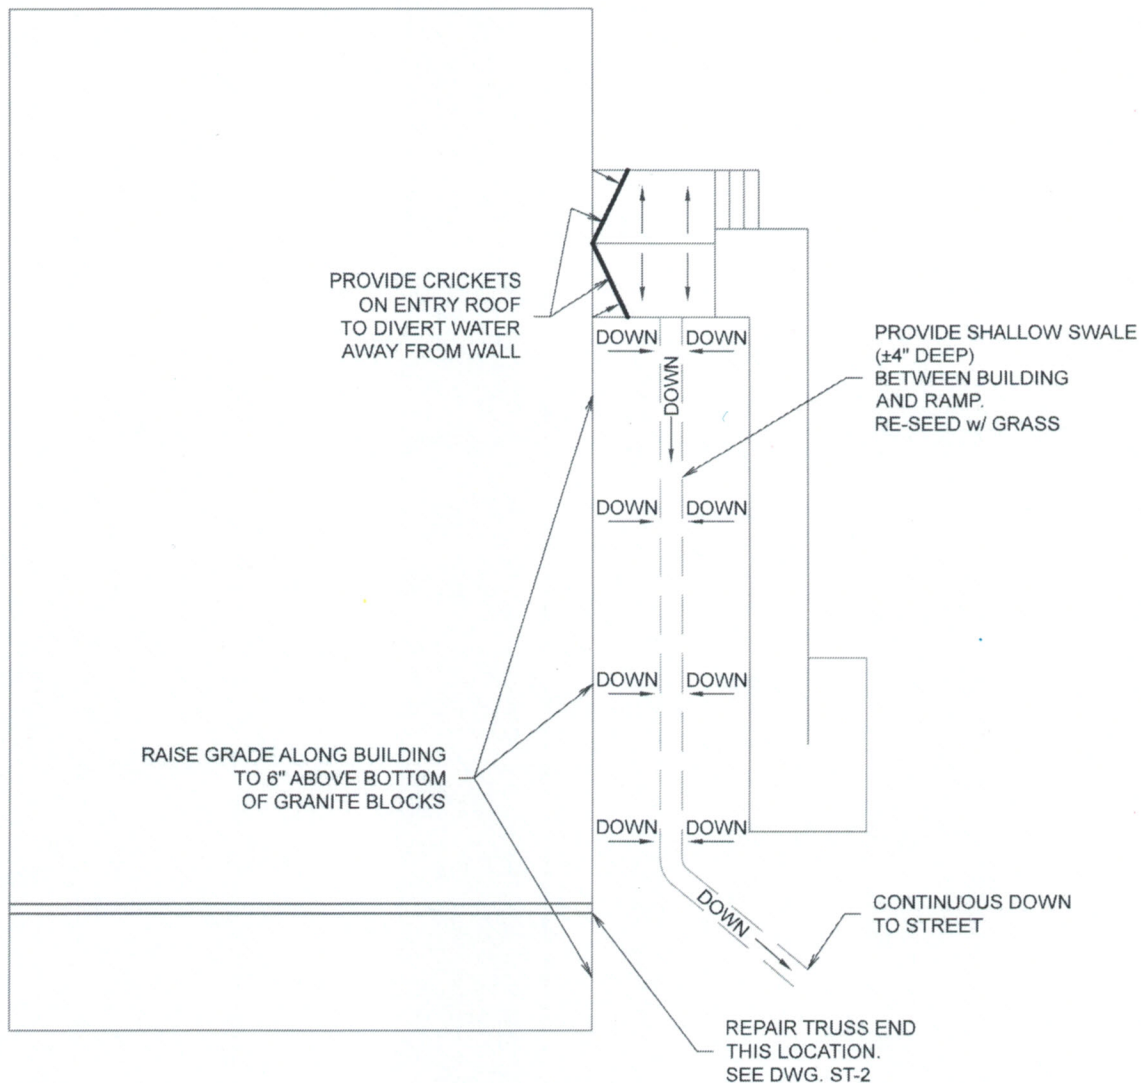
EAST SIDE DRAINAGE PLAN	DES. BY	RTL
	DWN. BY	RTL
BUILDING REPAIR	SCALE	3/32" = 1'-0"
	DATE	8/12/21
MONTAGUE CENTER LIBRARY MONTAGUE, MA	PROJECT NO.	21039
	REV.	
	DWG. NO.	ST-1

There is evidence of significant water intrusion into the basement along the east end of the building. I believe this is caused by poor grading along the east wall between the building and the handicap ramp. I have provided DWG. ST-1 to show how the area should be graded. Essentially, I recommend that a shallow swale be created midway between the building and the ramp, and also that the grade be brought higher on the foundation walls all the way to the southeast corner. I also recommend that the roof over the handicap entrance on be modified by creating crickets to divert the rain runoff away from the building. I believe these two measures should be taken before trying to modify the basement floor or interior foundation wall.

The Montague Center Library building is in decent shape for its age, but, as with all repairs, the longer one waits to repair a building the more expensive the project is likely to be. In the case of this building I recommend that the exterior grading be done quickly, as it will be a relatively inexpensive project and should prevent water intrusion from causing significant harm to the wood structure by rot and insect infestation. If water is still seen in that area after the area is regraded the issue should be revisited.

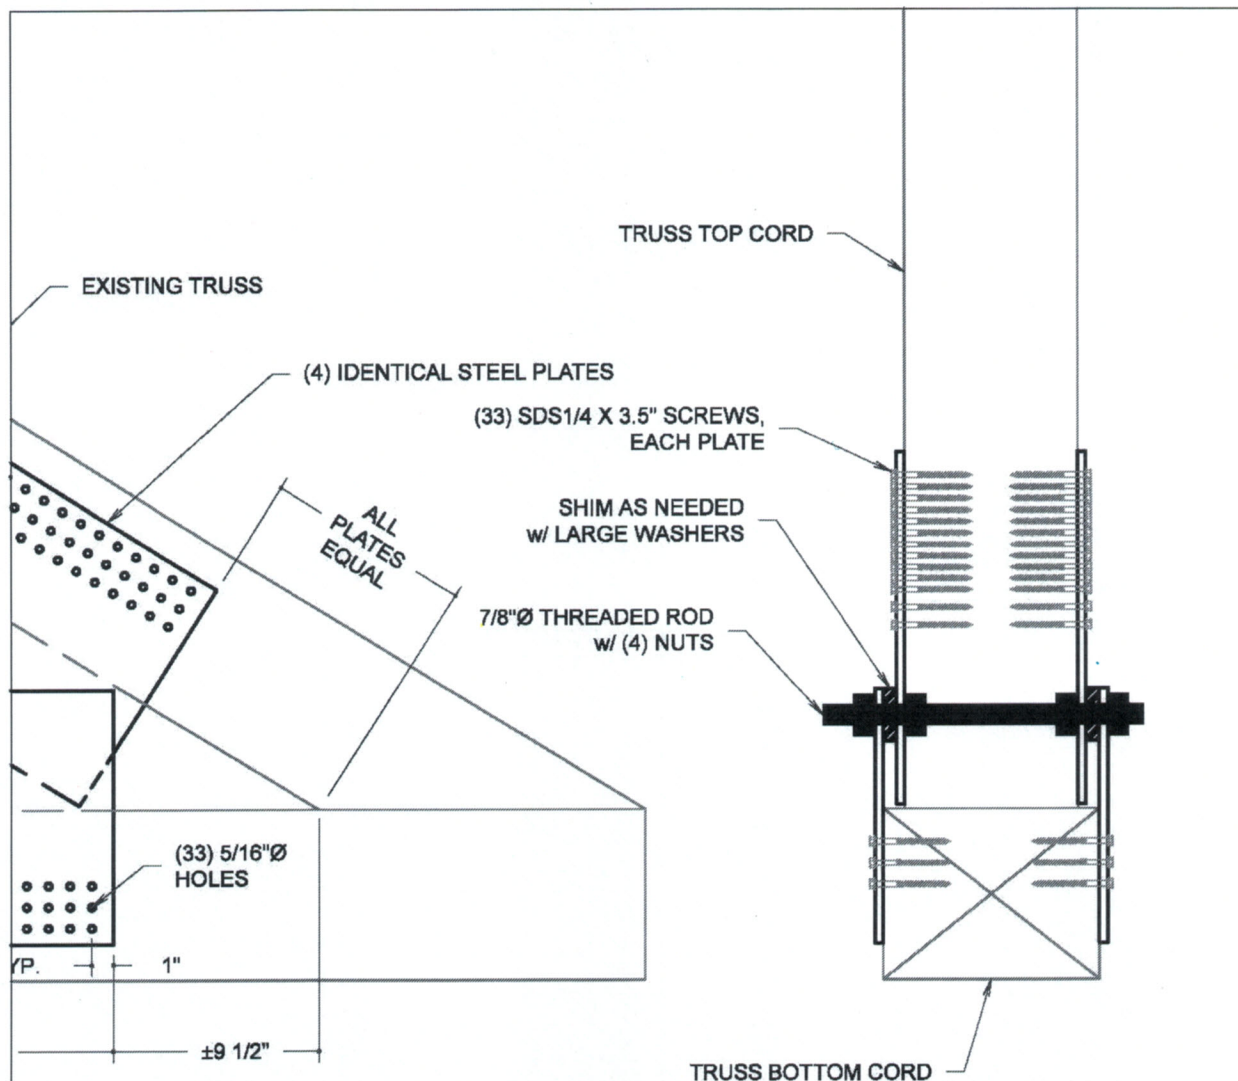
TRUSS END REPAIR	DES. BY	RTL
	DWN. BY	RTL
BUILDING REPAIR	SCALE	3/32" = 1'-0"
	DATE	8/12/21
	PROJECT NO.	21036
MONTAGUE CENTER LIBRARY	REV.	
MONTAGUE, MA	DWG. NO.	ST-2
<div style="text-align: center;">

I examined the attic during my second visit. I determined that the heating unit on the mezzanine is supported by its own frame, and does not affect the roof structure. Nevertheless, at some point it would be a good idea to remove it. I discovered that the east end of the southernmost truss underwent significant water damage at some time in the past. Although some repairs were made, and the leak apparently fixed, the end of the truss does not appear to have been sufficiently repaired. I have provided DWG. ST-2 to show a repair that will ensure that the truss remains structurally viable.

I believe it would be a good idea to fix the truss as soon as the budget allows as well. Although the truss does not appear to be moving yet, once it begins to deform the repair will be significantly more expensive, as it may require jacking the truss back into place.

- CONSTRUCTION NOTE:**
- 1) LOOSELY CONNECT PLATES w/ THREADED ROD BEFORE ATTACHING TO TRUSS CORDS
 - 2) WHEN ALL SCREWS ARE INSTALLED, TIGHTEN NUTS
