TOWN OF MONTAGUE CULVERT ASSESSMENT

September 2021

Town of Montague Culvert Assessment

Project Summary

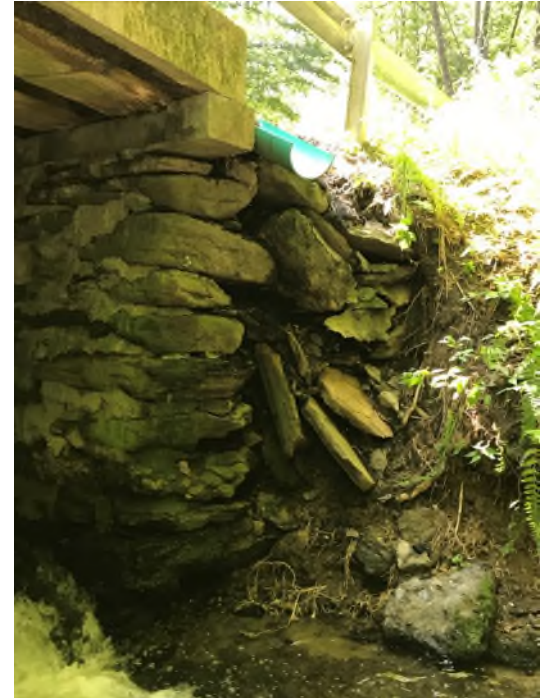
- Taylor Hill Road (Culvert 1951o) – this stream crossing is an open bottom structure with a 9 foot span. The headwall is concrete with metal beams and the wingwalls are composed of fieldstone. The beams are rusting with material loss. There is erosion at the footings of the wingwalls on both the inlet and outlet side. The outlet wingwall is falling down with many stones lost with water passing under the footing (see picture to the right).

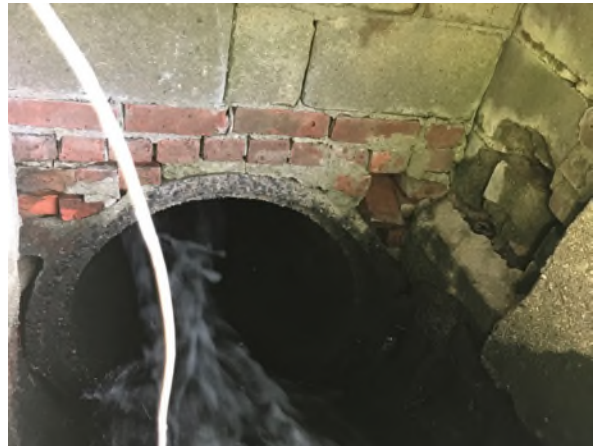
Culvert 1871i at School Street and Station Street:

- School Street and Station Street (1871i) – this culvert is a drop inlet that drains the wetland on the west side of School Street. It is a 36 inch concrete pipe with a brick and concrete structure. It has missing and loose bricks and the concrete walls around the pipe are crumbling.

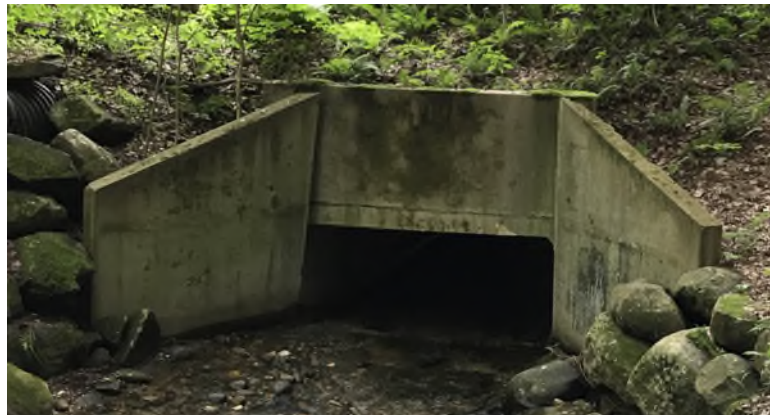
Culvert 2149i on Ripley Road:

- Ripley Road and Spaulding Brook Road (2149i) – this stream crossing is a concrete box culvert with concrete wingwalls and headwalls. Both wingwalls have separated from the headwall by several feet and one is leaning and in danger of falling over.

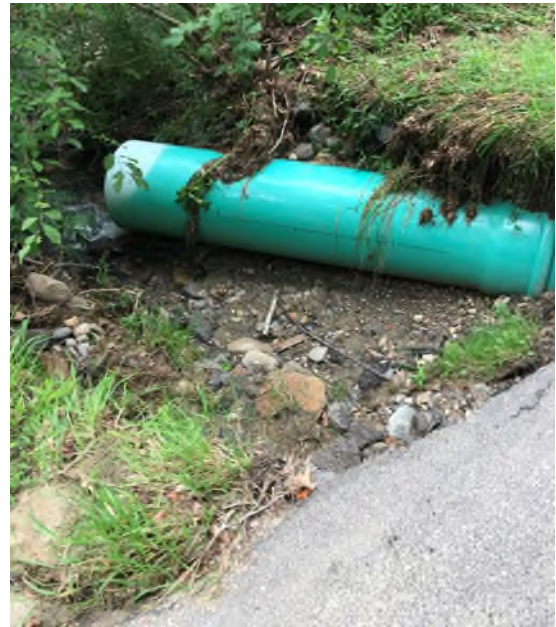
- There is a 24 inch plastic drainage pipe (2194o) on Dry Hill Road which experienced flows during the July rain events that greatly exceeded its capacity resulting in a portion of the road and its substructure to be washed out. It appears that the Town is aware of this situation. If this culvert is to be

Culvert 2194o at Dry Hill
Road with washed out
portion of roadway:

replaced, it is recommended that it be sized much larger to handle the runoff coming down both the hill and roadway.
