MONTAGUE TOWN BRIDGES

STRUCTURES INSPECTION FIELD REPORT

BR. DEPT. NO. M-28-16A

CITY/TOWN MONTAGUE	8-STRUCTURE NO. M2816A-0R2-MUN-NBI	11-Kilo. POINT 000.032	41-STATUS P:POSTED	90-ROUTINE INSP. DATE SEP 23, 2019
07-FACILITY CARRIED HWY SIXTH ST	MEMORIAL NAME/LOCAL NAME	27-YR BUILT 1988	106-YR REBUILT 0000	YR REHAB'D (NON 106) 0000
06-FEATURES INTERSECTED WATER UTILITY CANAL	26-FUNCTIONAL CLASS Urban Local	DIST. BRIDGE INSPECTION ENGINEER M. Barrett		
43-STRUCTURE TYPE 310 : Steel Truss - Thru	22-OWNER Town Agency	21-MAINTAINER Town Agency	TEAM LEADER A. R. Finck	
107-DECK TYPE 5 : Steel plate	WEATHER Clear	TEMP. (air) 26°C	TEAM MEMBERS W. MORIN

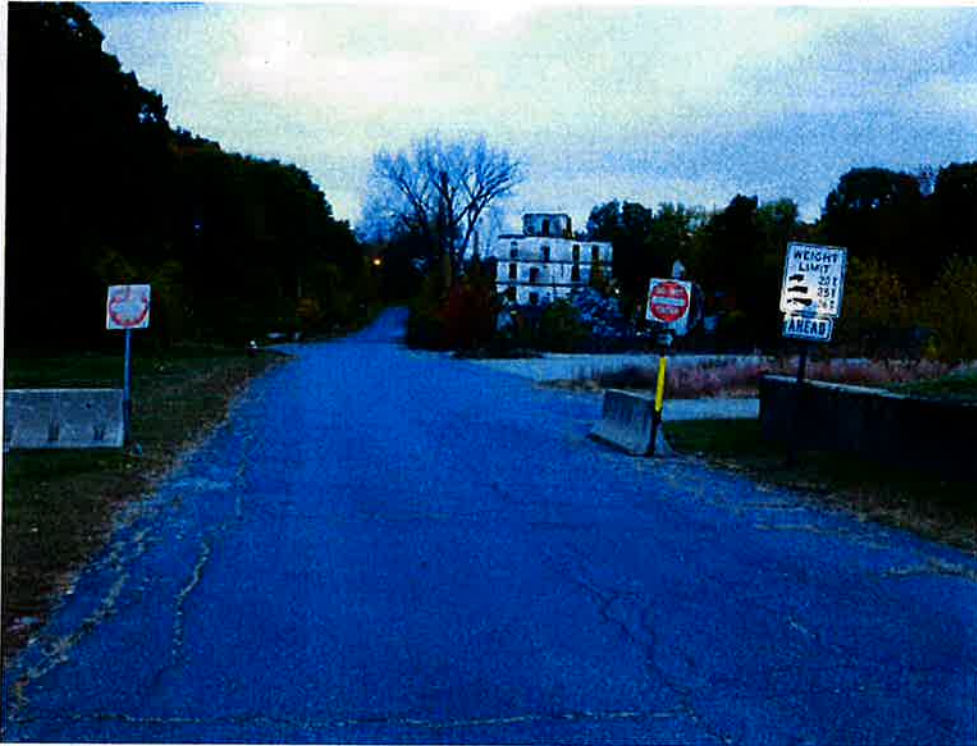
Photo 1: West Approach, has two "DO NOT ENTER" signs along with a "Advance" Weight Posting.

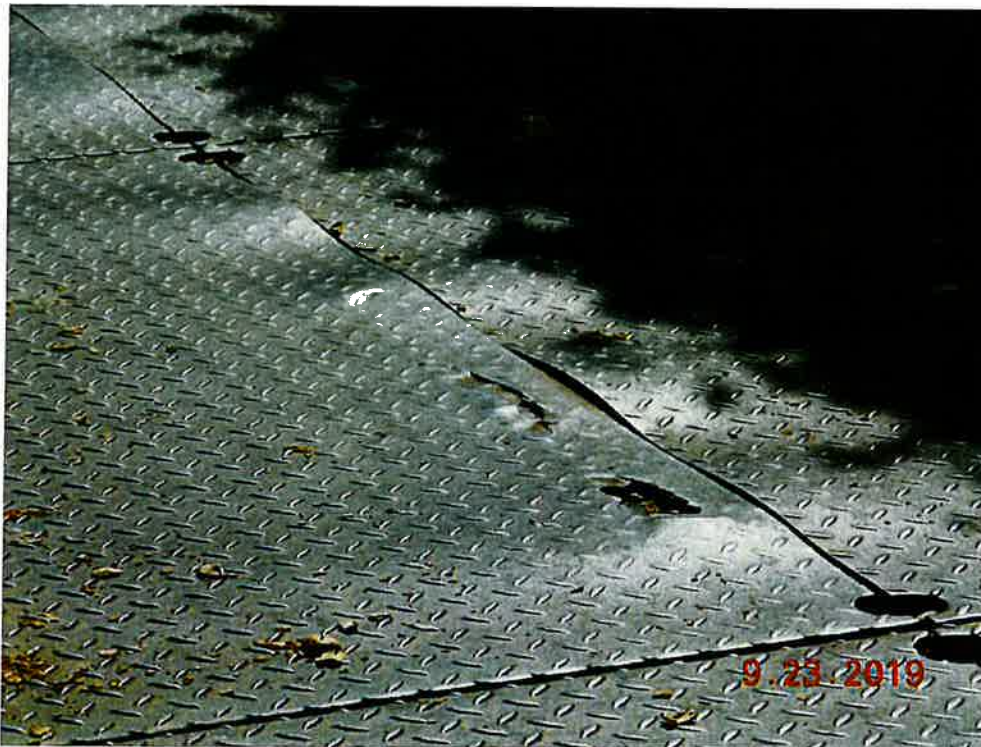
- Have some pack rusting between the top flange of the fascia stringers and the steel panels, making the top surface bumpy.
- Some of the Steel Deck Units, have holes, near the outer edges of the panels. **See Photo 2.**
 - Panels 5 & 6, Deck Unit 4
 - Panel 31, Deck Unit 4

Photo 2: Steel Deck Panels have some pack rusting, between top flange of the fascia joints and steel panels. A few Deck Panels have through holes near the outer edges of the panels.

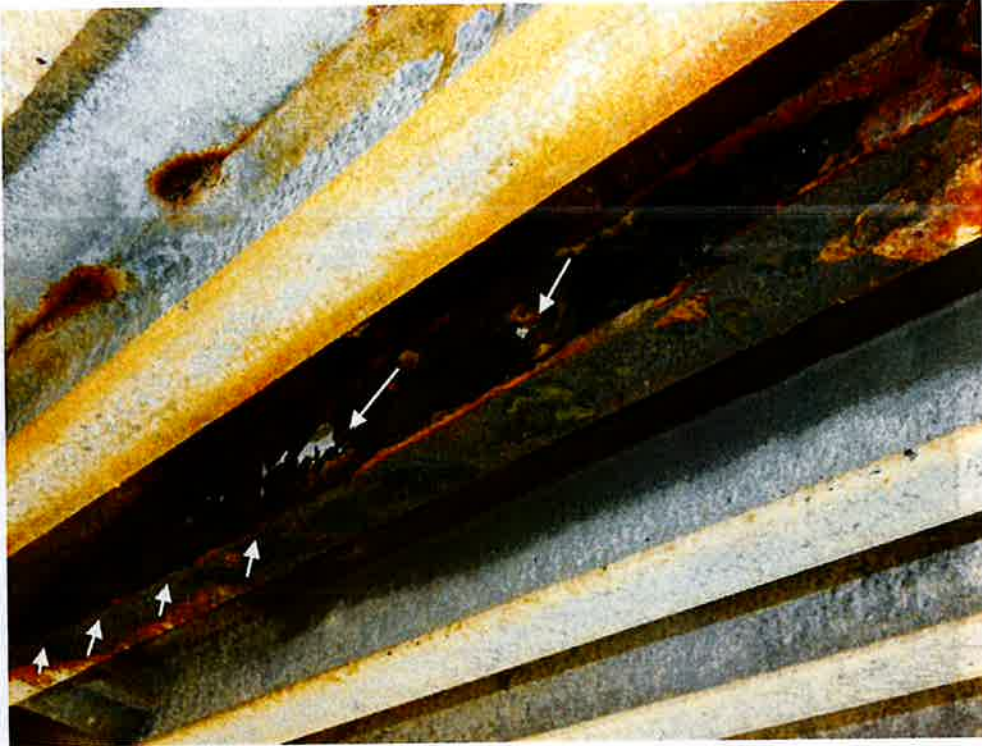
- Fascia Stringers have rust delamination with section loss.
- Following deck units have rust holes in the web and bottom flanges: **See Photo 3.**
 - Panel 5, Deck Unit 3
 - Panel 6, Deck Units 2, 4, & 5
 - Panels 7, 8, & 9, Deck Unit 5
 - Panel 11, Deck Unit 4
 - Panel 12, Deck Units 4 & 6
 - Panel 14, Deck Unit 2
 - Panel 22, Deck Unit 1

Photo 3: Deck Underside has rust delamination with section loss of some fascia stringers. Stringers have rust holes through the webs and bottom flanges.

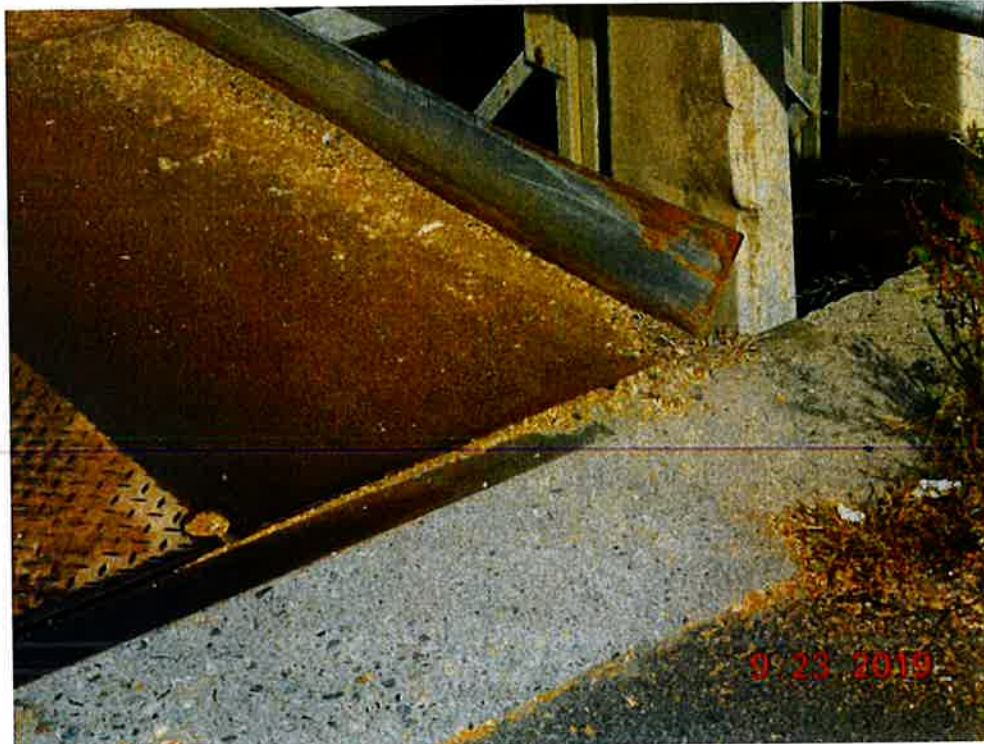
North and South Curbs, at the East End, are bent due to collision damage. **See Photo 4.**

Photo 4: Northeast corner of the Steel Curb is bent due to collision damage.

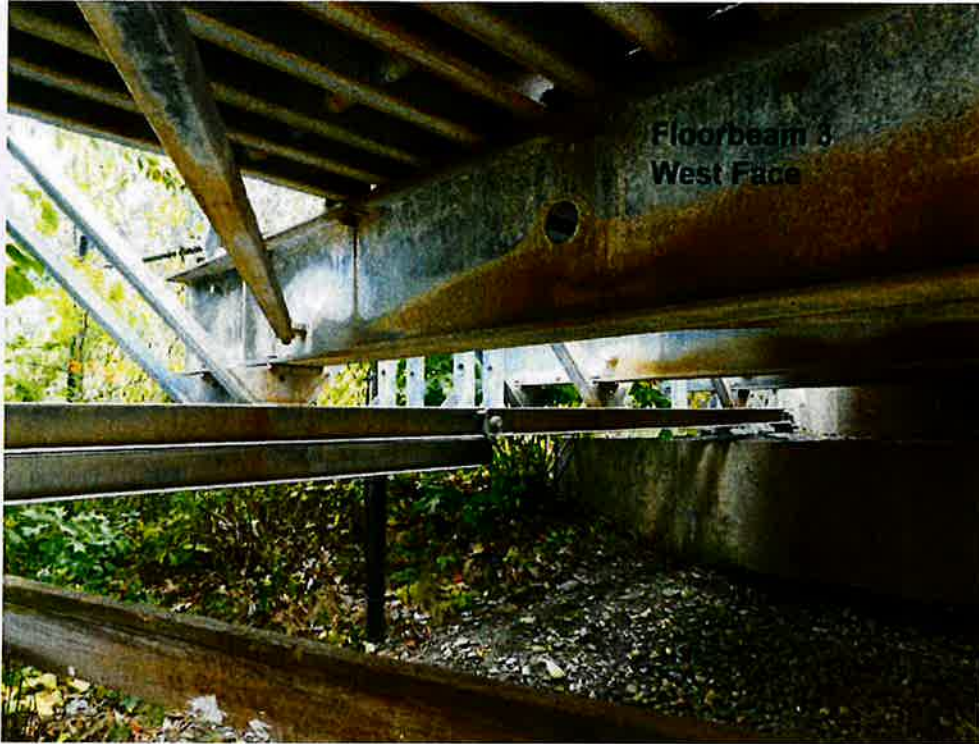
Floorbeams have areas of minor surface rust. **See Photo 5.**

Photo 5: Floorbeams have areas of minor surface rust. West Abutment is undermined.

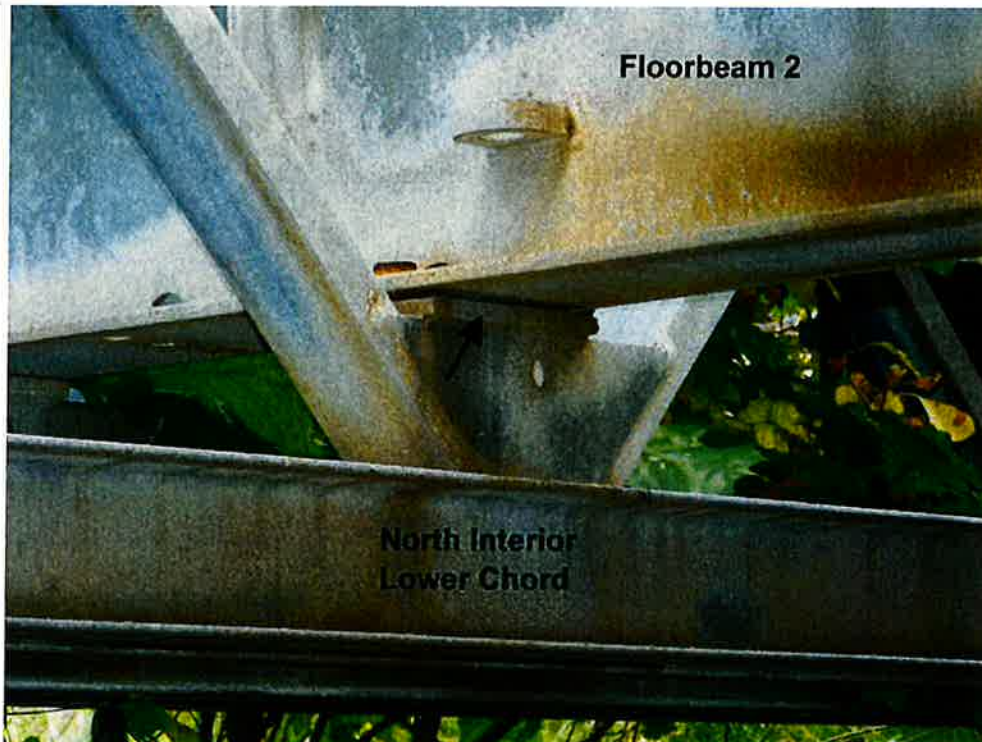
Floorbeam Bracing System has areas of light rust staining. **See Photo 6.**

Photo 6: Some Floorbeams, are slightly lifting up from Floorbeam Bracing System. Floorbeam Bracing System has areas of light rust staining.

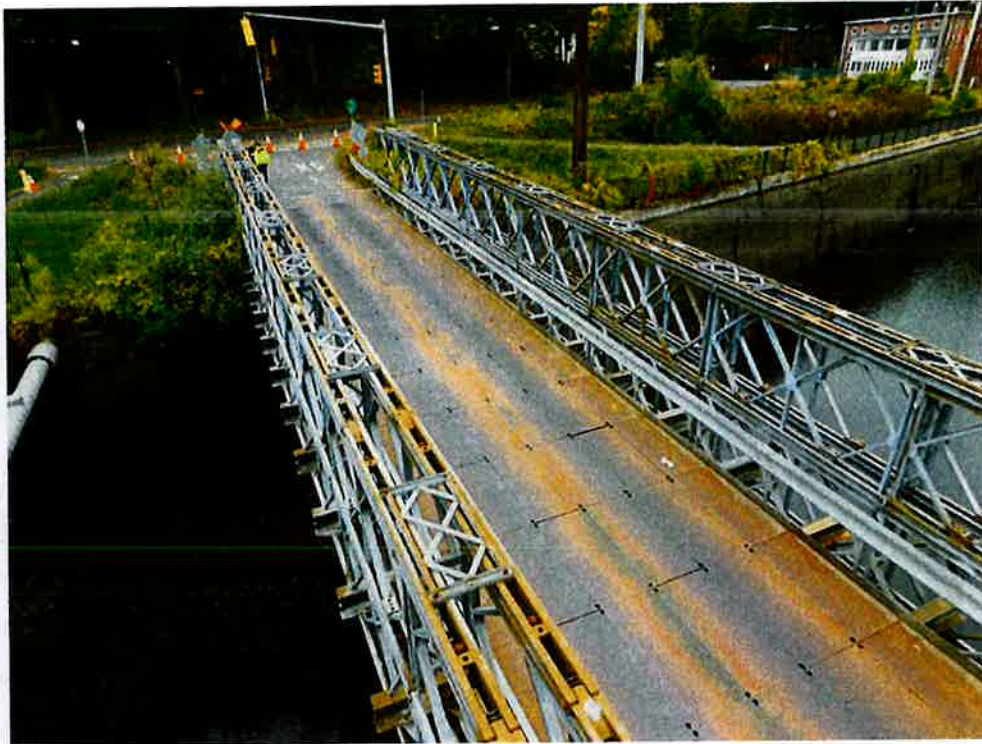
Top surface of Upper Chords have areas of light rust staining. **See Photo 7.**

Photo 7: Top surface of Upper Chords have areas of light rust staining.

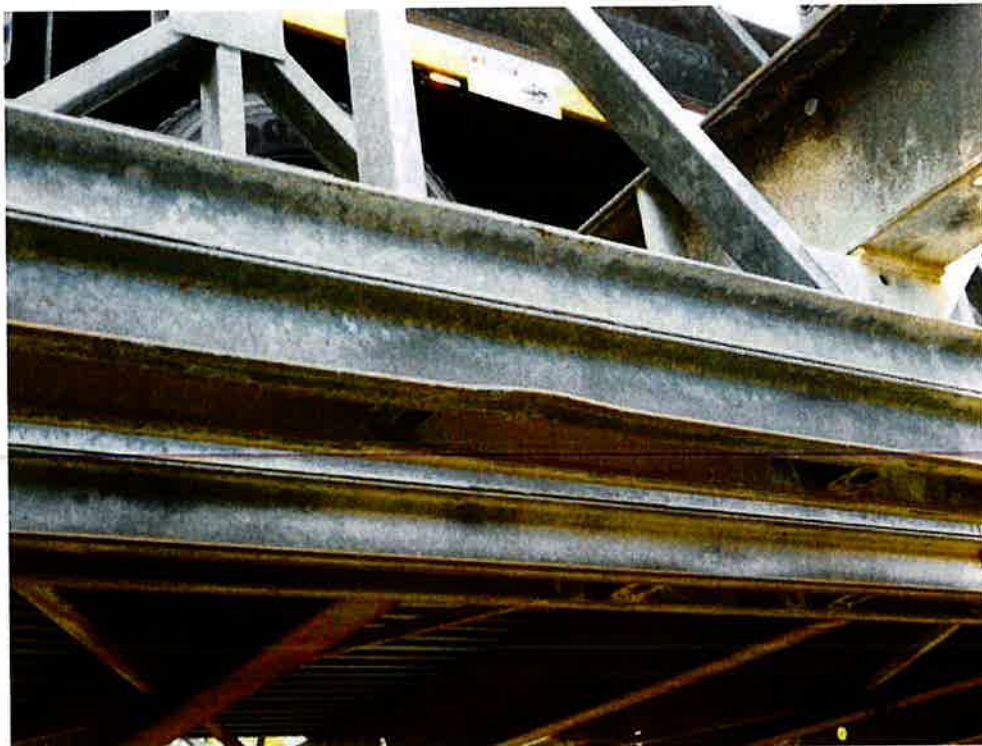
Photo 8: Lower Cord has a few small dents scattered throughout the bridge.

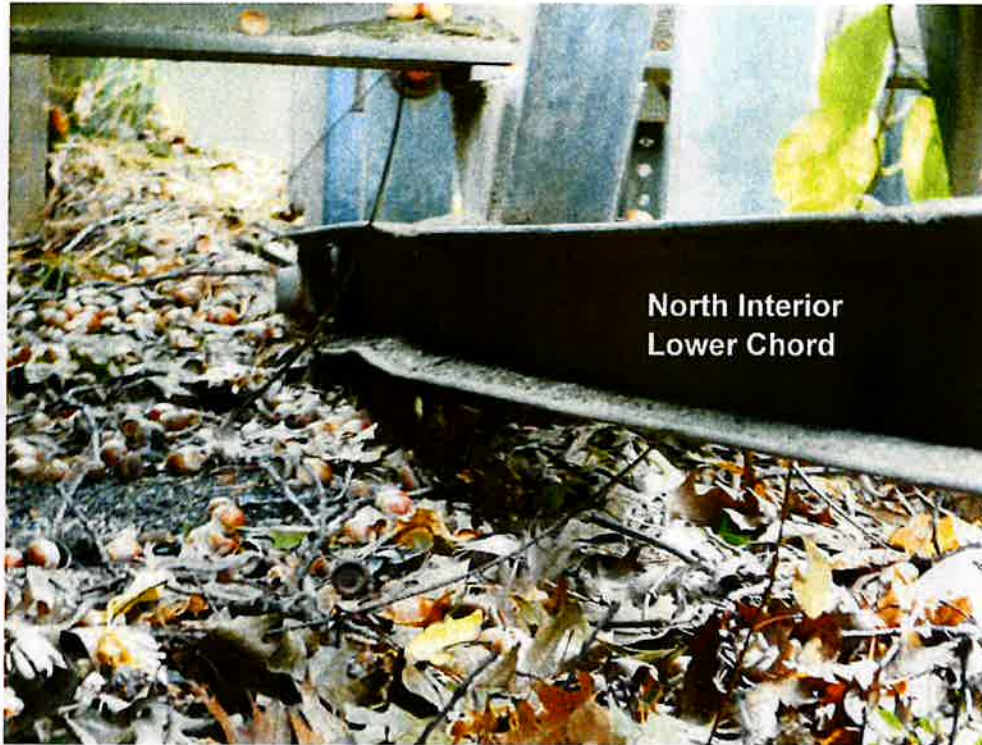
Photo 9: North Truss, Lower Interior Cord, East Back Wall, is bent and twisted. This appears to be from original construction.

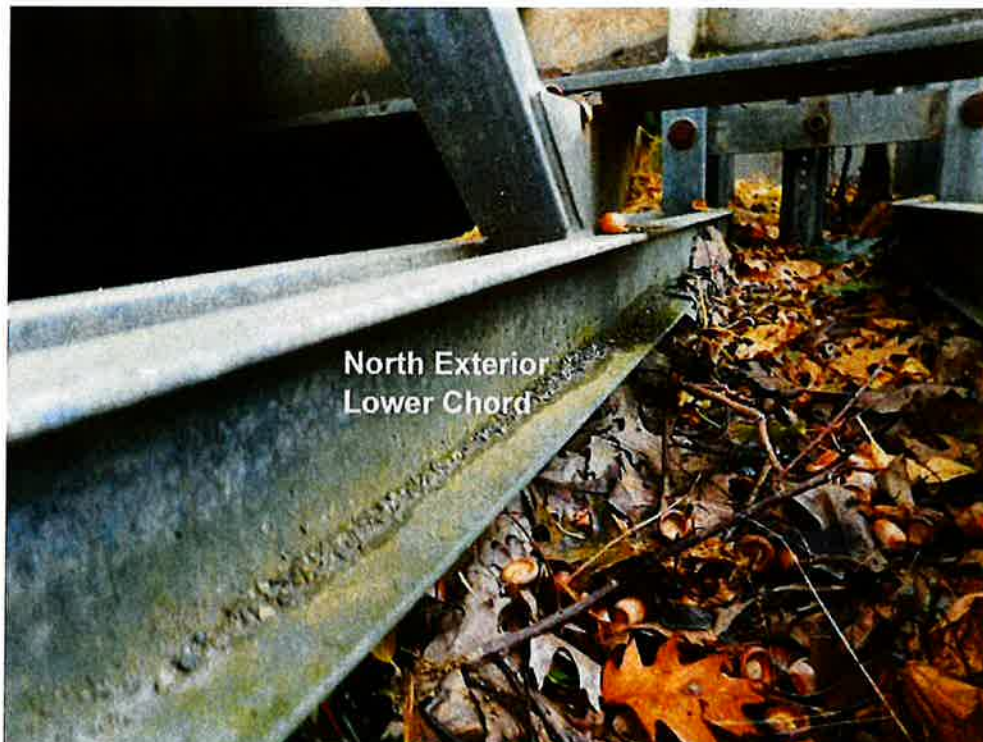
Photo 10: North Truss, Lower Exterior Cord, East Back Wall is "NOT" bent or twisted.

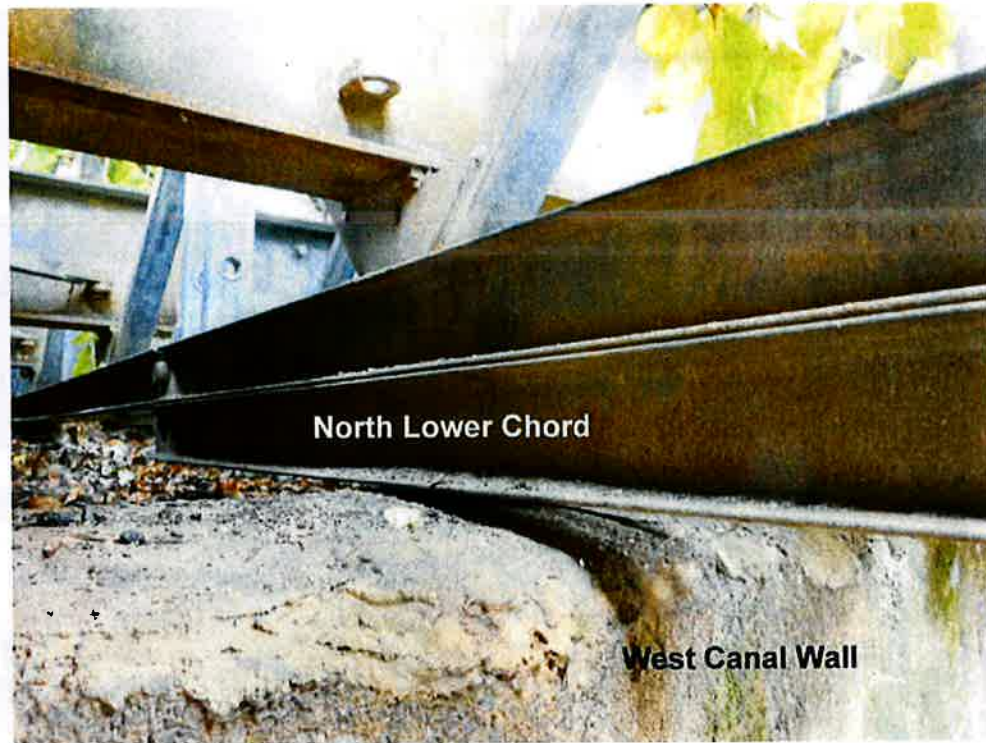
Photo 11: North Truss, Lower Chord, West Abutment, is almost in contact with the top of the canal wall, leaving only 1/2" of clearance.

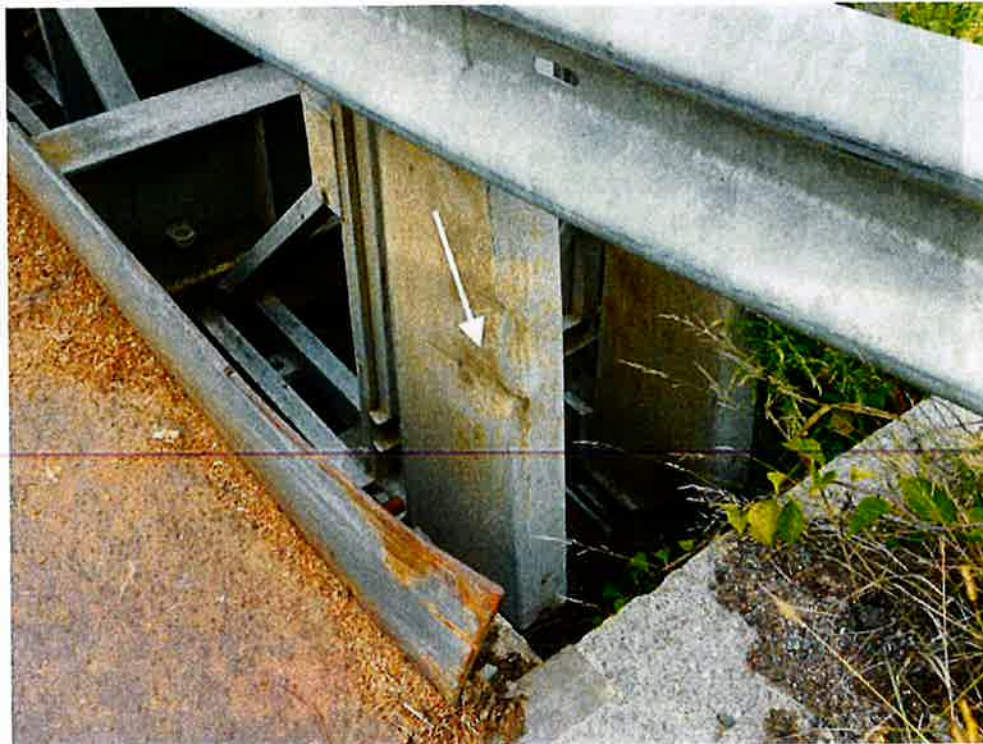
Northeast End Post, interior vertical web member base, is bent from collision damage. **See Photo 12.**

There is minor collision damage to the northeast corner of the bridge. See Photo 12.

Photo 12: Northeast End Post, interior vertical web member base, is bent from collision damage.

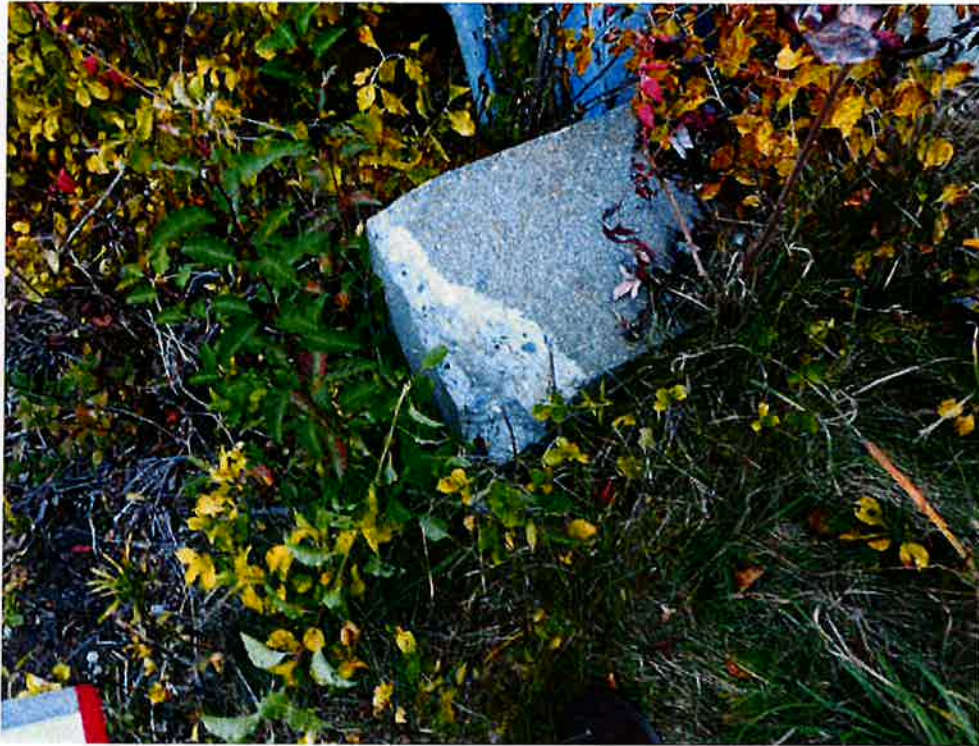
East Concrete Header, top South End, is spalled. **See Photo 13.**

Photo 13: East Concrete Header, South End, is spalled.

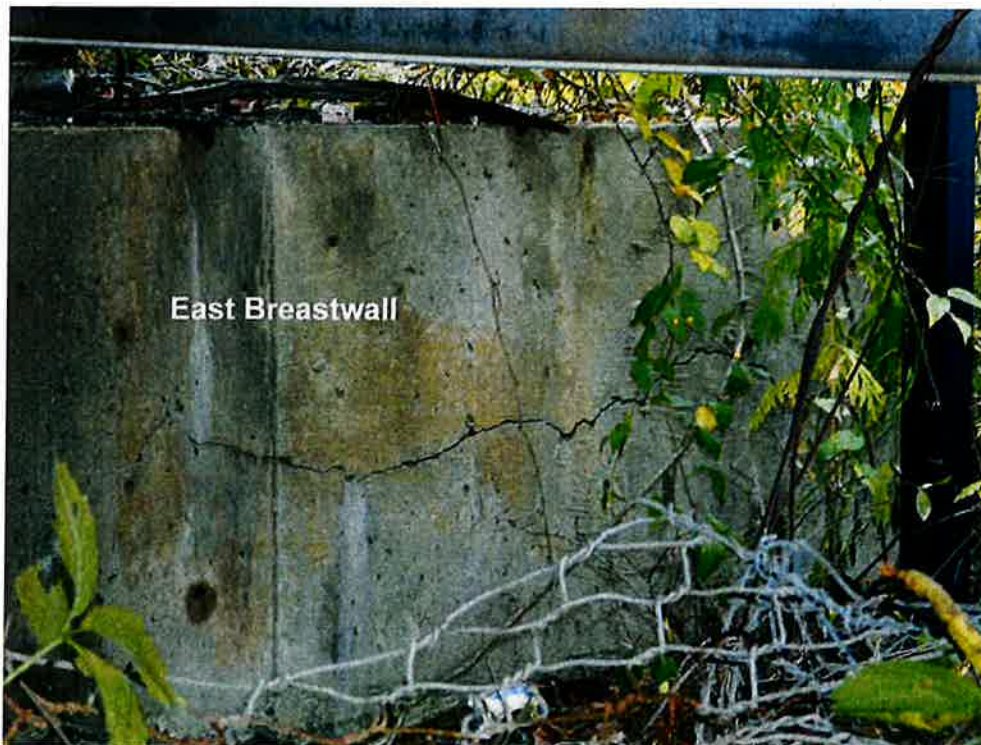
East Breastwall, under the south truss, has a 4' long x up to 1/8" wide horizontal crack. **See Photo 14.**

Photo 14: East Breastwall, under South Truss, has a 4' long x up to 1/8" wide horizontal crack.

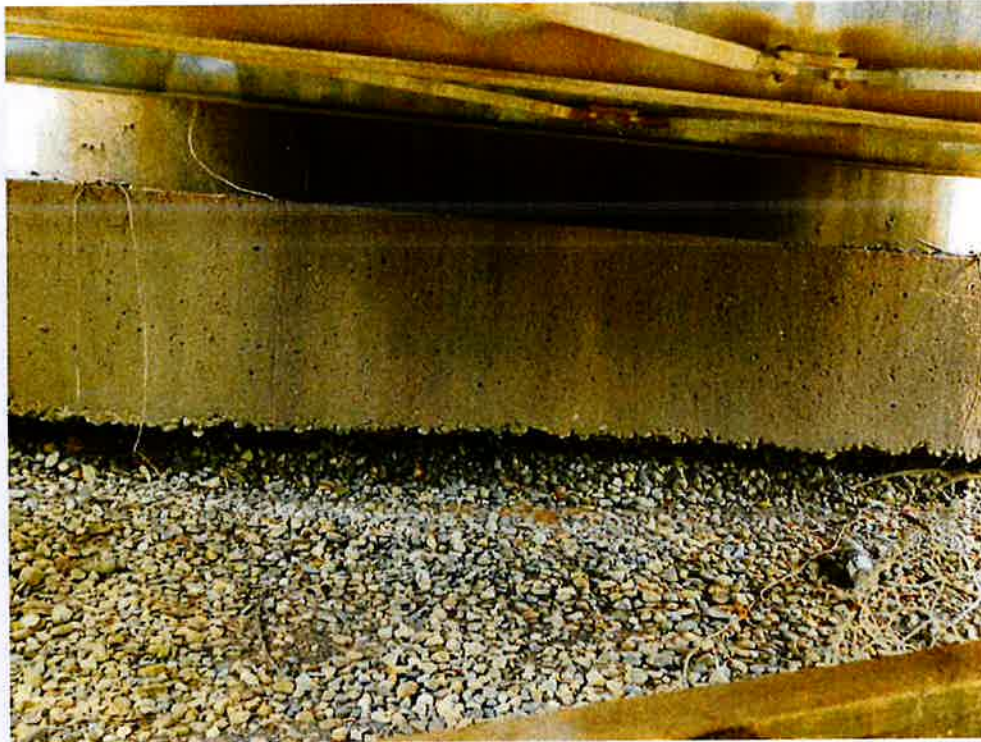
Photo 15: East Breastwall is undermined along the front face with up to 20" penetration.

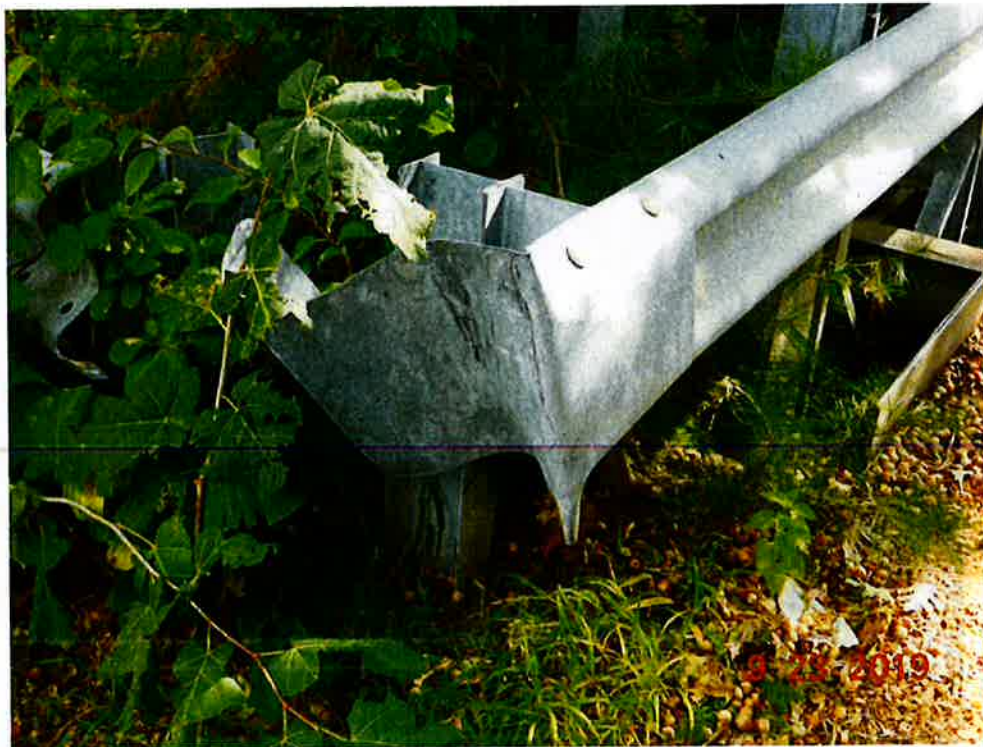
Northwest Approach Guardrail End has collision damage. **See Photo 16.**

Photo 16: Northwest Approach Guardrail End has collision damage at the bridge abutment.

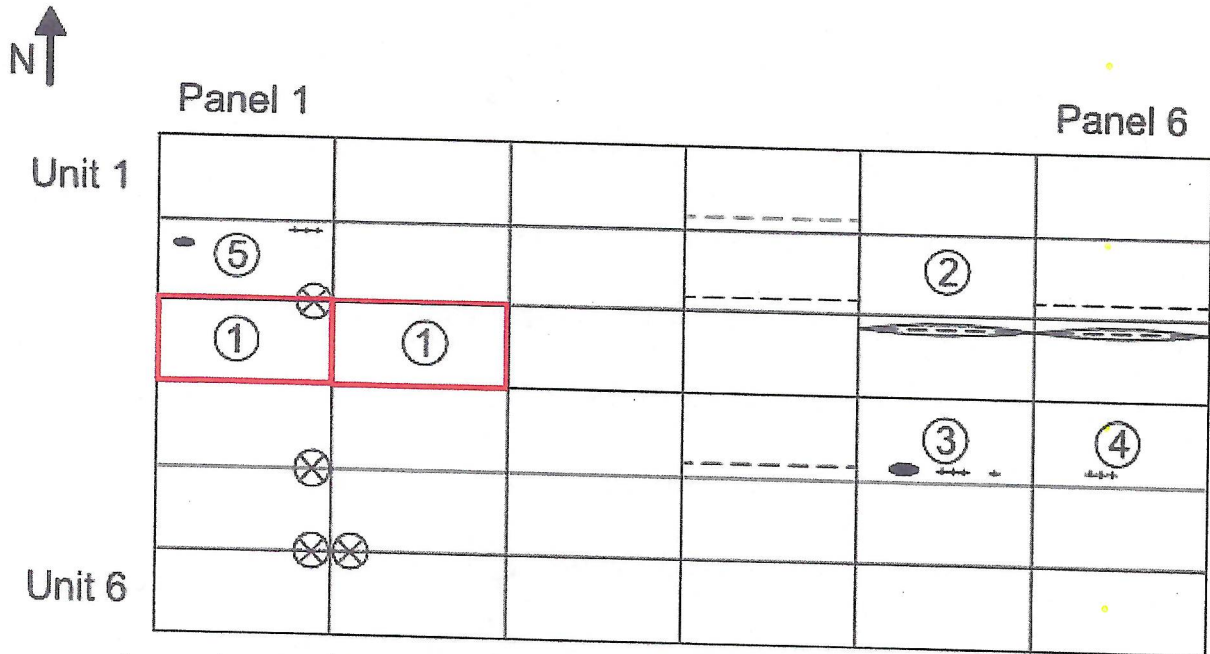
Sketch 7: Deck Panel and Longitudinal Joist Deficiencies - Panels 1 through 6

- ⊗ : Loose Deck Panel to Floorbeam Connection Bolt
- +—+— : Tear in Deck
- : Hole in Deck
- : Longitudinal Joists with Heavy Section Loss
- : Longitudinal Joists with Heavy Rust and Minor Section Loss
- 1: Stringers are buckled $\frac{1}{8}$ " laterally up to 3"H
- 2: (2) tears up to 1"L x $\frac{1}{2}$ "W
- 3: (1) 4'L x 2"W hole, (2) tears up to 9"L
- 4: (1) 9"L tear
- 5: (10) holes up to $\frac{1}{2}$ " diameter, (1) 2" diameter hole, (2) tears up to 6"L

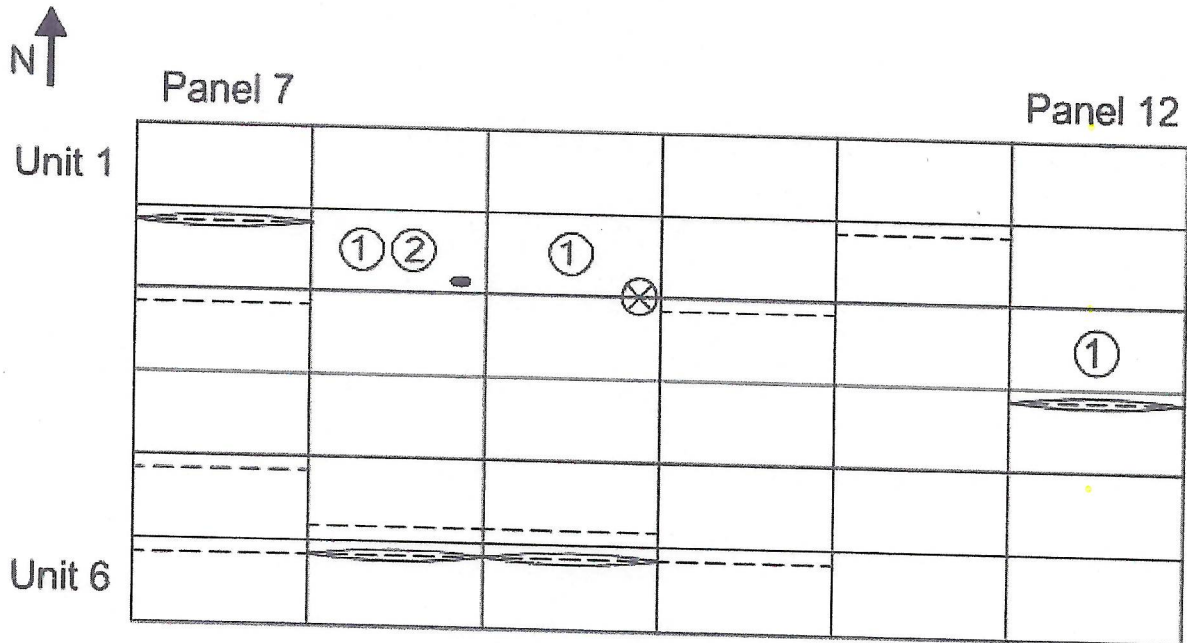
Sketch 8: Deck Panel and Longitudinal Joist Deficiencies - Panels 7 through 12

- ⊗ : Loose Deck Panel to Floorbeam Connection Bolt
- : Tear in Deck
- : Hole in Deck
- ~~~~~: Longitudinal Joists with Heavy Section Loss
- : Longitudinal Joists with Heavy Rust and Minor Section Loss
- 1: Verified Deck Unit Fascia Stringer tack welds failed
- 2: 1/2" diameter hole

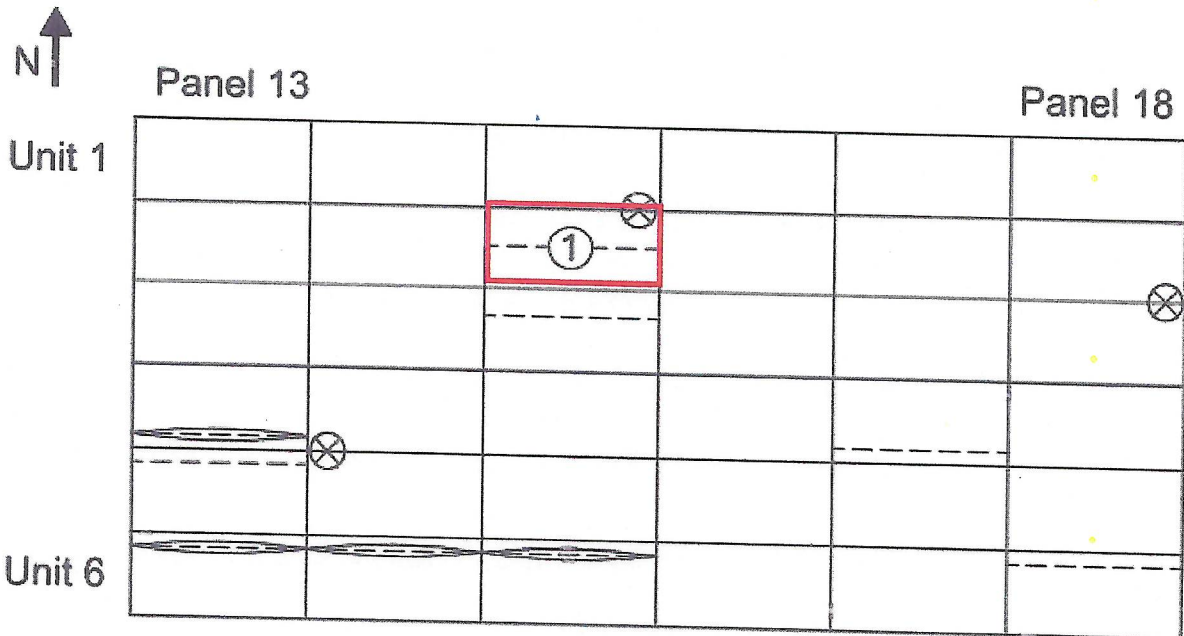
Sketch 9: Deck Panel and Longitudinal Joist Deficiencies - Panels 13 through 18

- ⊗ : Loose Deck Panel to Floorbeam Connection Bolt
- - - : Tear in Deck
- : Hole in Deck
- (with oval) : Longitudinal Joists with Heavy Section Loss
- - - (with oval) : Longitudinal Joists with Heavy Rust and Minor Section Loss
- 1 : Stringers are buckled $\frac{1}{8}$ " laterally up to 3"H

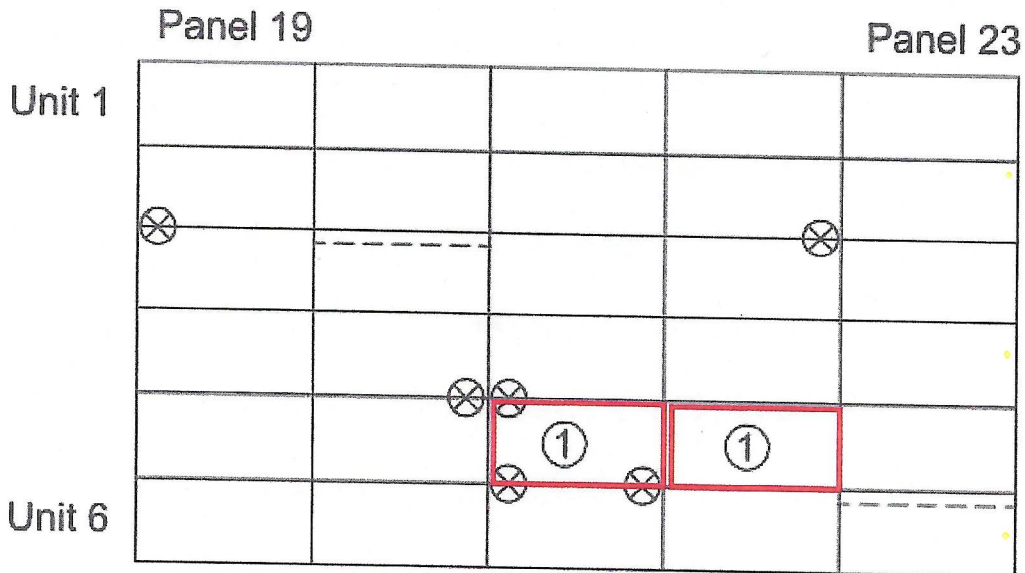
Sketch 10: Deck Panel and Longitudinal Joist Deficiencies - Panels 19 through 23

- ⊗ : Loose Deck Panel to Floorbeam Connection Bolt
- : Tear in Deck
- : Hole in Deck
- : Longitudinal Joists with Heavy Section Loss
- - - : Longitudinal Joists with Heavy Rust and Minor Section Loss
- 1 : Stringers are buckled $\frac{1}{8}$ " laterally up to 3"H

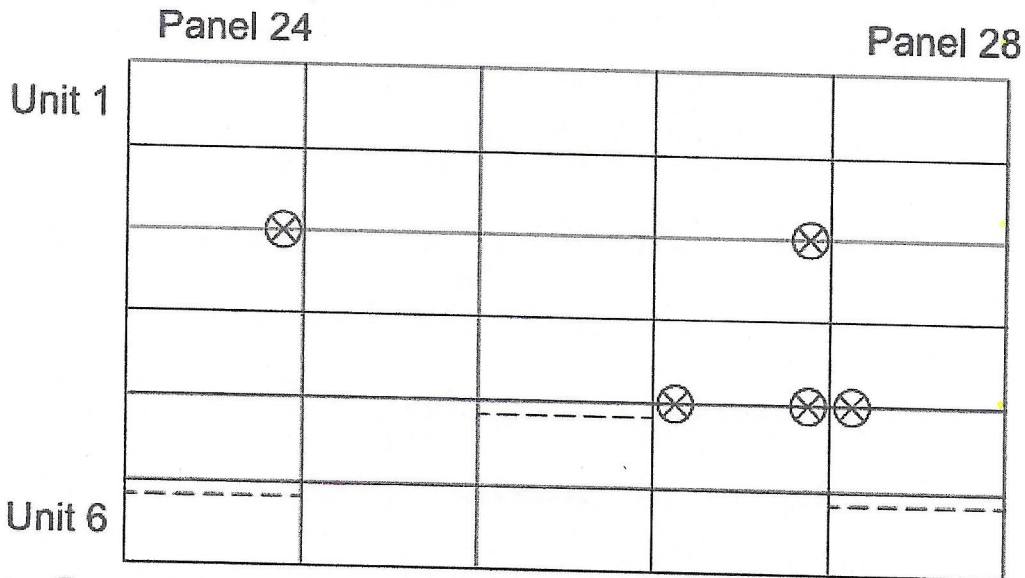
Sketch 11: Deck Panel and Longitudinal Joist Deficiencies - Panels 24 through 28

- ⊗ : Loose Deck Panel to Floorbeam Connection Bolt
- : Tear in Deck
- : Hole in Deck
- - - : Longitudinal Joists with Heavy Section Loss
- - - : Longitudinal Joists with Heavy Rust and Minor Section Loss

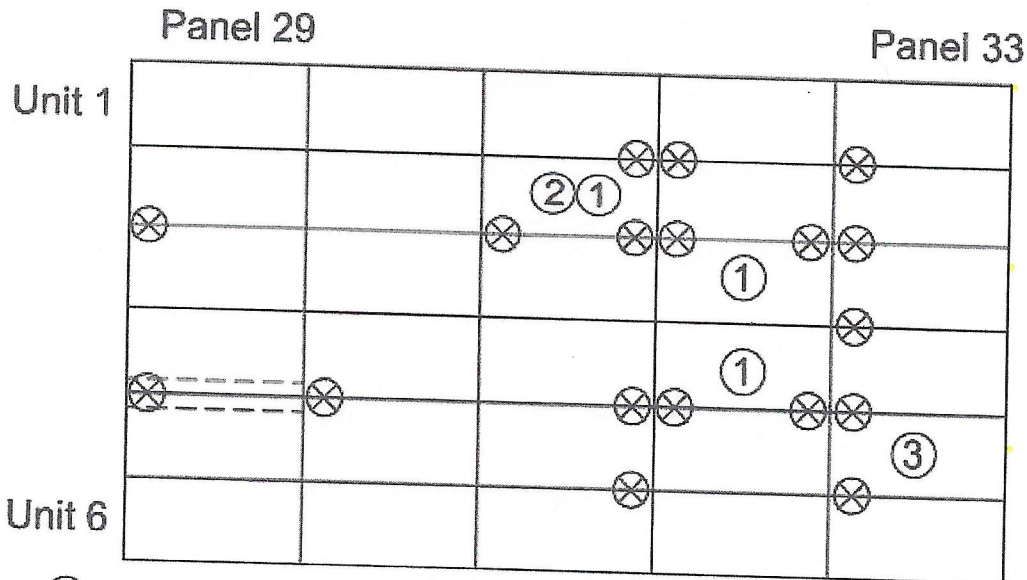
Sketch 12: Deck Panel and Longitudinal Joist Deficiencies - Panels 29 through 33

- ⊗ : Loose Deck Panel to Floorbeam Connection Bolt
- : Tear in Deck
- : Hole in Deck
- : Longitudinal Joists with Heavy Section Loss
- - - - - : Longitudinal Joists with Heavy Rust and Minor Section Loss
- 1: Verified Deck Unit Fascia tack welds failed
- 2: 5" long tear
- 3: Full panel width x up to 2"D gouge at east end
