SITE DEVELOPMENT ASSESSMENT

Strathmore Mills Redevelopment

Town of Montague

August 12, 2008

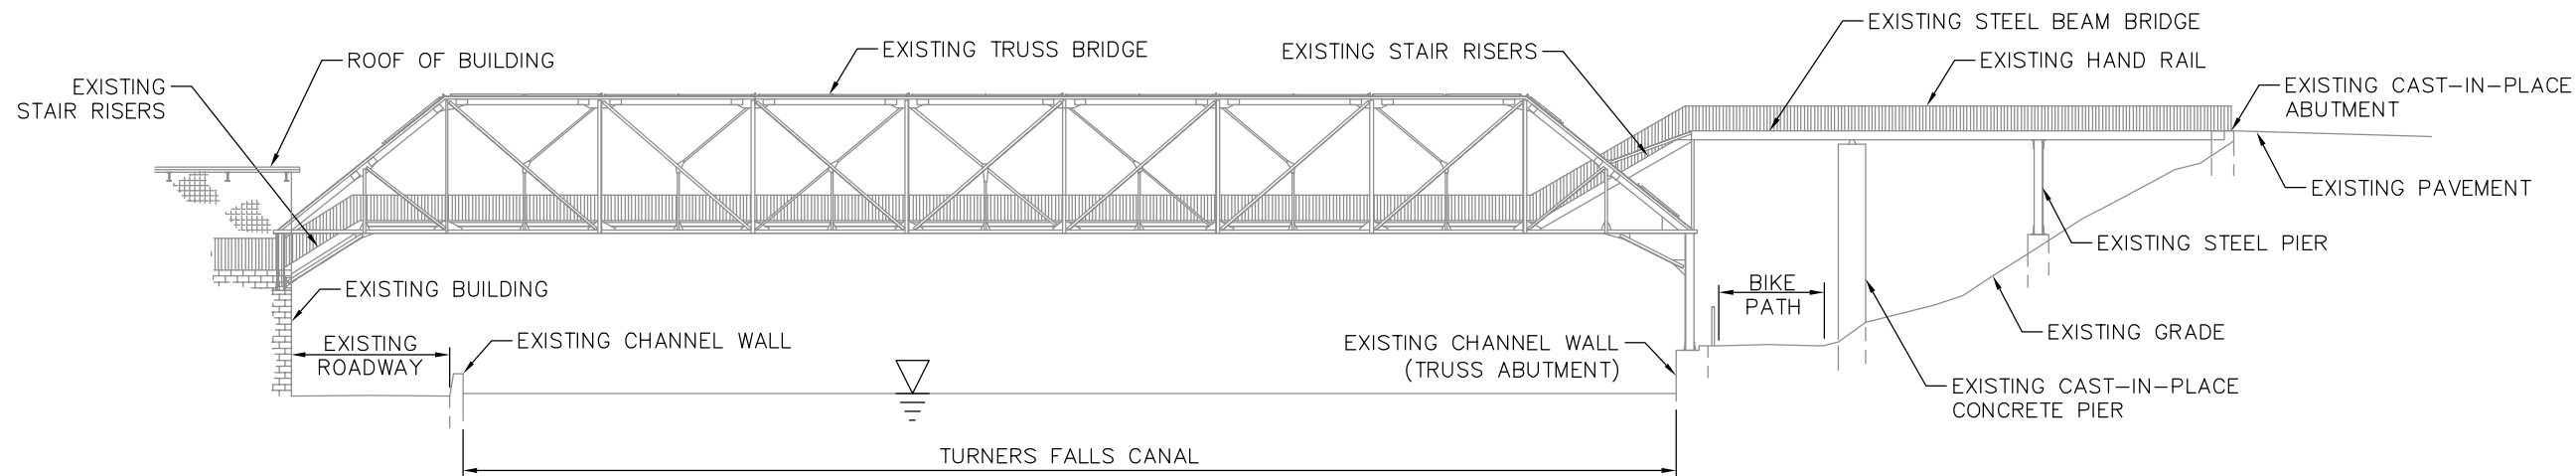
EXISTING ELEVATION
NOT TO SCALE

- The timber decking is in poor condition.
- The stair framing at both ends is in very poor condition.
- The truss top chords, diagonals and verticals appear to be in good condition.
- The bottom chords are in fair condition with isolated areas of impacted rust.
- The vertical gussets at the bottom chord panel points are in fair condition.
- Approximately 50% of the horizontal gusset plates at the bottom chord panel points that connect the cross members to the trusses are in poor condition.
- The bearings are in poor condition.
- The utility supports are in fair condition.

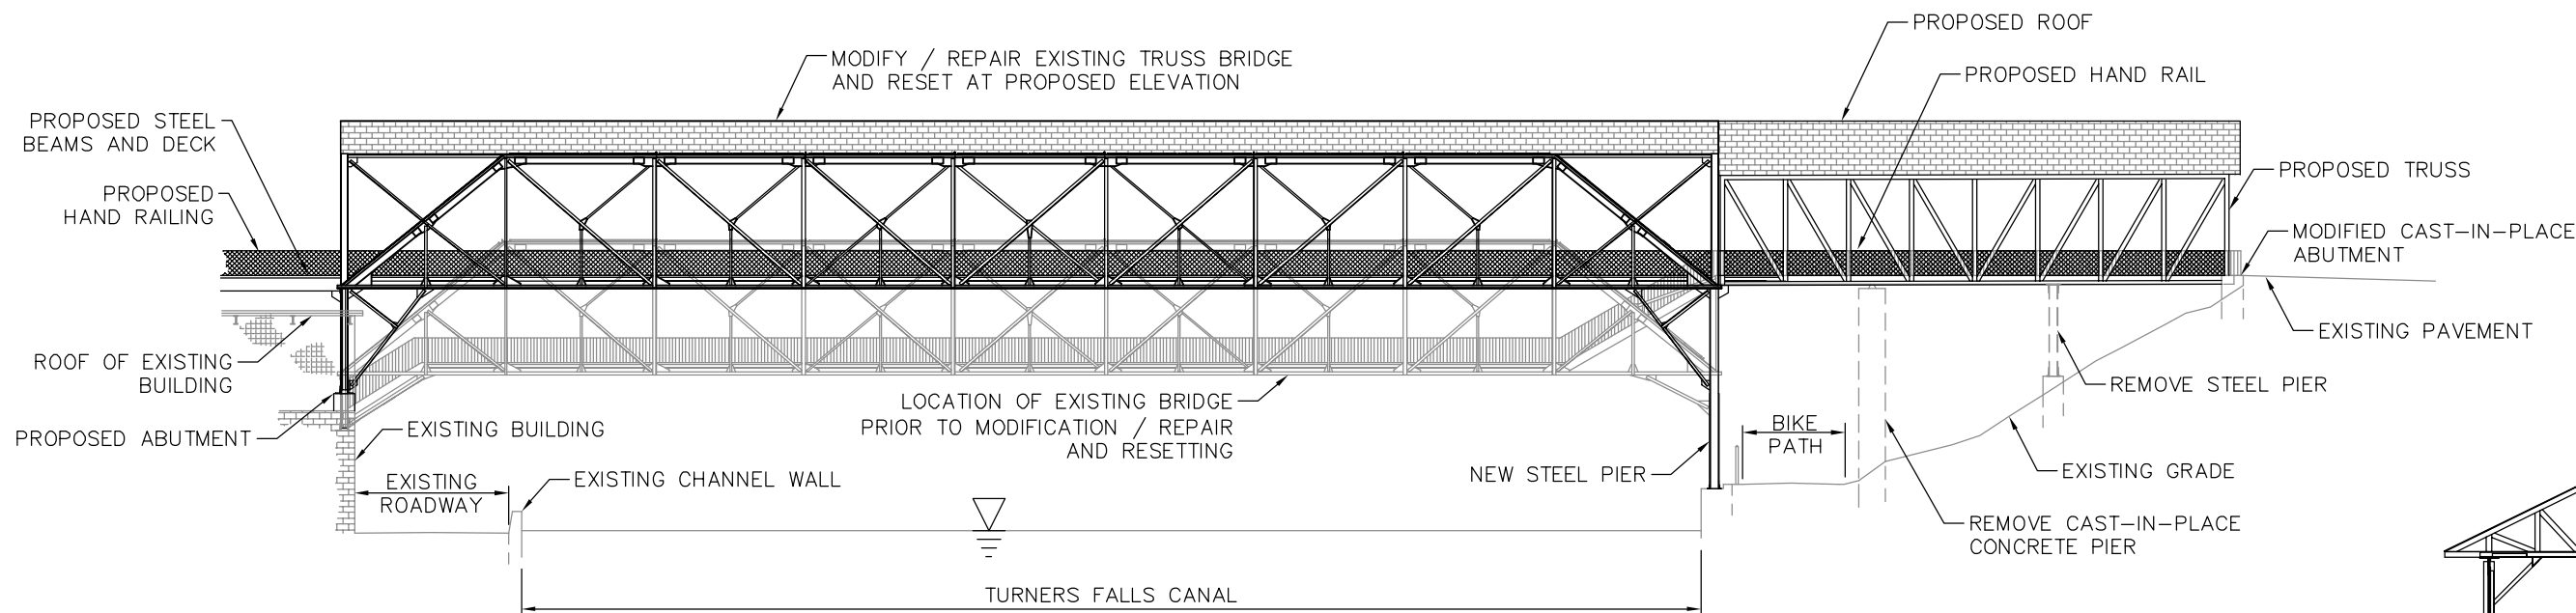
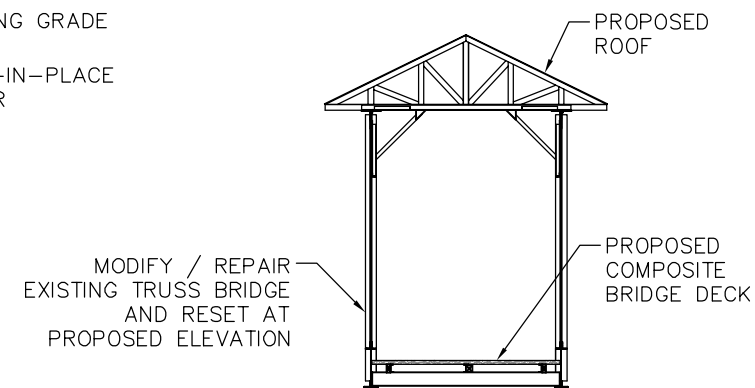
PROPOSED ELEVATION
OF MODIFIED AND REPAIRED EXISTING BRIDGE
NOT TO SCALE

Although some of the existing bridge components are in poor condition, it is our opinion that the existing steel truss pedestrian bridge can be repaired and rehabilitated. The work required for this option includes:

- Raise the bridge to the next building floor elevation.
- Modify the north end framing to remove the stairs and add floor framing.
- Remove the south approach span and stairs.
- Repair the deteriorated steel framing components (assume lead paint containment is required).
- Strengthen the existing gussets and chords as required to accommodate the weight of a new roof.
- Add a new roof.
- Install new timber decking.
- Replace the existing south pier.
- Modify the existing north abutment at the building.
- Construct a new south abutment at Canal Street.
- Install a new 60 foot span steel truss south approach span with roof.

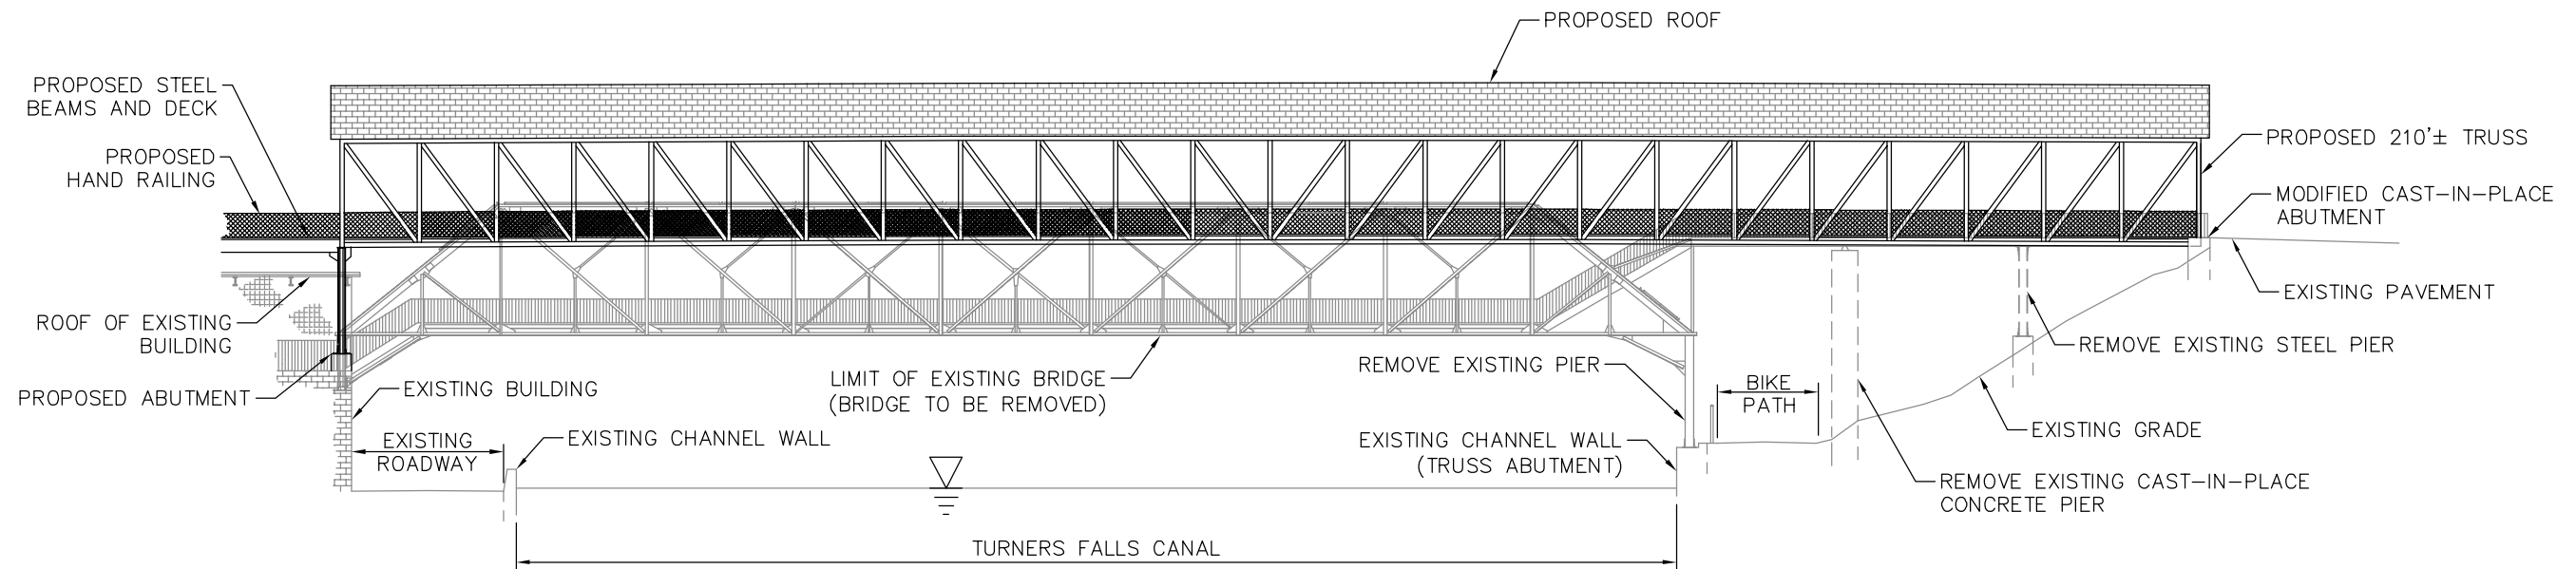
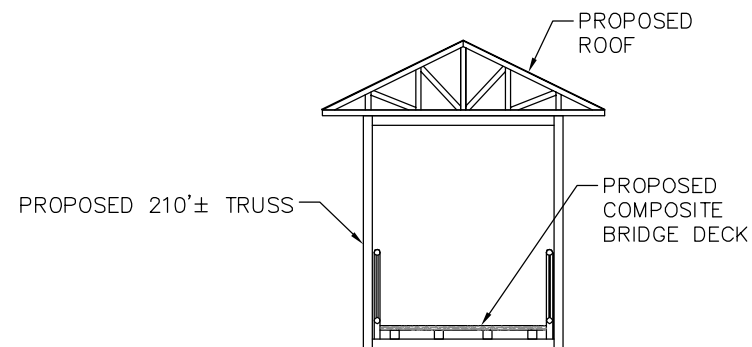
PROPOSED ELEVATION

It is our opinion that the existing main span truss and south approach span should be replaced with a single span prefabricated steel truss bridge. This will eliminate the need to reconstruct the south pier. The work required for this option will include:

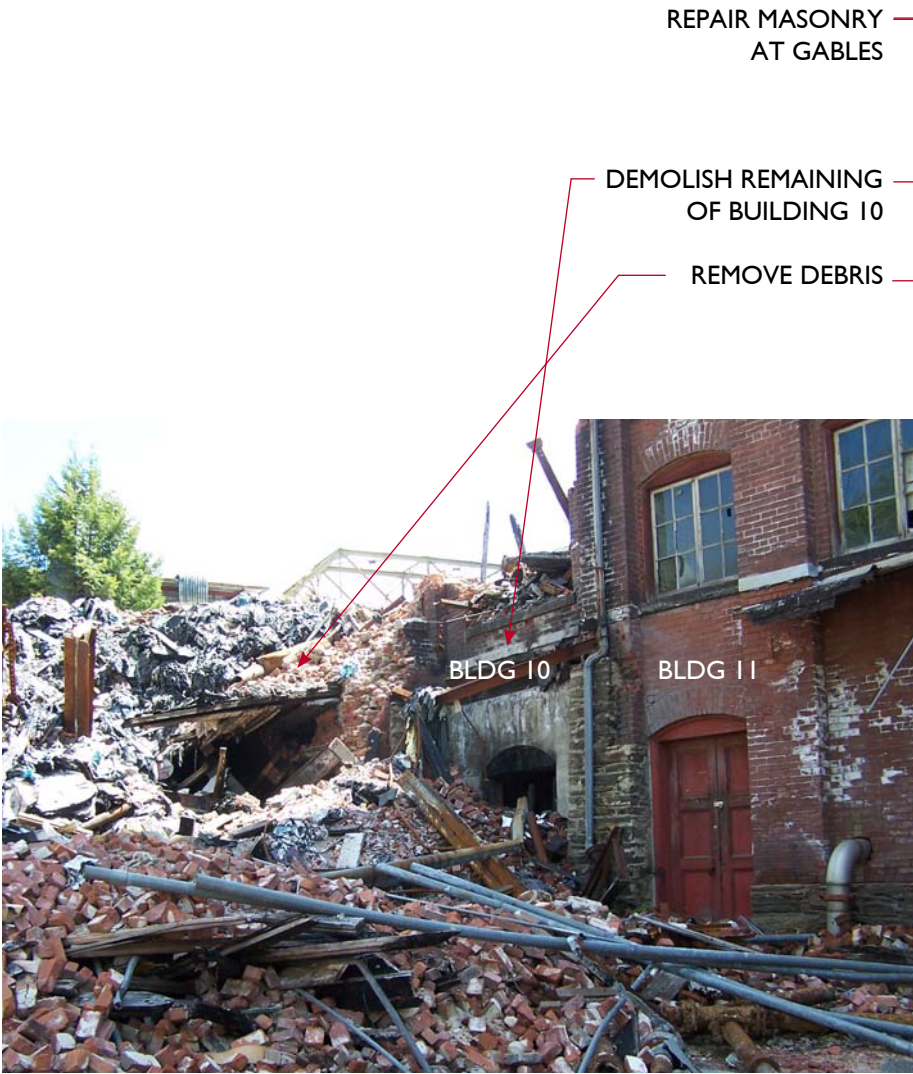
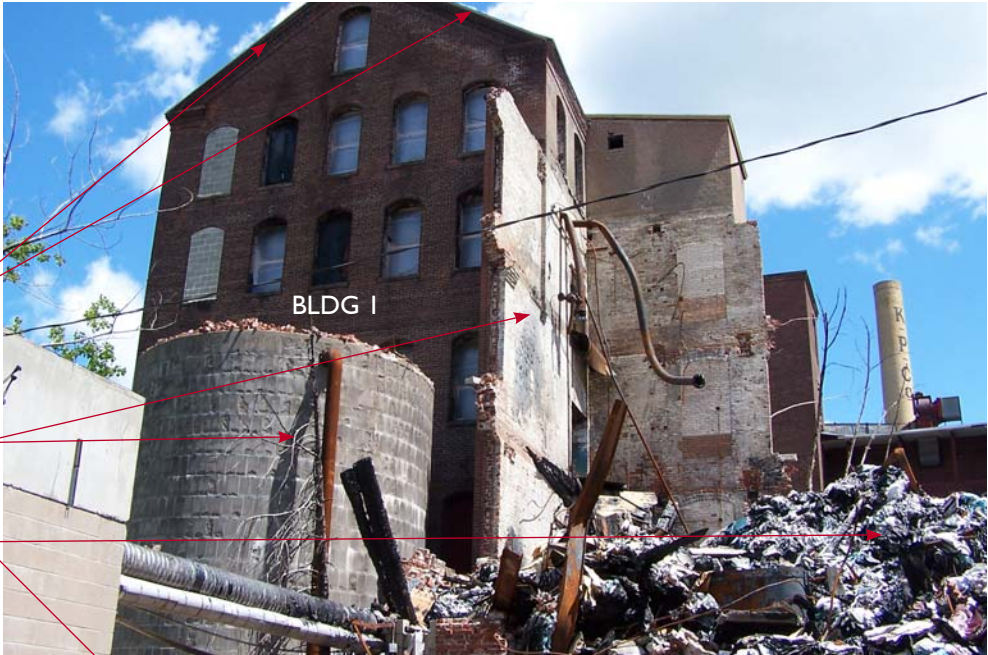
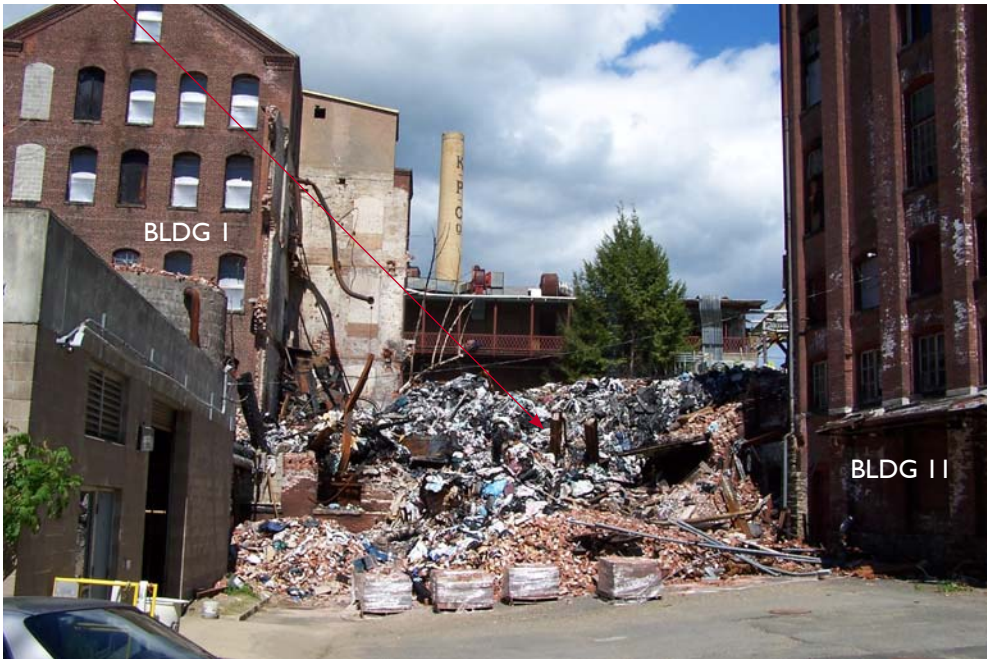
STAIR & ELEVATOR
TOWER:
EXISTING/PROPOSED

There are several areas of Building #1 that were adversely affected by the fire and collapse of Building #10. The elevator tower on the east facade of the building should be demolished as it was found to be structurally deficient by engineers who reviewed the structure. The stair tower on the east facade where Building #1 meets Building #4 was also found to be structurally incapable of meeting current codes with reasonable repairs and is proposed to be demolished.

EX. ELEVATOR TOWER:
REMOVE STRUCTUALLY
DEFICIENT TOWER,
PROVIDE NEW EGRESS
STAIR TOWER

MOVE ACCESS DOORS
TO SWIFT RIVER
HYDRO TO ALLOW
FOR NEW ELEVATOR
TOWER

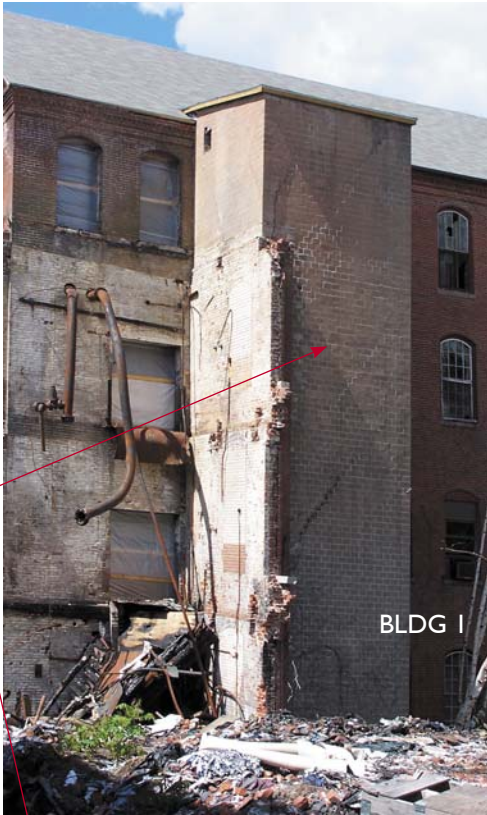
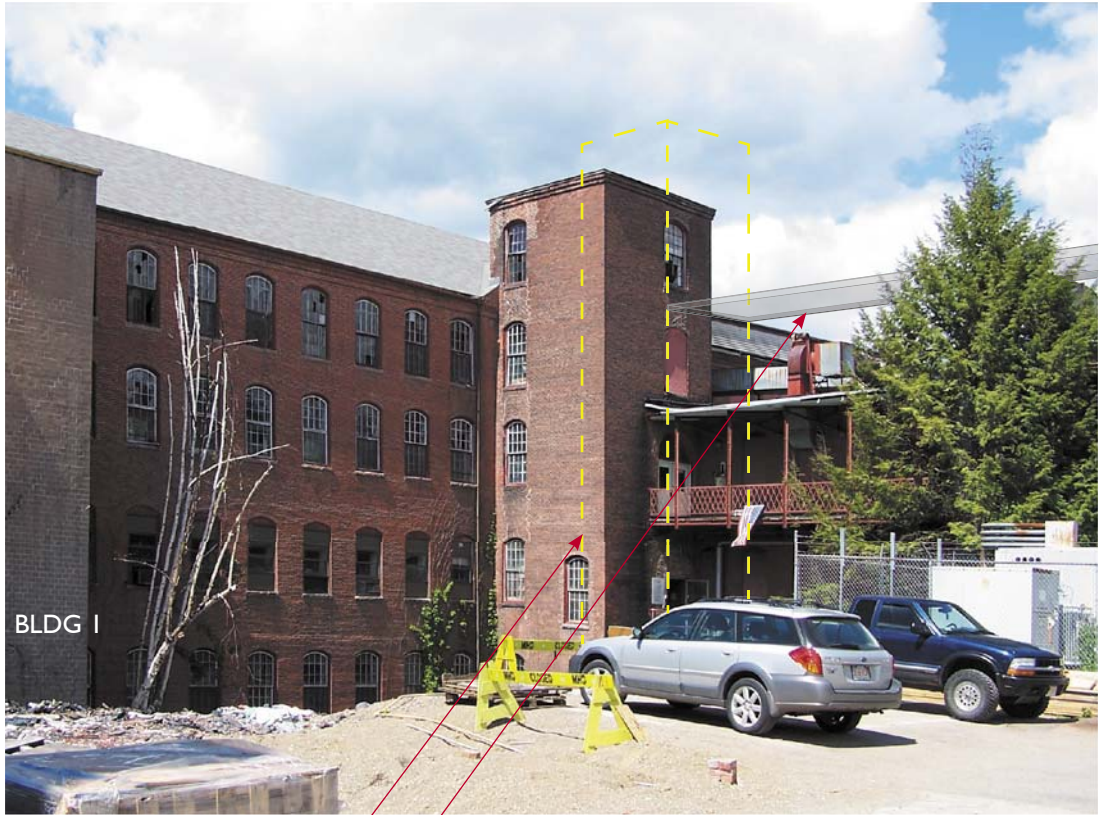
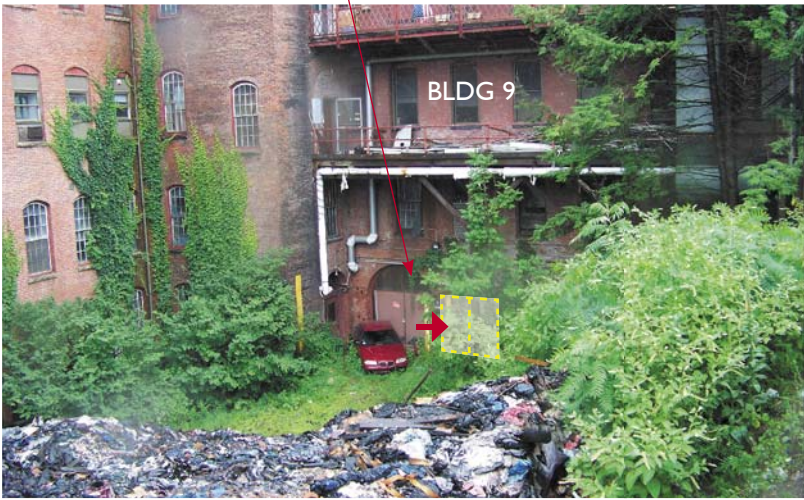
In addition to the fire damaged areas of this building, we noticed that the stairway in the southeast corner of the building (adjacent to Building #4) is in poor condition. The loadbearing exterior masonry walls have extremely large cracks in them and the wall sections around the cracks are moving (bulging) outward. The condition of the masonry in this stairway is of a significant concern regarding its continued use and should be addressed immediately.

REMOVE STRUCTUALLY
DEFICIENT TOWER,
PROVIDE NEW ELEVATOR &
STAIR TOWER

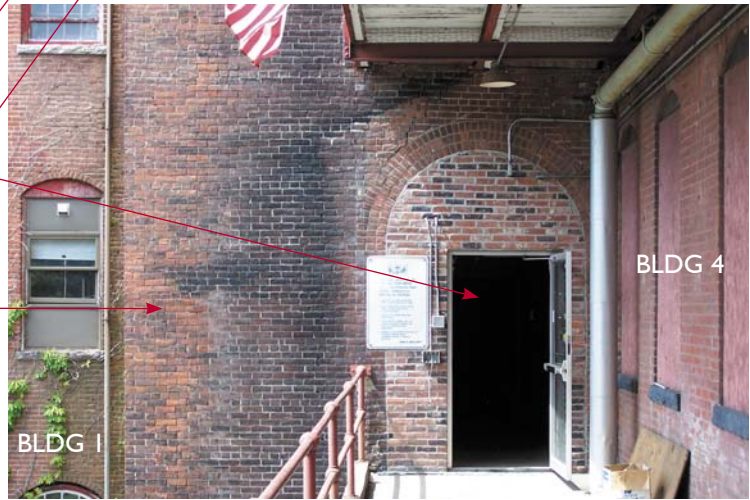
BUILDING 11 MODIFICATIONS

- The bricks on the outside face of the exterior masonry wall on the east side of the building (adjacent to the former Building #10) are damaged or missing in several locations. Based on the condition of this wall, it is likely that this damage occurred during the fire or subsequent collapse.
- At the roof level, the first bay of roof framing (wood rafters and sheathing) along the east wall has been replaced.
- Some of the mortar in the east wall at the 3rd floor is soft and friable.
- The framing in the remaining floors appears to have only sustained some smoke damage.

- CHANGE DOORS TO WINDOWS
- CREATE NEW BUILDING ENTRANCE
- REPAIR FIRE DAMAGE

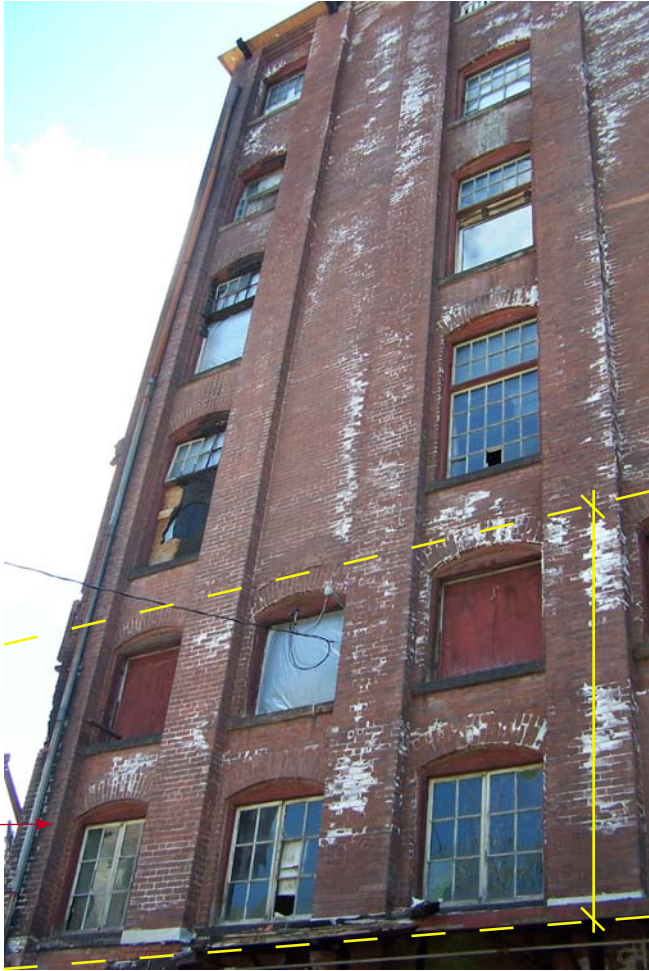
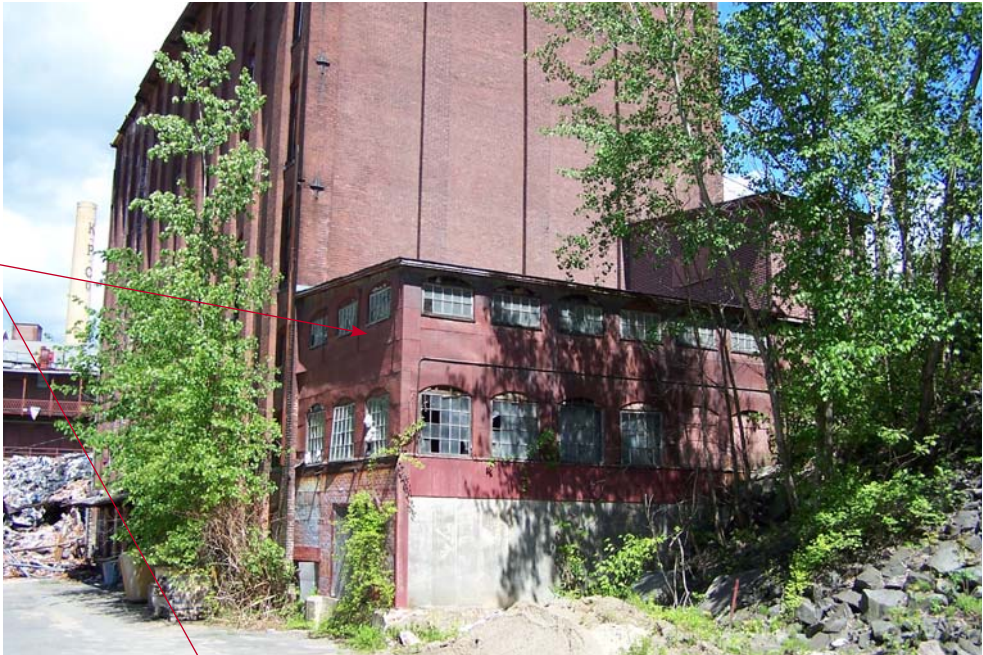
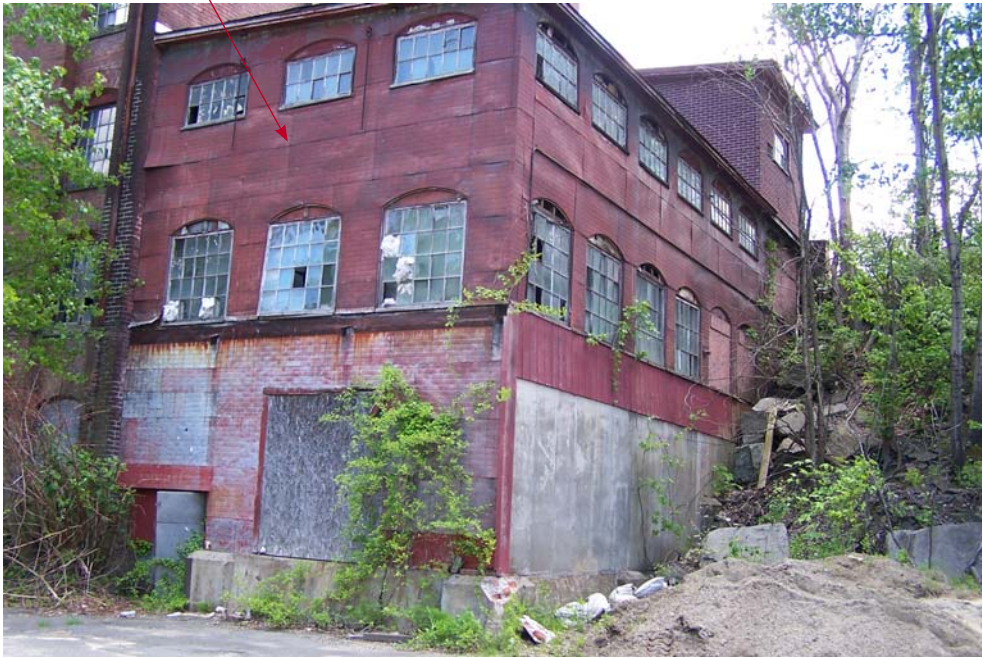
BUILDING 11 MODIFICATIONS

Building #11 has two additions to the original structure. One is the loading dock on the east side, which opens directly onto the access road. The other addition is a three and four story addition on the south end of the building. This addition has a structure of steel beams, exposed metal decking and a fake brick façade, made of tin. Due to their incompatibility with the proposed use of the building, it is recommended that both of these additions be demolished.

DEMOLISH ADDITION ON
SOUTH SIDE TO ALLOW
FOR PARKING RAMP

COMBINE 2 FLOORS
WITH 7' CEILING
HEIGHTS TO CREATE
ONE LEVEL OF HIGH
LOFTS
