Project No.: **21005**

To: **Town of Montague, MA**

From: **Wright-Pierce; Lisa Muscanell-DePaola, PE; Lindsey Sylvester, PE; Meghan Otis**

Subject: **Turners Falls, Lake Pleasant, and Montague Center Wastewater Collection System Study - FINAL**

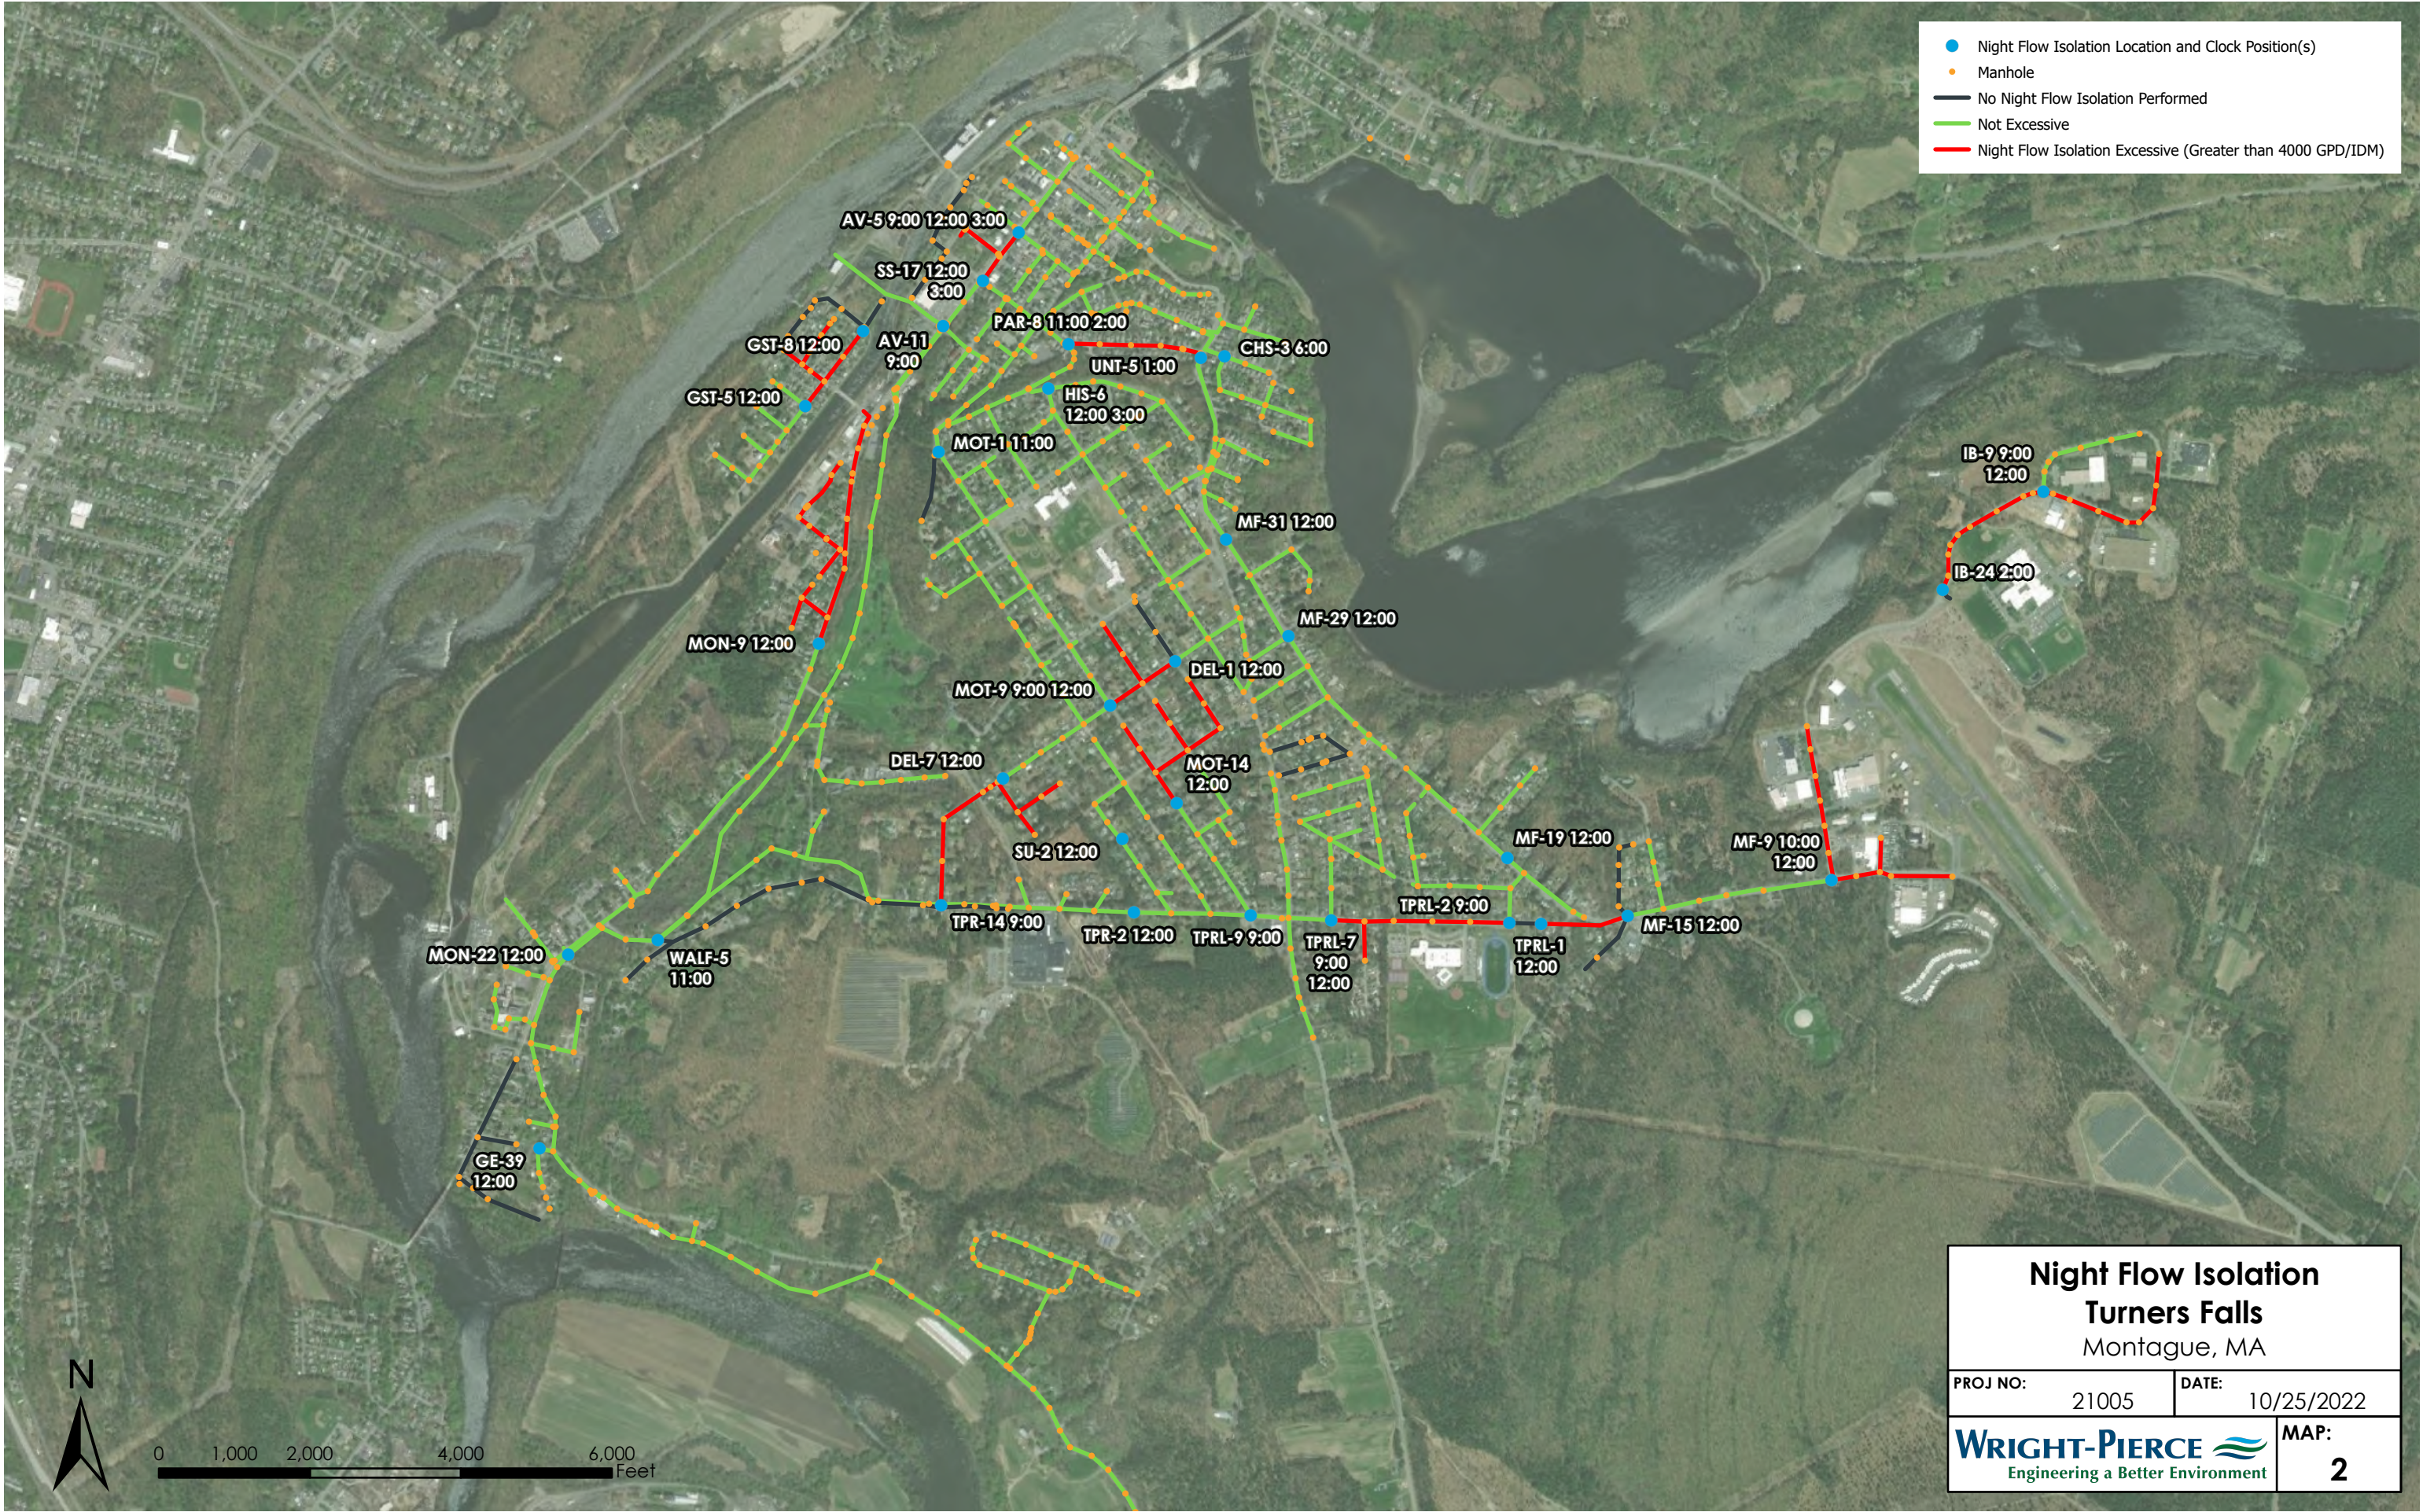
**Night Flow Isolation**  
Turners Falls  
Montague, MA

**Map 2** shows the areas targeted for NFIs and the infiltration rate results. **Table 3** contains the results of the NFIs, ranked according to the net infiltration rate of the isolation area. In this table, the areas of excessive infiltration are highlighted in blue.

Surcharge was observed at reading number IB-24-2:00. This reading is directly upstream of the Industrial Boulevard pump station and downstream of Lightlife Foods, Inc, a known industrial discharger. It is suspected that the surcharge is related to both nighttime industrial discharges and the pump station not being on at the time of the measurement. Since the infiltration rate could not be determined, it is recommended that this area is investigated further.

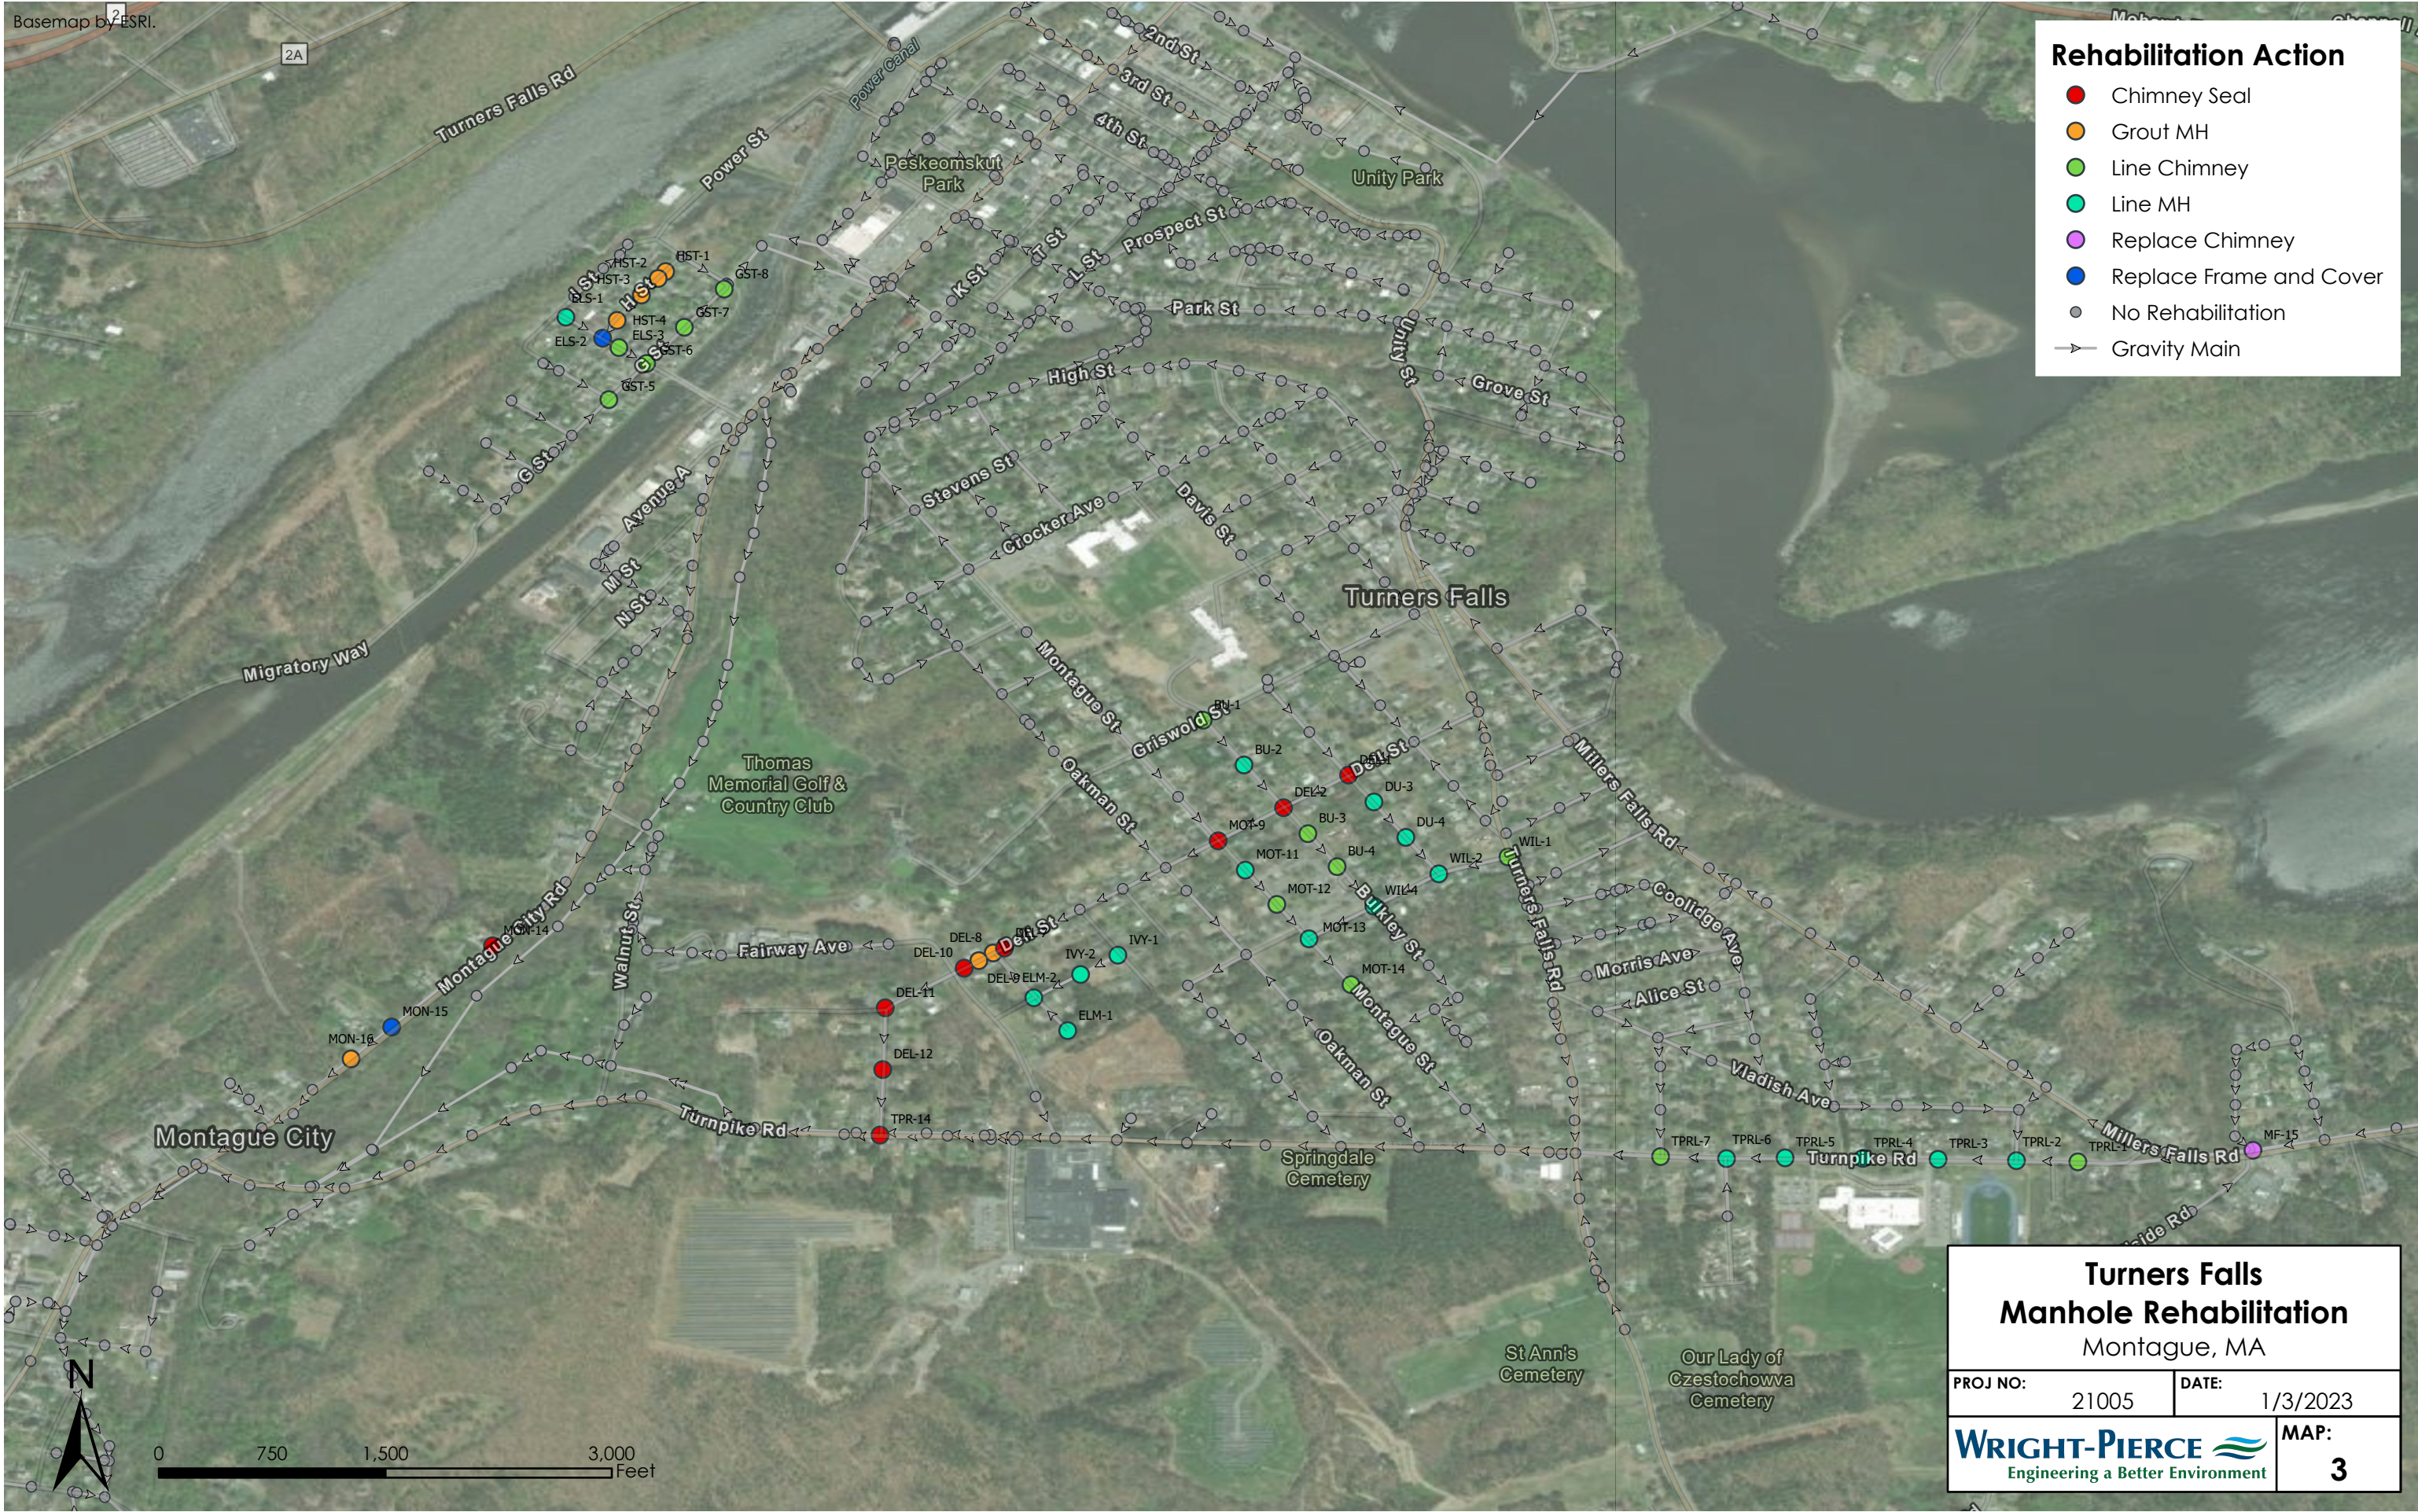
<b>Turners Falls Manhole Rehabilitation</b>	
Montague, MA	
PROJ NO: 21005	DATE: 1/3/2023
MAP: <b>3</b>

The results from the manhole inspections are summarized in **Table 9**. Most manholes have an LoF of 3 and the highest LoF is 5. Inspected manholes and their rehabilitation recommendations are depicted in **Map 3**.

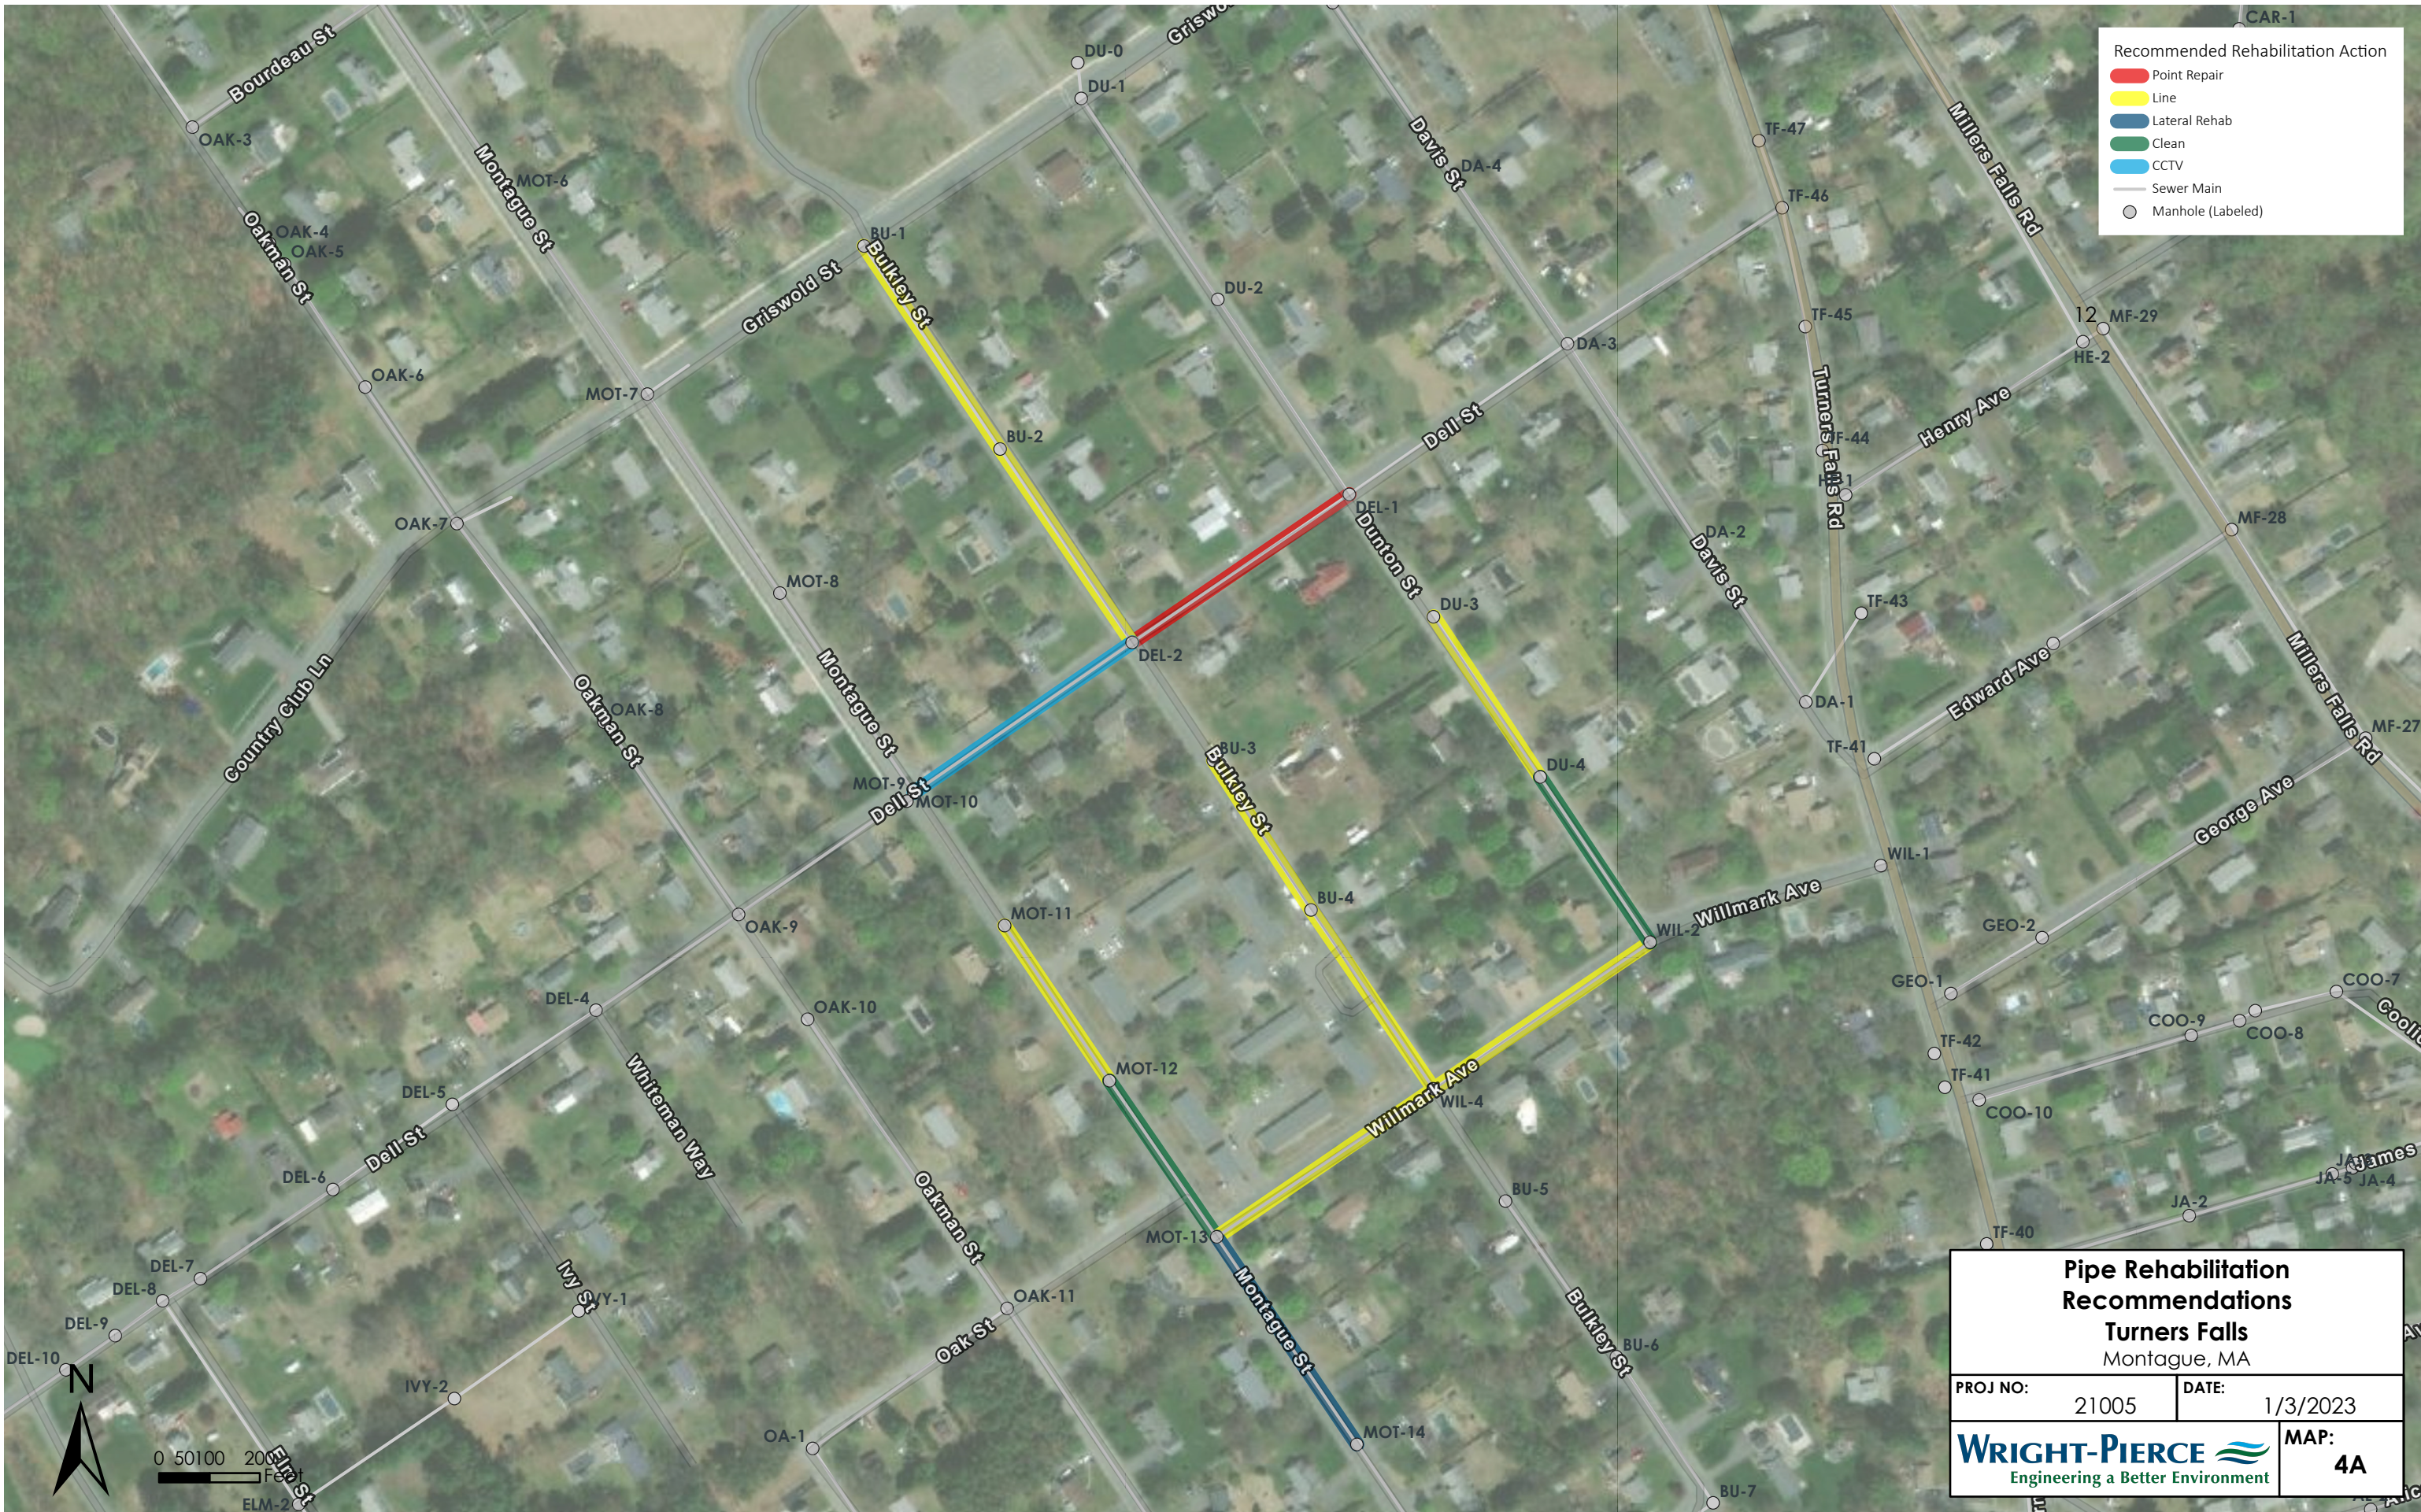
<b>Pipe Rehabilitation Recommendations</b>	
<b>Turners Falls</b>	
Montague, MA	
PROJ NO: 21005	DATE: 1/3/2023
<b>WRIGHT-PIERCE</b>	
Engineering a Better Environment	
MAP: <b>4A</b>

Pipe inspections were conducted by flushing the sewer pipes between manholes using a high-pressure jetter to loosen any debris and provide a clear view of the infrastructure. A camera was then run through the pipe, so the operator could see the entire pipe above the water line from the inside. The camera is mounted to a robotic vehicle, which can navigate through the sewer pipes and can rotate to almost any angle to get a closer look at any defects seen by the operator. The entire inspection was recorded on video for review. Any defect in the pipe was noted as well as the distance of the defect from the camera launching manhole. A Wright-Pierce NASSCO PACP certified engineer then performed an independent review of twenty percent of the reports and videos to provide quality control for the pipe inspections. The CCTV inspection reports are included in **Appendix B**. Inspected pipe segments and their rehab recommendations are depicted in **Map 4**.

One gravity sewer pipe segment (DEL-2 to MOT-9) could not be CCTV inspected in its entirety due to a joint offset and high-water levels preventing the camera from accessing the full pipe. This pipe segment will need to be

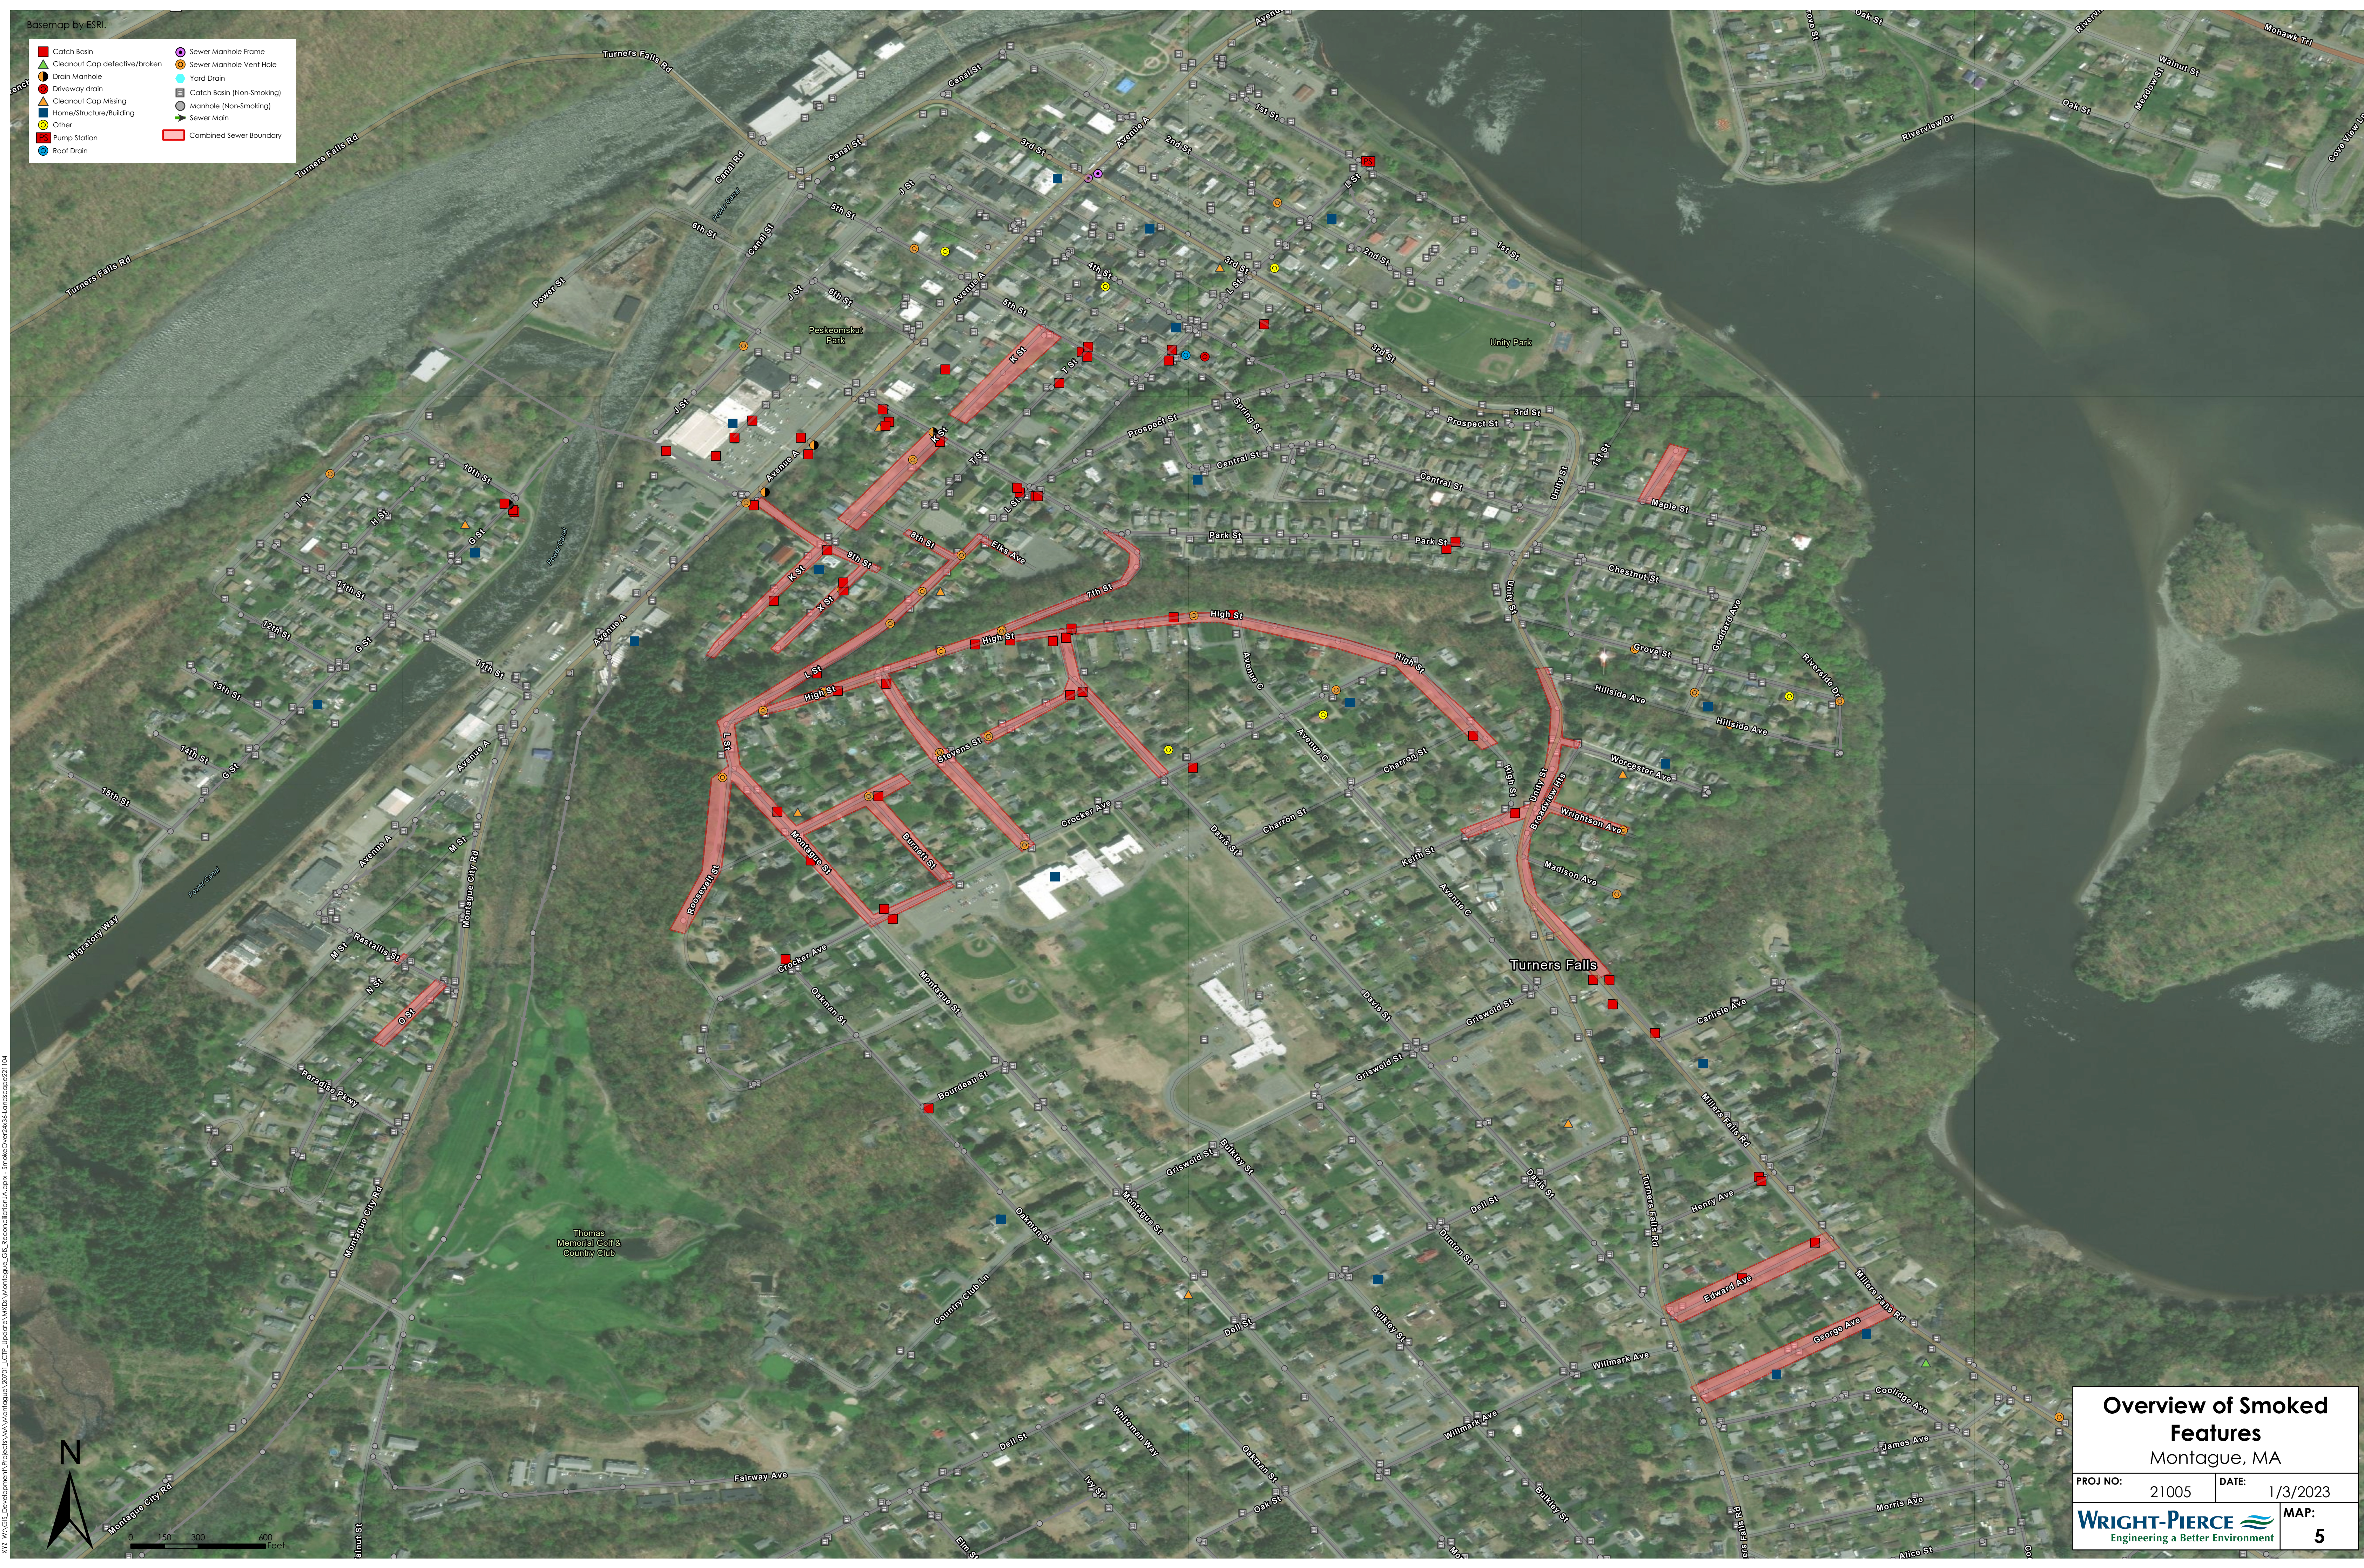
**Overview of Smoked Features**  
Montague, MA

The Town has several areas they are aware of that still have combined sewer and stormwater elements. This combined system is known to exist in the areas of High Street, 7th Street, and L Street. These areas are depicted in **Map 5** and are based on the 2003 Existing Sewers figure in the Town's 2005 LTCP and discussions with the Town in 2021. Smoke observations in these areas were documented, but these observations were separated from the observations found in areas that are supposed to be part of separated systems.
