ROOF ASSESSMENT REPORT

TOWN HALL ANNEX, REAR ENTRANCE ROOF & EQUIPMENT ROOM ROOF
ONE AVENUE A
TURNER FALLS, MA 01376

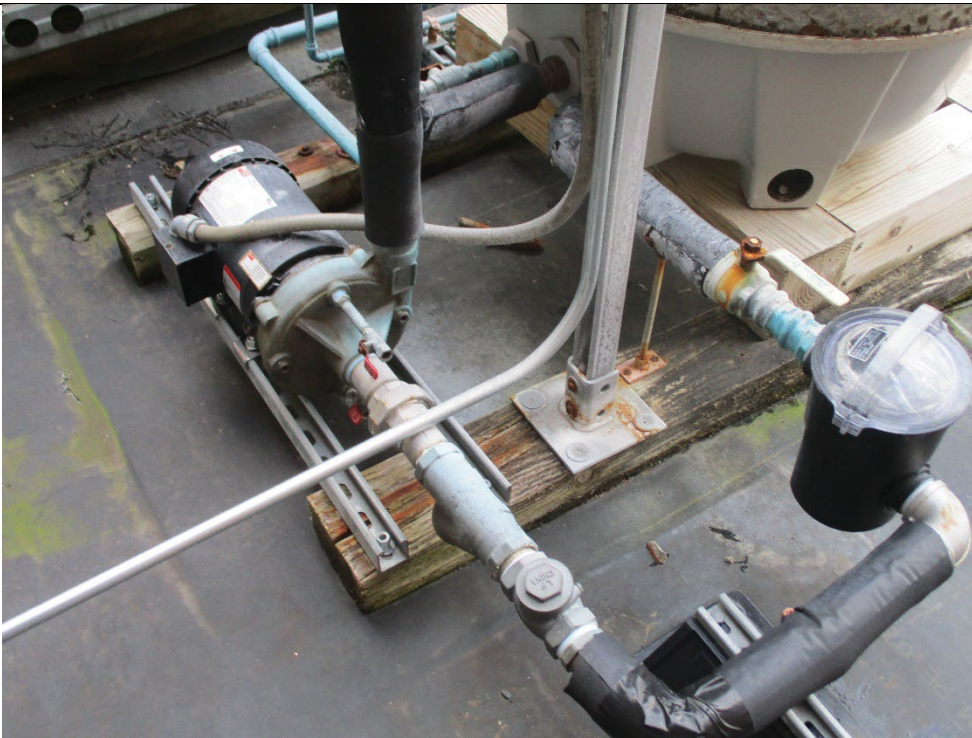
Description:
View of rear
overhang roof with
minor standing
water. No roof
issues found during
inspection.
