Farren Care Center

Selected Photos for Review by the Montague Historical Commission

December 6, 2022

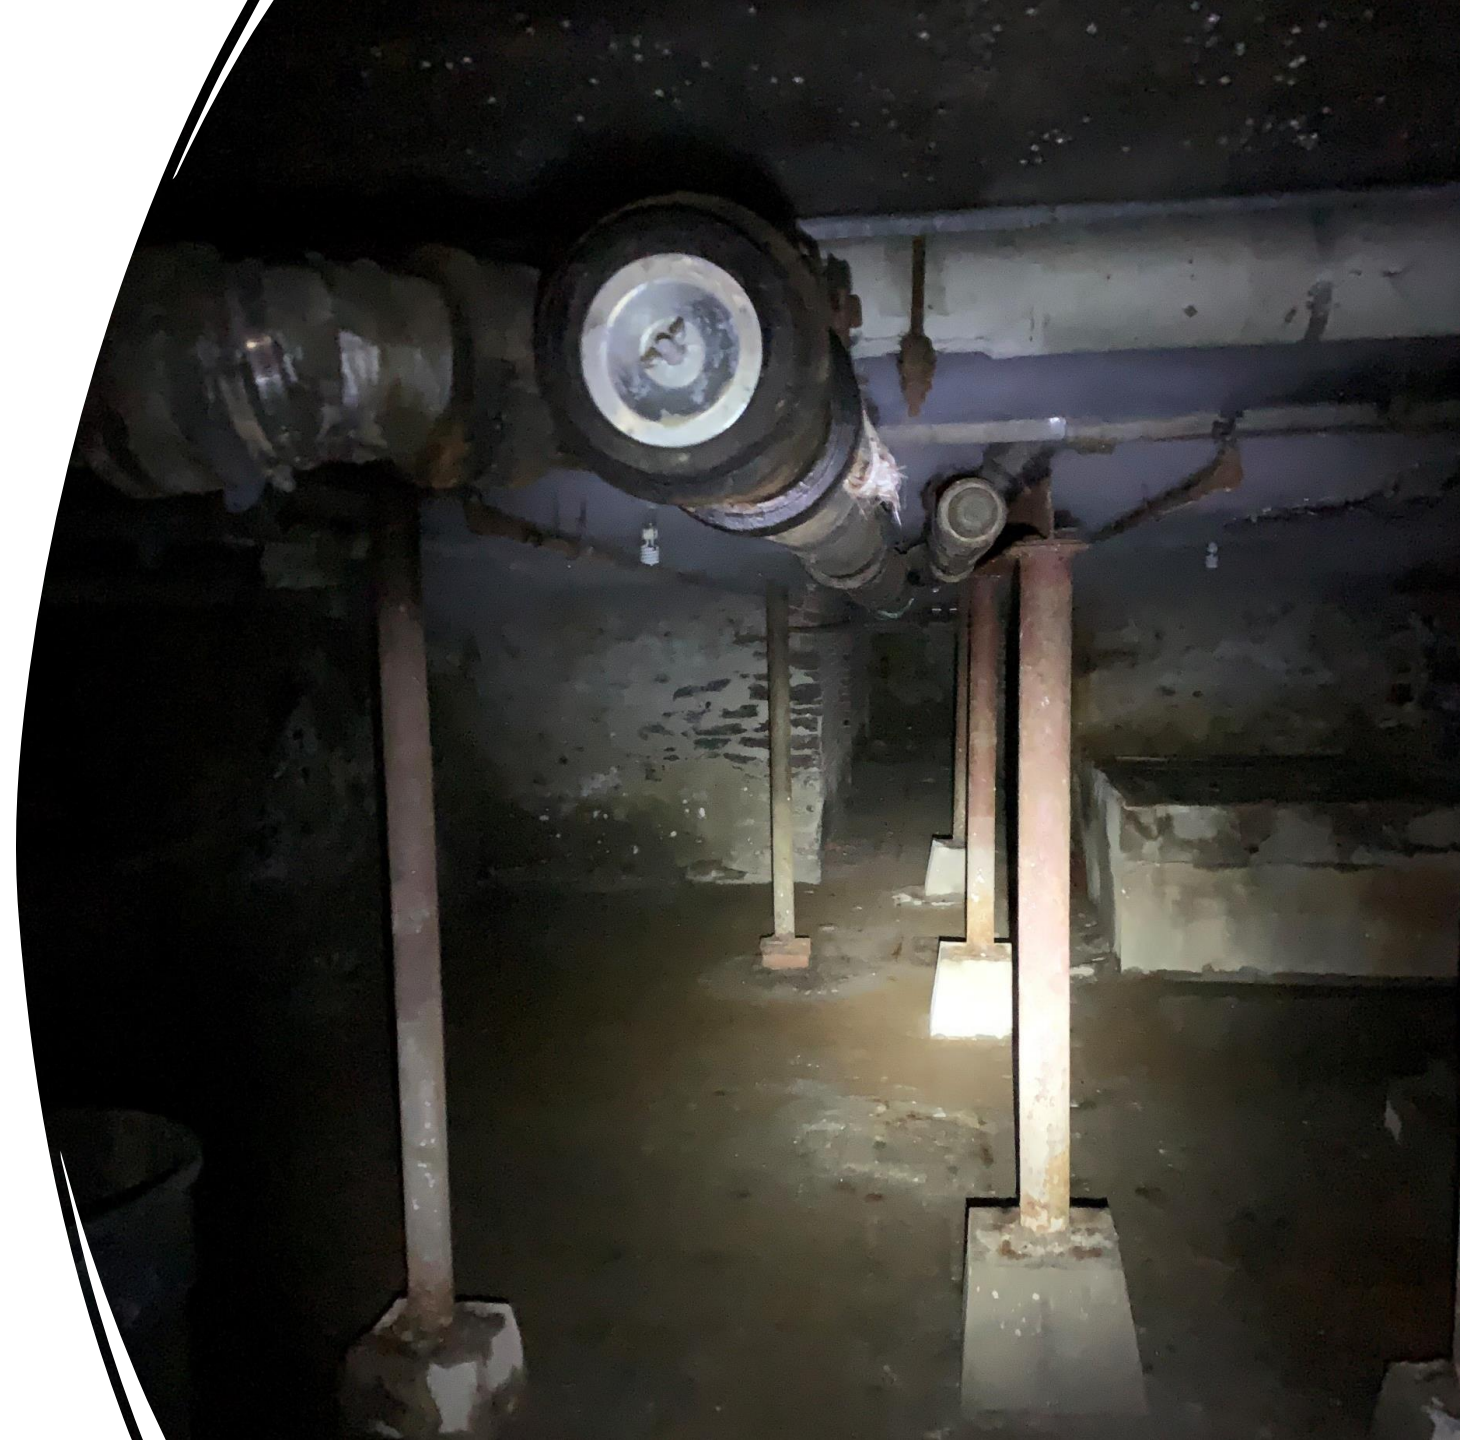
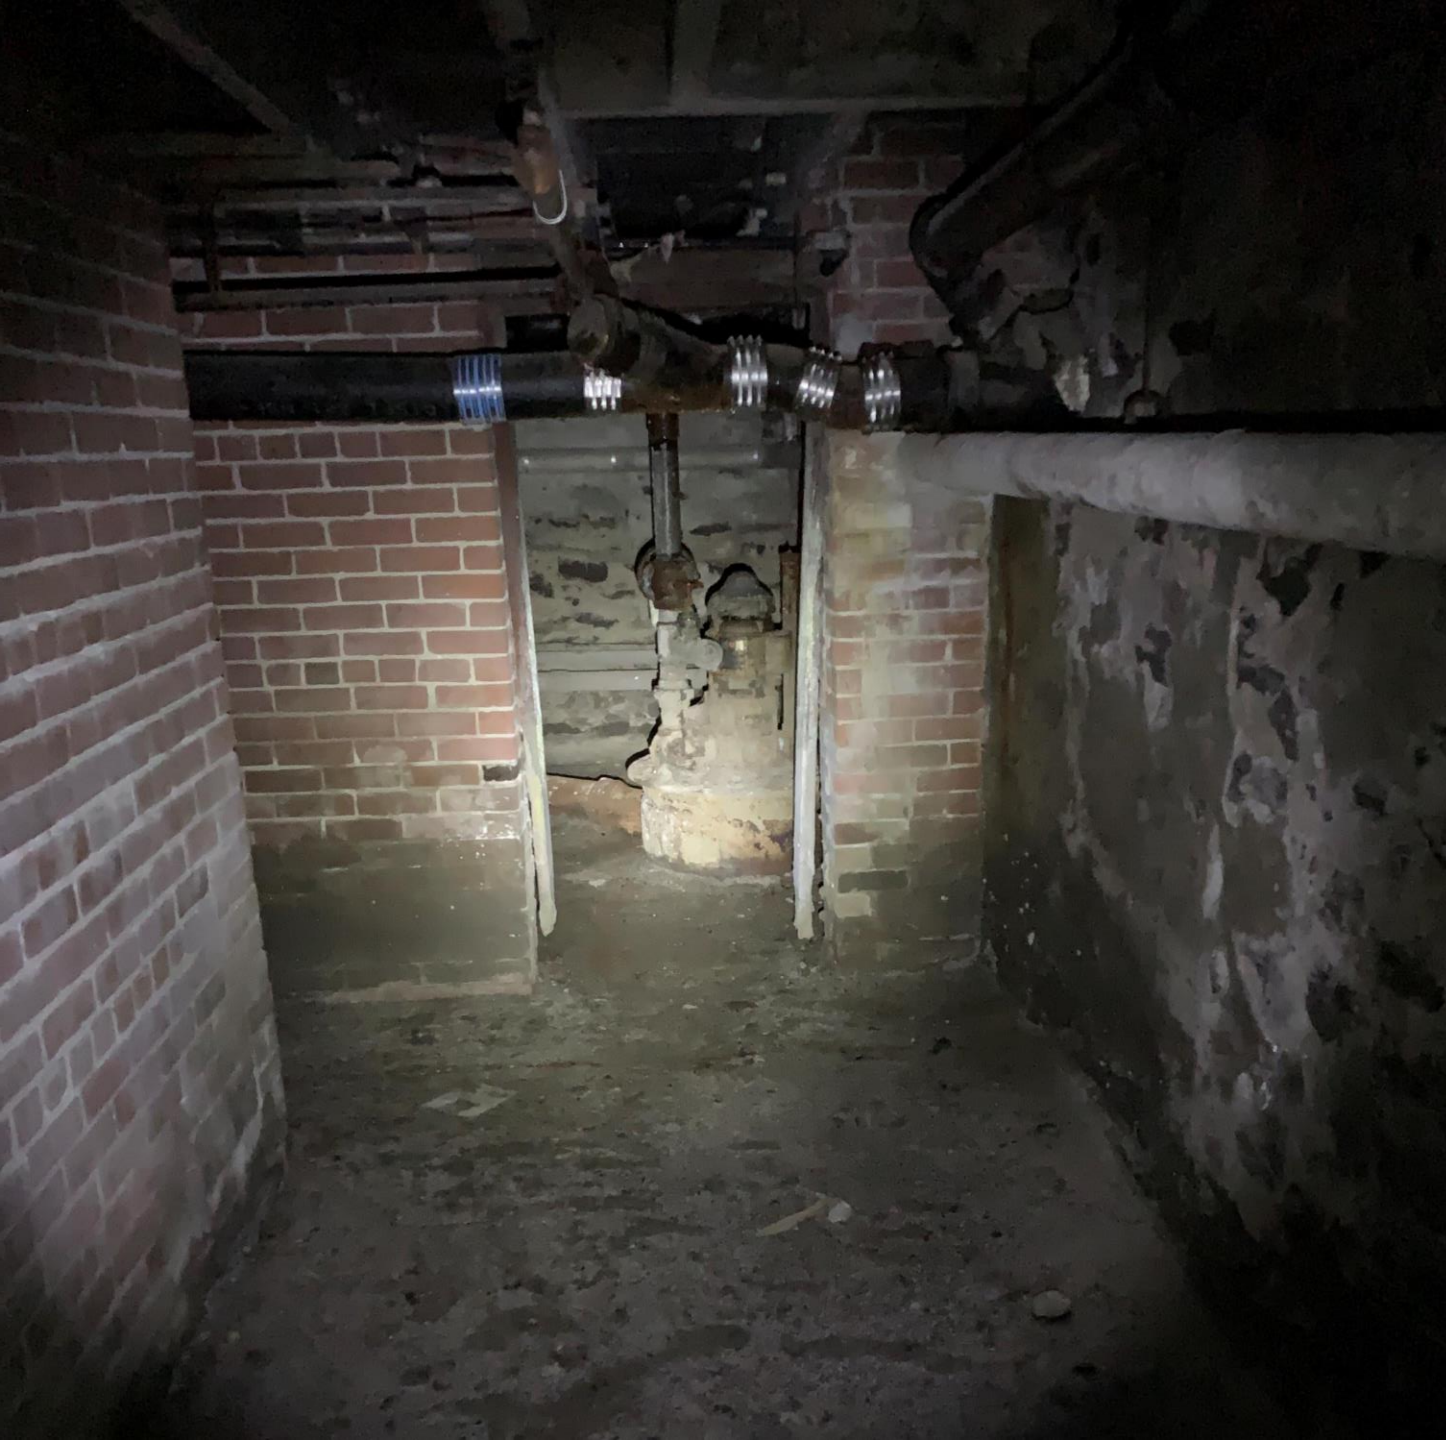
Basement, 1900 Building

- Water infiltration at foundation and exterior walls
- Sump pump runs continuously, even during drought conditions in the local area
- Grid pattern building subdrainage system has collapsed beneath floor slabs
- Piping system for sanitary drainage system beyond life expectancy

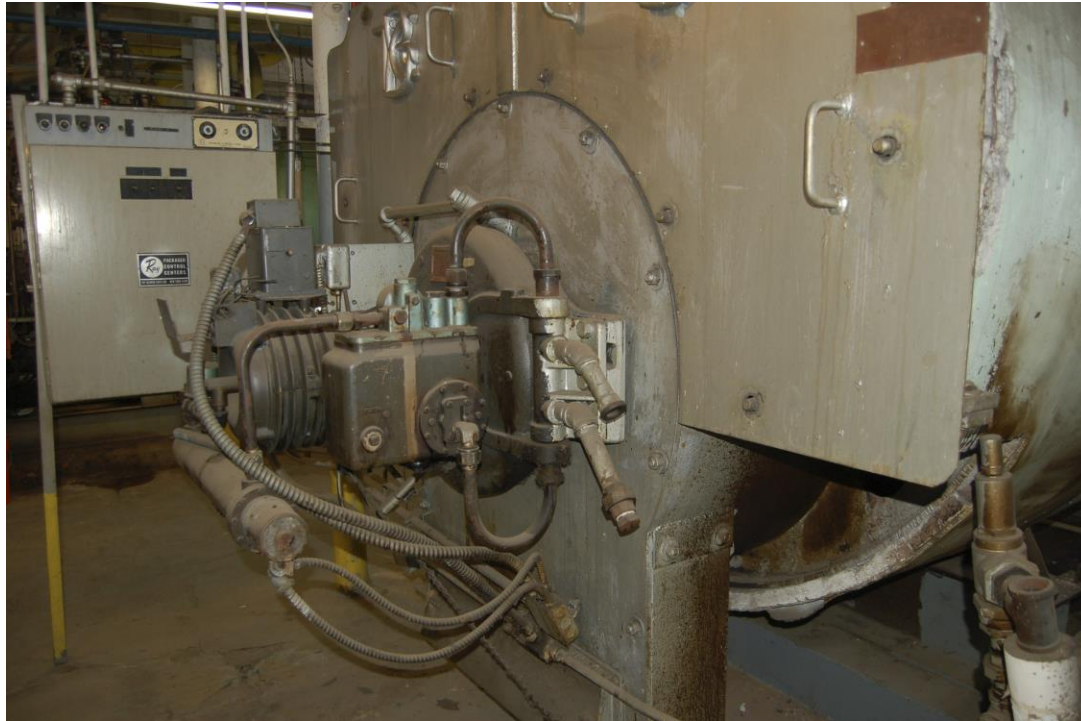
**Bigelow Boiler is covered in 4" of asbestos;
taken out of service ca. 1995 due to
inefficiency**

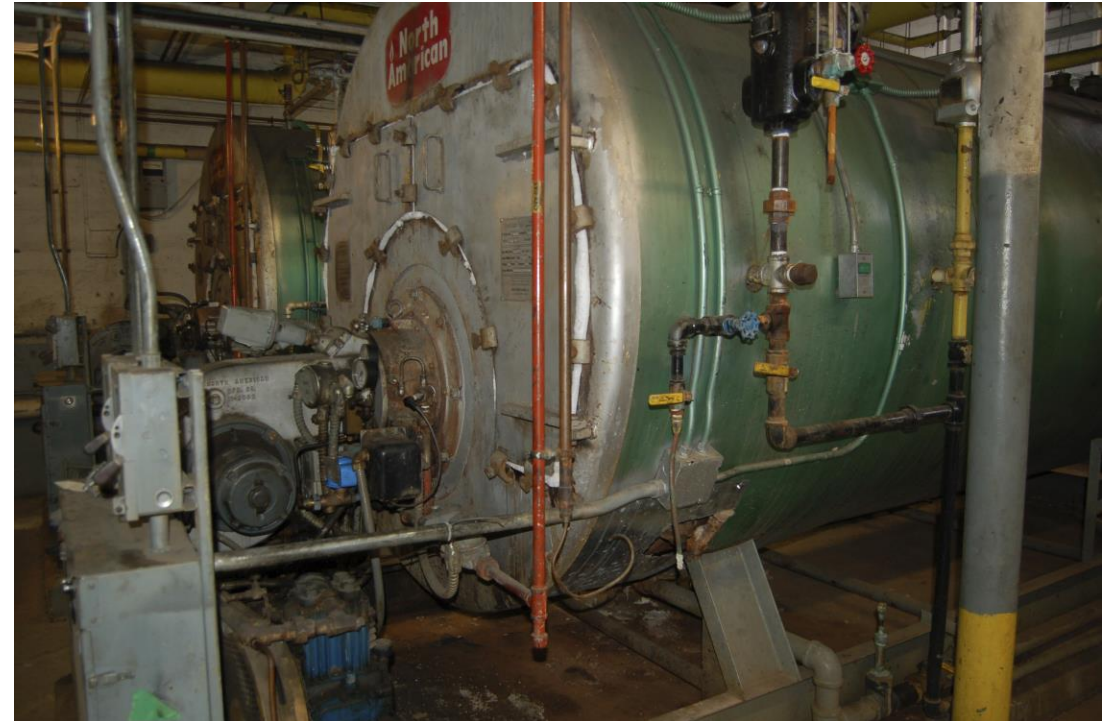
**Two North American boilers are vintage 1975;
insurance inspection indicates that boilers
likely to reach end of life within two years**

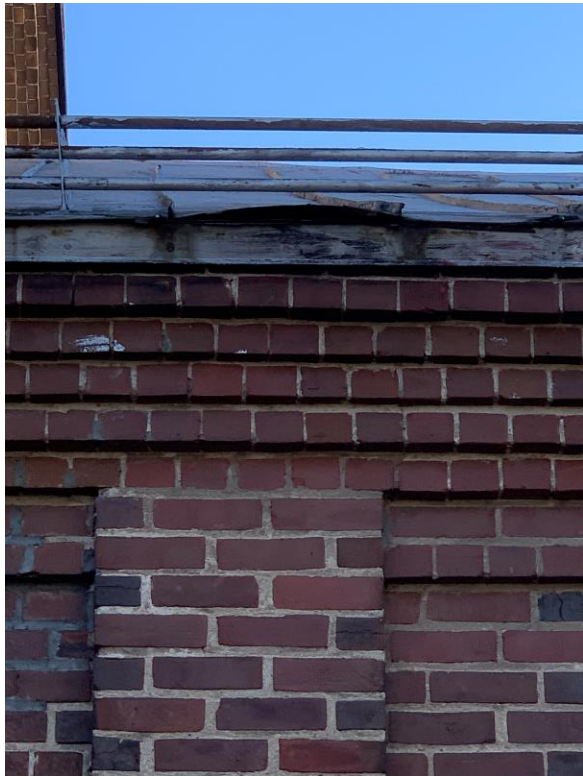
Roof structure deterioration

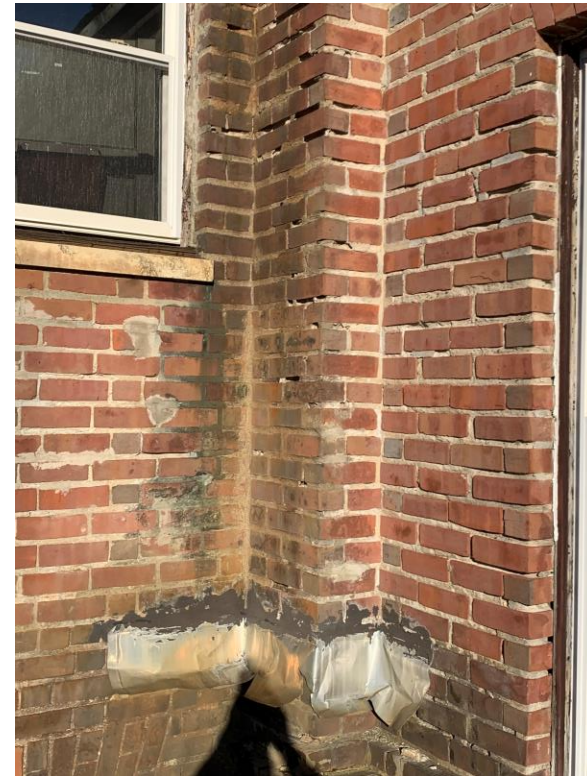
Deterioration of northwest inside corner of the 1900 Building

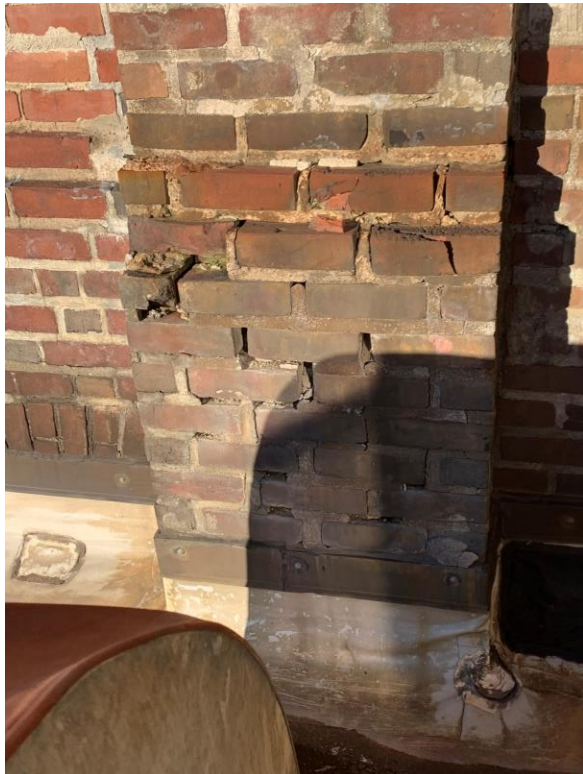
Outside buttress mortar failure due to rain water from roof, design flaws in brick work

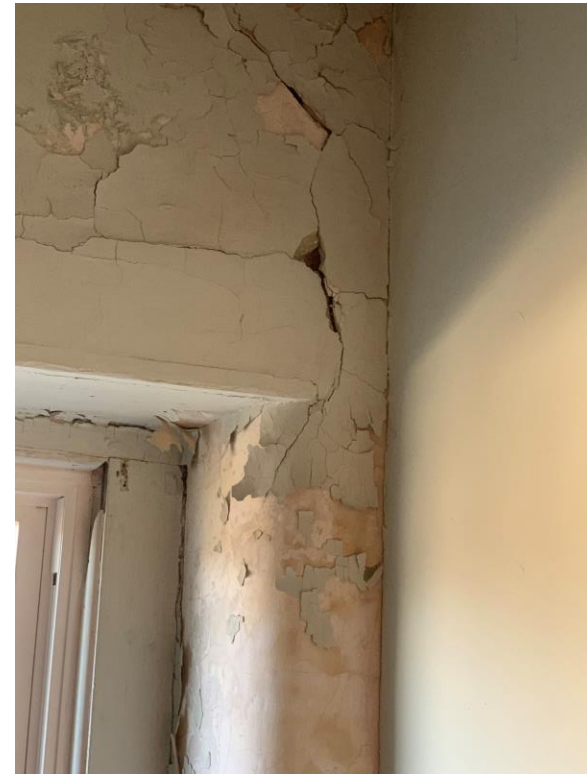
Water infiltration from exterior working its way through three courses of brick and causing significant damage to interior walls; structural integrity of the wall has formed a crack from inside to outside
