**ROOF ASSESSMENT REPORT**  
**WATER POLLUTION CONTROL FACILITY**  
**ADMINISTRATION BUILDING**  
**34 GREENFIELD ROAD**  
**MONTAGUE, MA 01351**

Date: March 24, 2022  
NRC Project No. 22-001

RE: Roofing Consulting Services  
Roof Assessment and Report  
Water Pollution Control Facility (Administration Building)  
Montague, MA

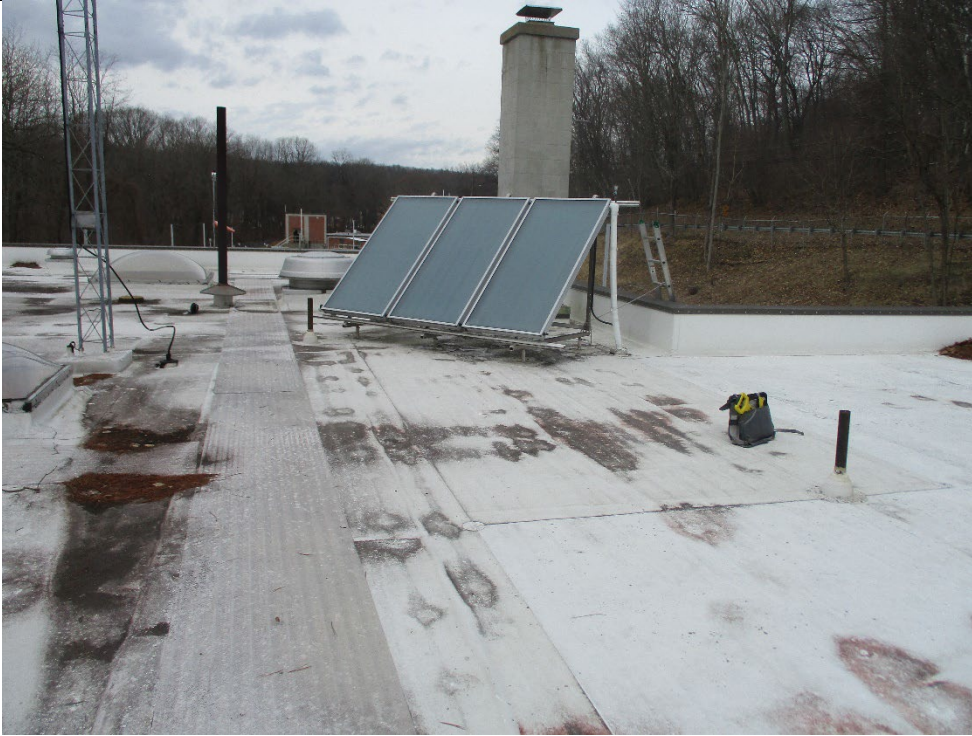
**Photo R1**  
02/17/22

Photo Location:  
Overview of  
Administration  
Roof.

Description:  
View of  
thermoplastic white  
membrane roofing  
system. Note areas  
of previous  
standing water has  
discolored  
membrane.

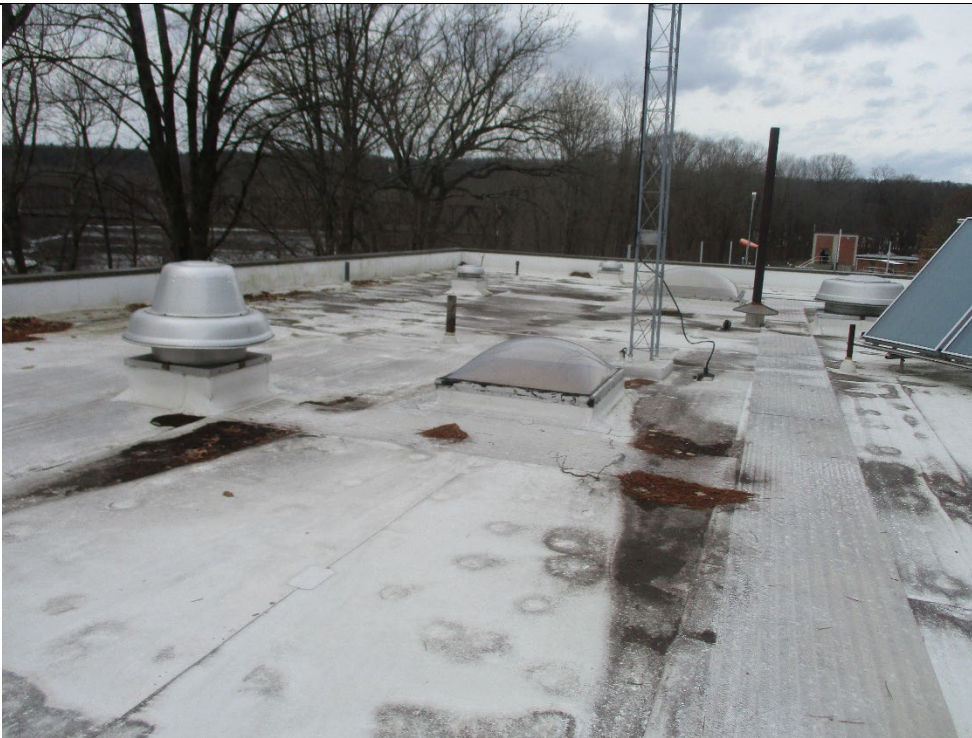
**Photo R2**  
02/17/22

- The existing roof slope is fair to good. Drain sumps are present, but could have enlarged to prevent standing water. Areas of standing water were evident along the sides of the tapered saddles.

Photo Location:  
Overview of  
Administration  
Roof.

Description:  
View of  
thermoplastic roof  
membrane and  
accumulated  
debris. Note:  
tapered insulation  
saddle blocked by  
skylight curb  
interrupts water  
flow to the roof  
drain.

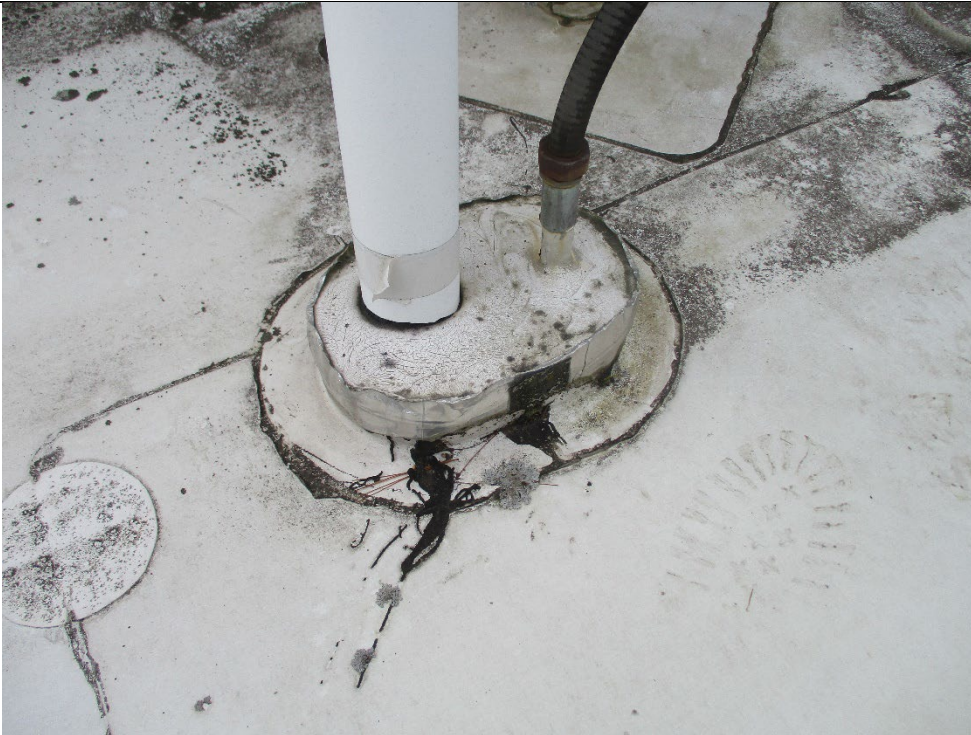
Photo Location:  
Base of Solar Array

Description:  
View of penetration pocket. Sealant does not come to top of pocket and will trap water within the penetration pocket.

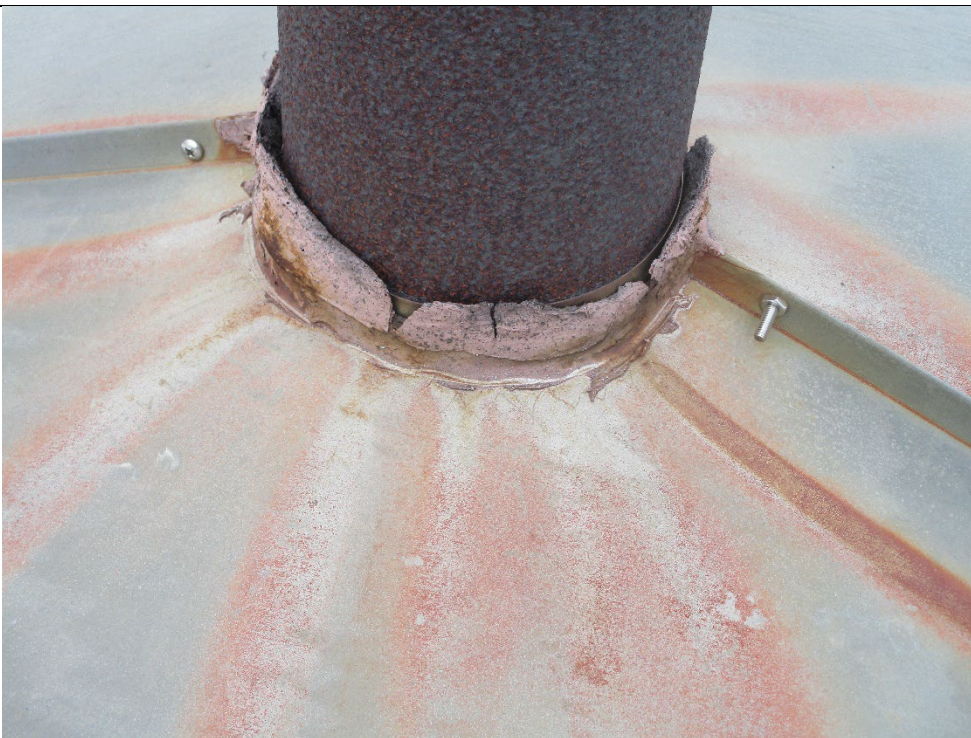
**Photo R4**  
02/17/22

Photo Location:  
Base of Flue Pipe.

Description:  
Deteriorated sealant around top of rain collar will allow moisture behind cone flashing below.

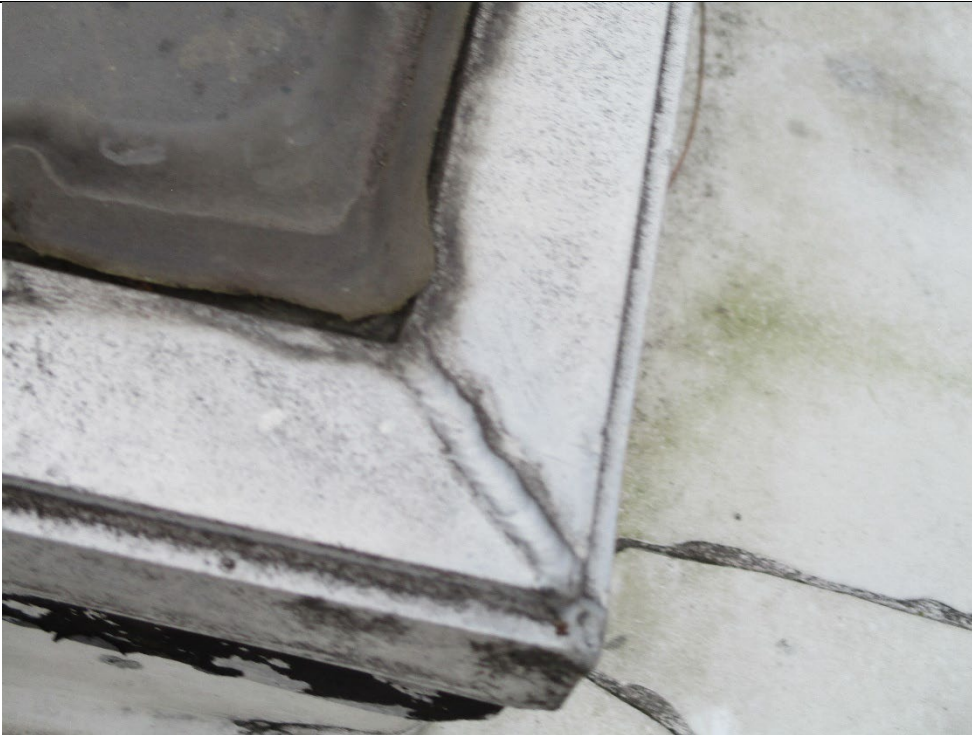
**Photo R5**  
02/17/22

Photo Location:  
Corner of Skylight  
Dome

Description:  
Sealant between  
metal frame and  
skylight dome is  
aged and shrinking  
and pulling away  
from outside frame.

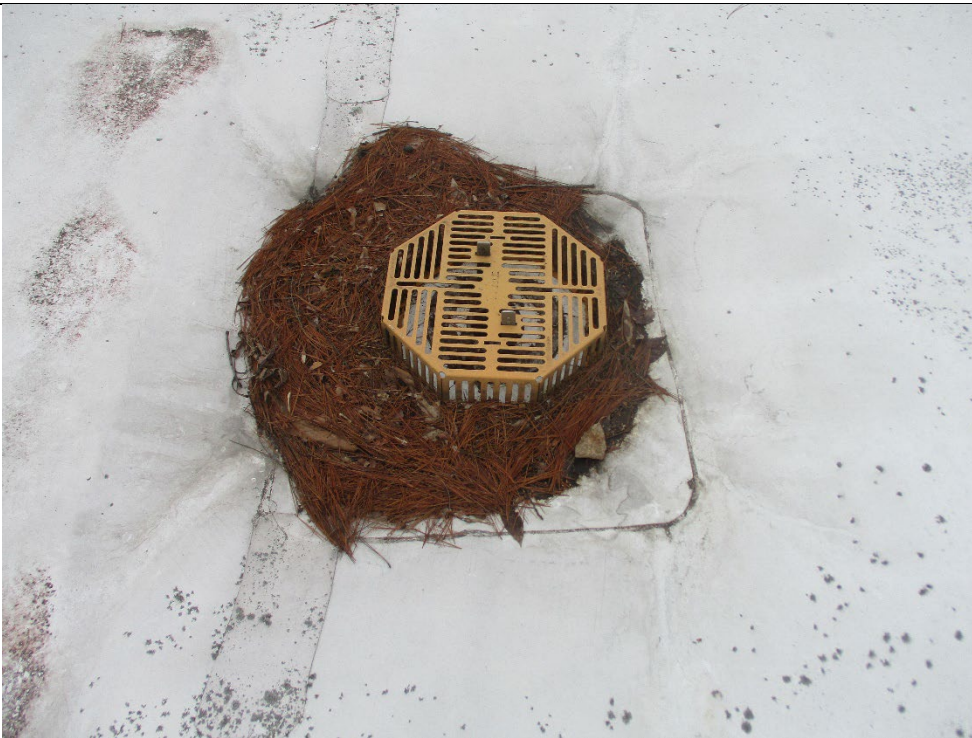
**Photo R6**  
02/17/22

Photo Location:  
RAC Insert Drain.

Description:  
Basket around roof  
drain is clogged  
with pine needles  
and debris.

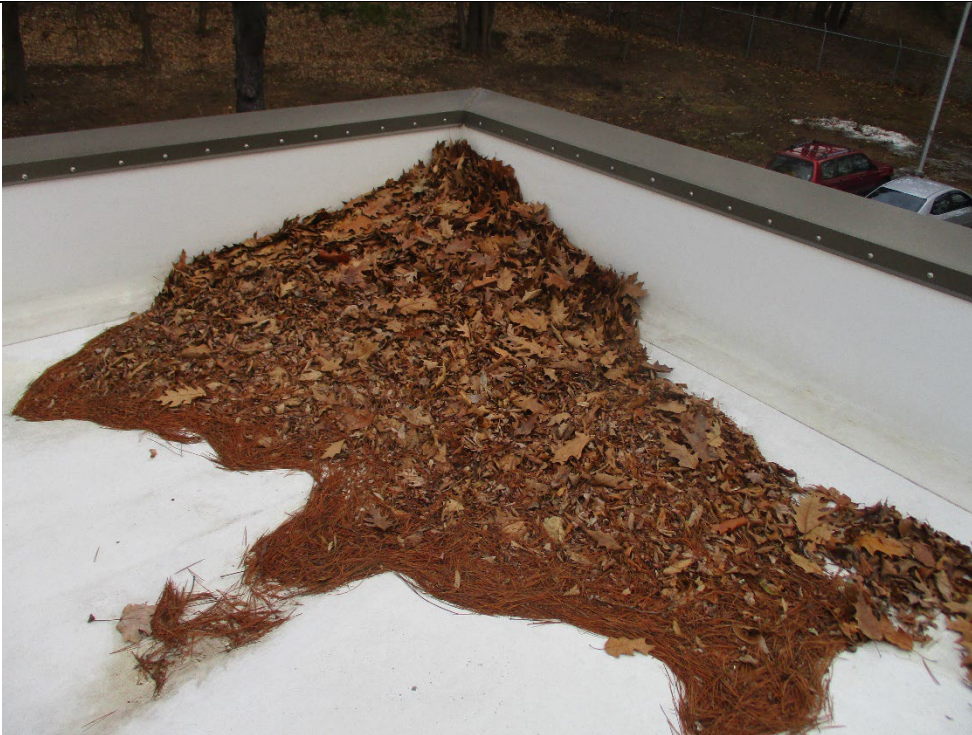
**Photo R7**  
02/17/22

Photo Location:  
Corner of Roof

Description:  
Accumulation of pine needles and leaves has built up against the outside parapet.

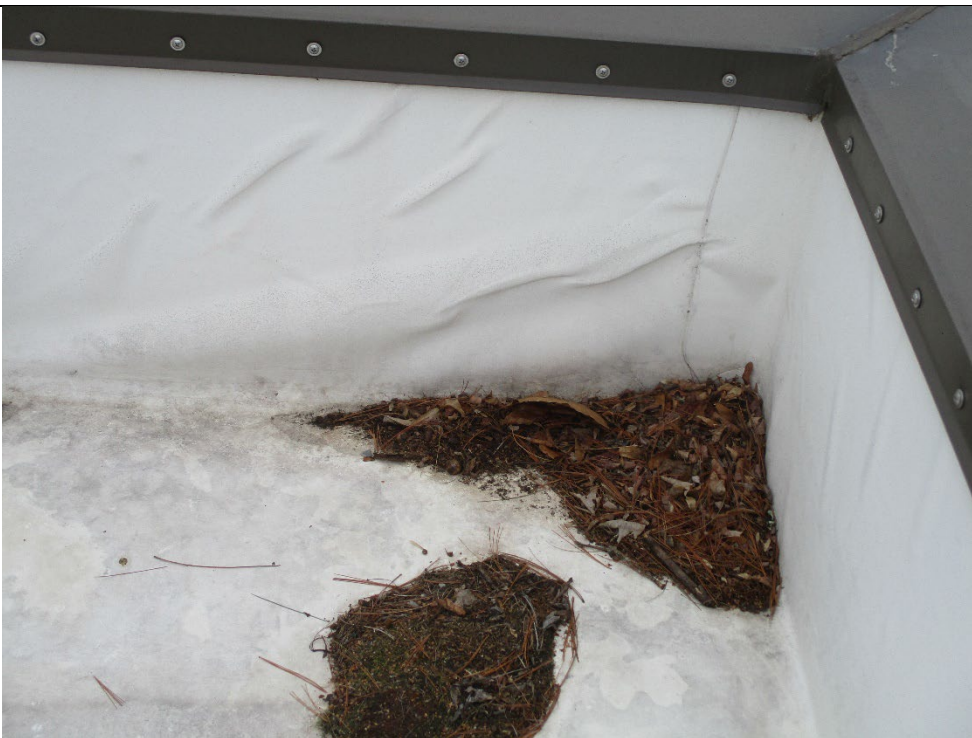
**Photo R8**  
02/17/22

- The thermoplastic membrane at the inside face of the perimeter parapet is poorly adhered and wrinkled in areas. These areas should be monitored on a yearly basis.

Photo Location:  
Outside Corner of Roof.

Description:  
Thermoplastic membrane at inside face of parapet is wrinkled and unadhered from parapet substrate.
