Phase I – Environmental Site Assessment

First Street Parking Lot, Turners Falls, Massachusetts

January 2023

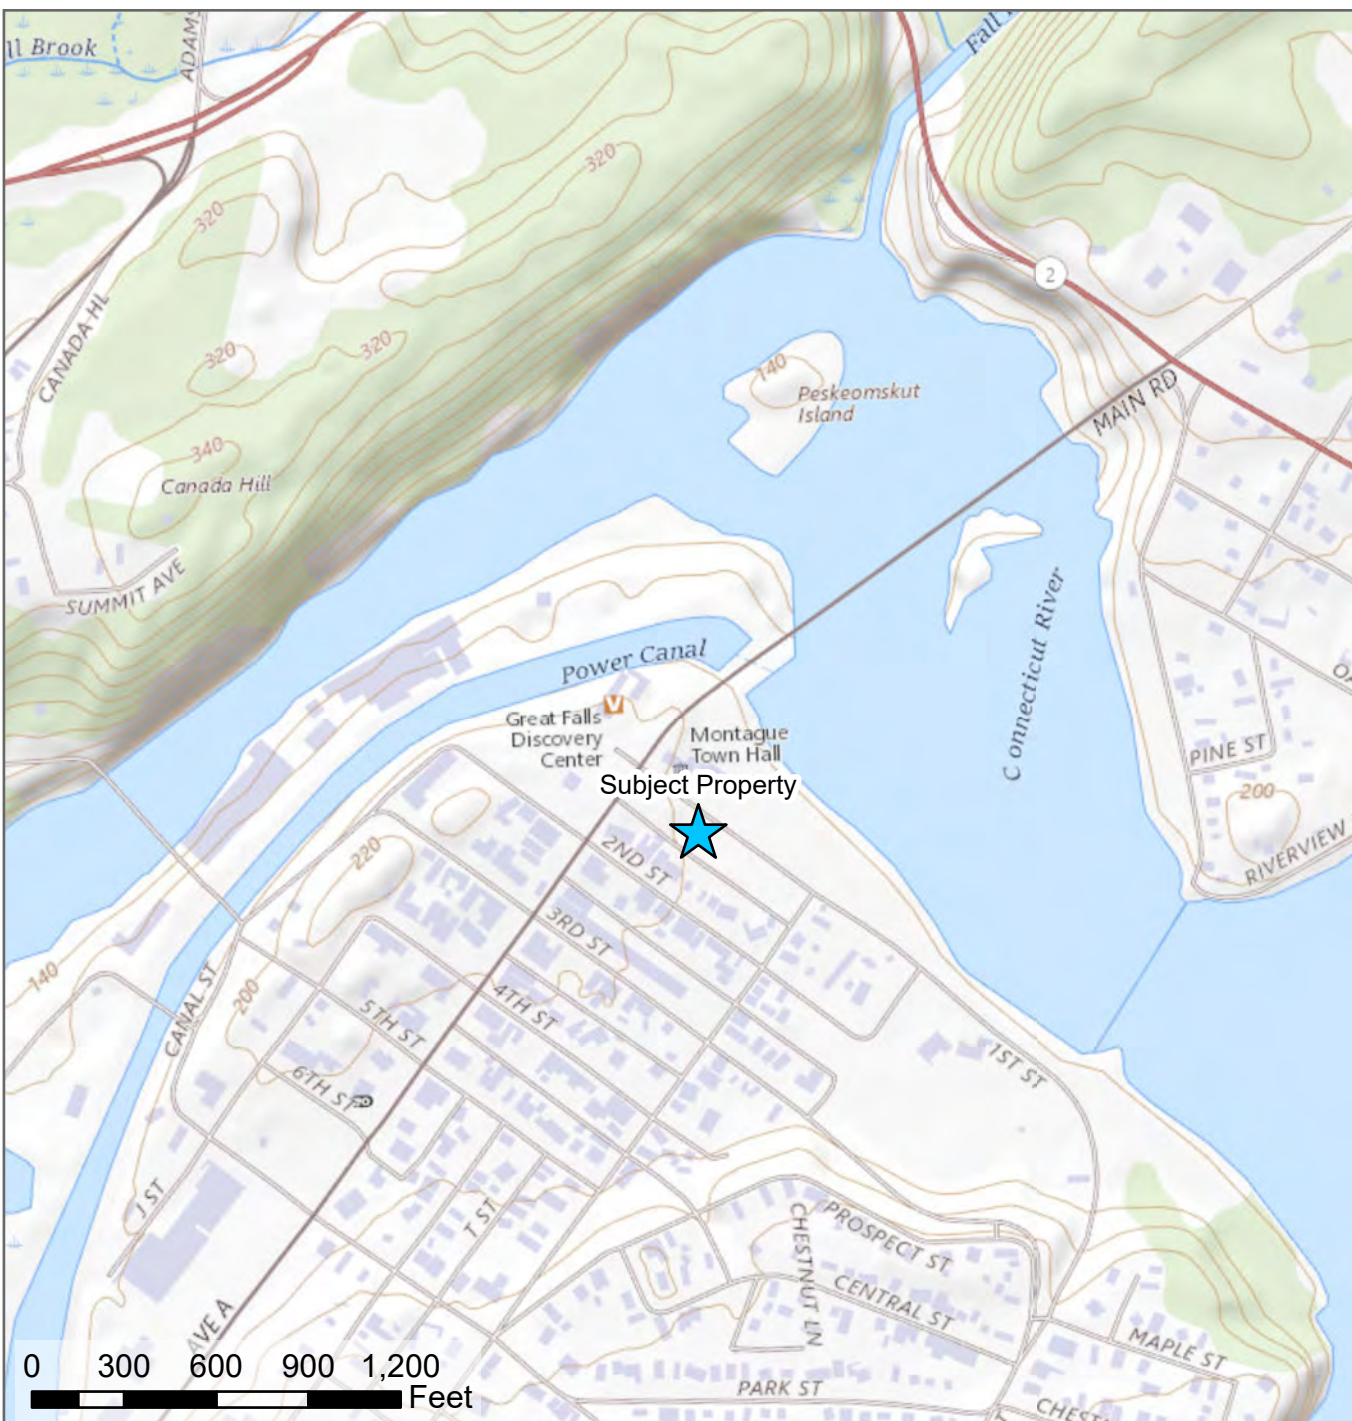
Figure 1: Site Location
 First Street Parking Lot
 Turners Falls, MA

The Site is a 0.65-acre parcel (ID 04-0-0031) located on First Street, downtown in Turners Falls, Massachusetts. Turners Falls is an unincorporated village located in the town of Montague in Franklin County. Franklin County is situated in northwestern Massachusetts. The Site is located at the following coordinates: 42.608842°, -72.55475°. The Site location is presented in Appendix A, Figure 1.

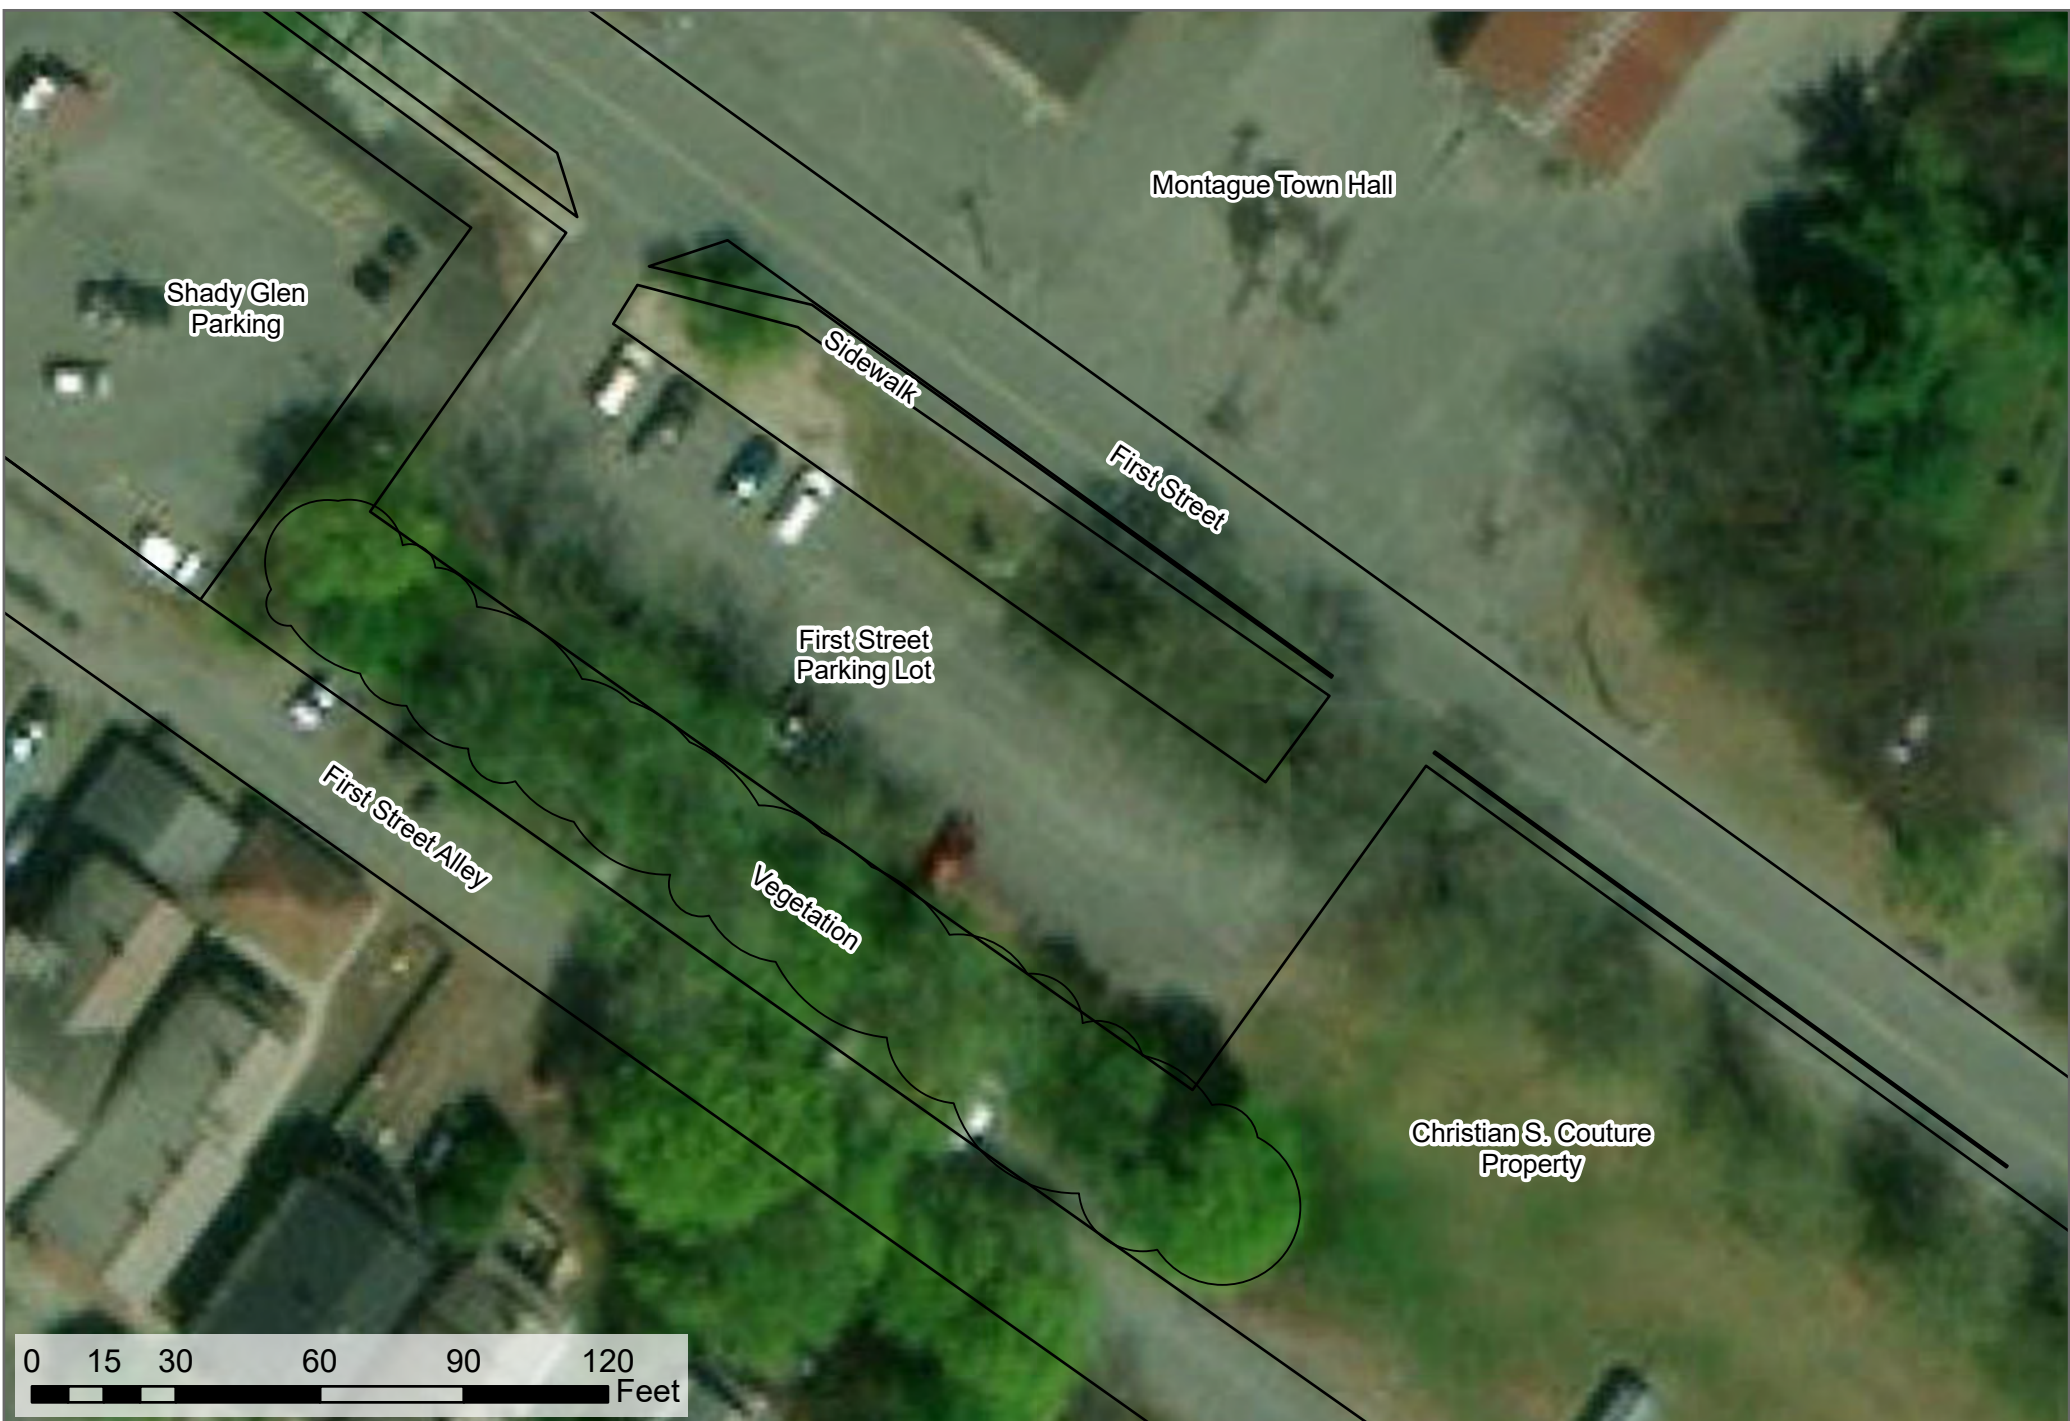
The Site is primarily a paved asphalt lot surrounded by grass and trees. There are no buildings or other structures located at the Site. The paved area approximately measures 80 by 190 feet. The lot is accessed by paved drives on both ends of the lot that allow vehicles to enter and exit from First Street, which is located immediately northeast of the Site. A paved concrete sidewalk, grass median, and several trees are

located between the lot and First Street. The southeastern portion of the Site is grass-covered. Trees and vegetation line the southwestern edge of the Site. Bare gravel and soil slope up in a northwestern direction at the northwest edge of the Site. The paved lot contains a few cracks but is kept in relatively good condition. A layout of the site is presented in Appendix A, Figure 2. Photographs of the Site are included in Appendix B.
