ADS is pleased to submit the January 2021 report for the 2021 Flow Monitoring Project .

7th_L_CSO	
Location:	7th Street at L Street

Ave_A_CSO	
Location:	7th Street at L Street

Greenfield_M1	
Location:	Greenfield Road - CSO

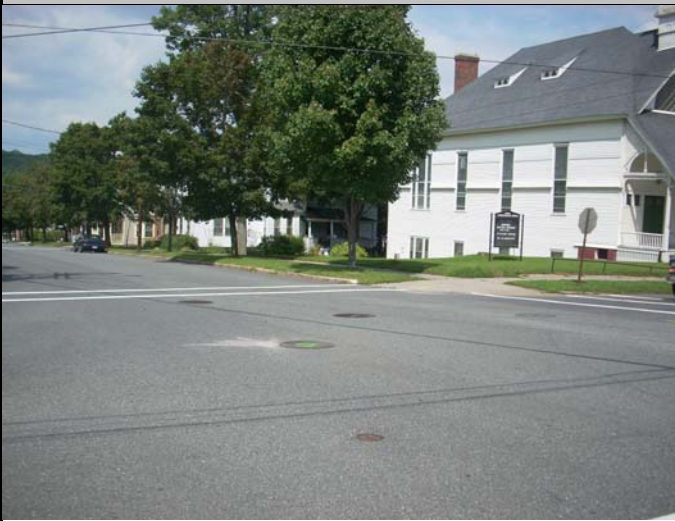
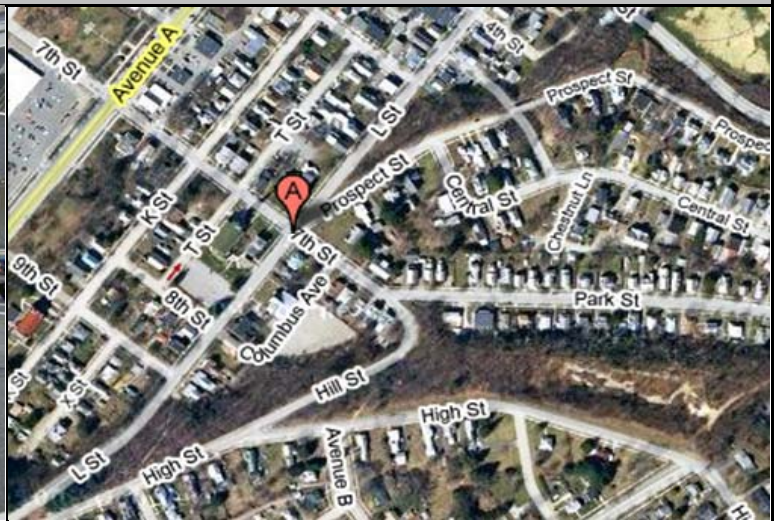
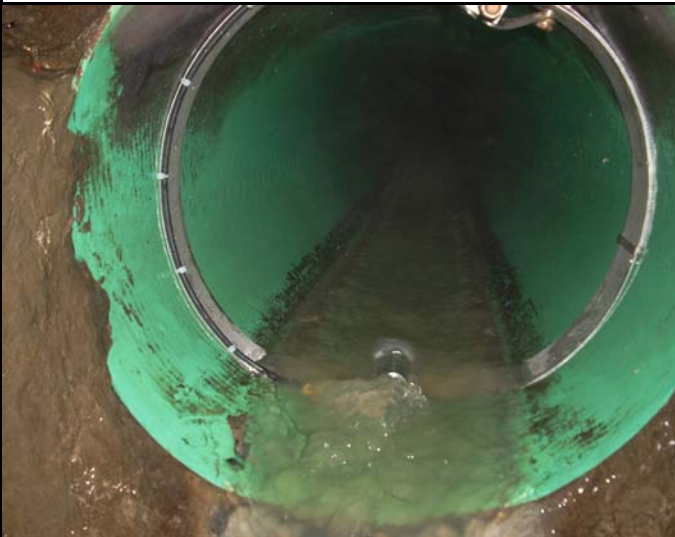
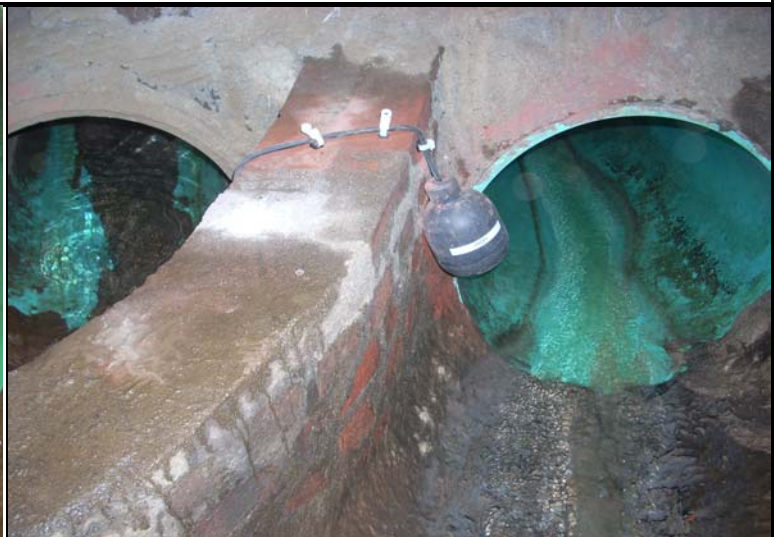
Site Name:	Montague_ 7TH L-CSO	Meter Type:	FlowAlert	Monitor S/N:	6096	Manhole #:	N/A
Address / Location:	7TH STREET AT L STREET			Map Page #:	N/A		
Access:	Drive	Type of System:	Combined	Pipe Height:	14.25 Inches		
				Pipe Width:	14.25 Inches		
				Phone Number:	I.P. 166.219.50.204

Investigation Information:			Manhole Information:		
Date/Time of Investigation:	August 26, 2009	10:50 AM	Manhole Depth:	6 Feet	2 Inches
Site Hydraulics:	slightly choppy flow with good velocity		Manhole Material / Condition:	PRECAST	Good
Upstream Input: (L/S, P/S)	N/A		Active Drop Connections?		
Upstream Manhole:	DNI		Pipe Material / Condition:	PVC	Good
Downstream Manhole:	DNI		Mini System Character:	RESIDENTIAL	
Depth of Flow (Wet Dof):	1.13		Telephone Information:		
Range (Air Dof):			Access Pole #:	N/A	
Peak Velocity:	3.03 fps		Distance From Manhole:	N/A Feet	
Silt:	0 Inches		Road Cut Length:	N/A Feet	
			Trench Length:	N/A Feet

INVERT TO TOP OF WEIR WALL 8.0" OF trigger Pdepth greater than 8"

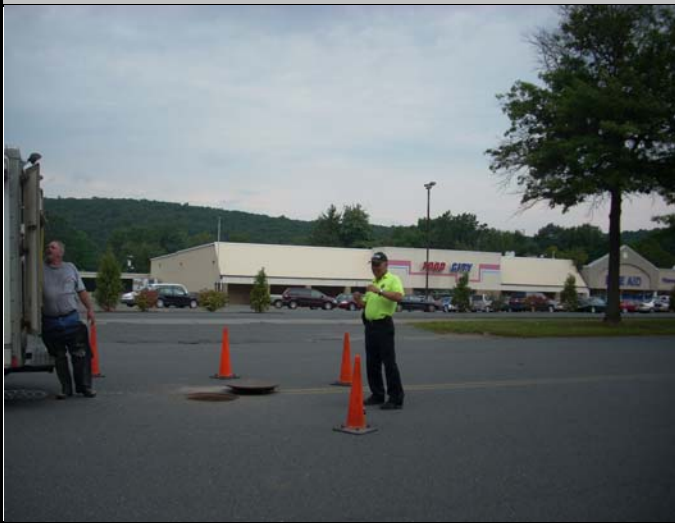
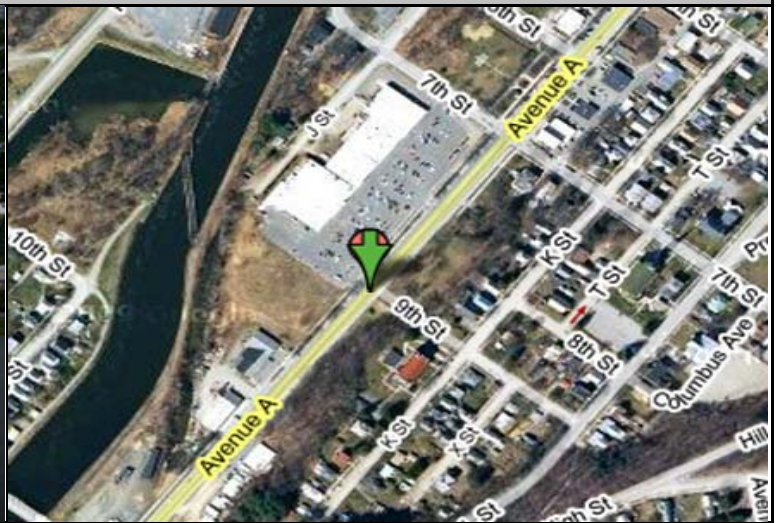
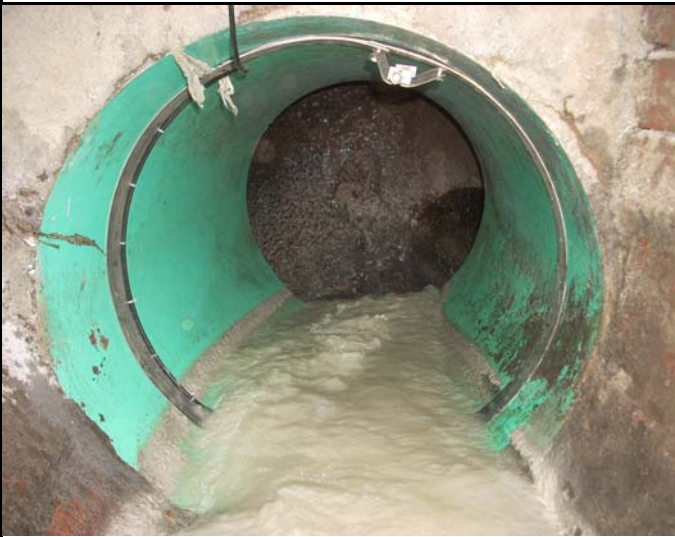
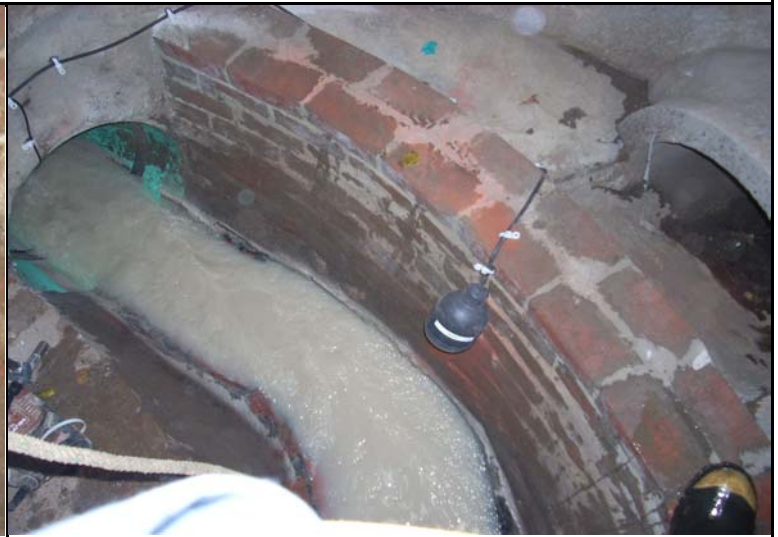
Site Name:	Montague_ AVE A-CSO	Meter Type:	FlowAlert	Monitor S/N:	6035	Manhole #:	N/A
Address / Location:		AVENUE A - IN FRONT OF FOOD CITY		Map Page #:		N/A	
Access:		Drive	Type of System:	Combined		Pipe Height:	21 Inches
						Pipe Width:	21 Inches
						Phone Number:	I.P. 166.219.48.162

Investigation Information:			Manhole Information:		
Date/Time of Investigation:	August 26, 2009	1:25 PM	Manhole Depth:	10 Feet	9 Inches
Site Hydraulics:	Fast slightly choppy flow. Outgoing install due to turbulence		Manhole Material / Condition:	Precast	Good
Upstream Input: (L/S, P/S)	N/A		Active Drop Connections?		
Upstream Manhole:	DNI		Pipe Material / Condition:	PVC	Good
Downstream Manhole:	DNI		Mini System Character:	COMMERCIAL	
Depth of Flow (Wet Dof):	2.13		Telephone Information:		
Range (Air Dof):			Access Pole #:	N/A	
Peak Velocity:	4.79 fps		Distance From Manhole:	N/A Feet	
Silt:	0 Inches		Road Cut Length:	N/A Feet	
			Trench Length:	N/A Feet

INVERT TO TOP OF WEIR WALL 26.70 - PRESSURE IN OUTLET PIPE- PRESSURE OFFSET 1.13

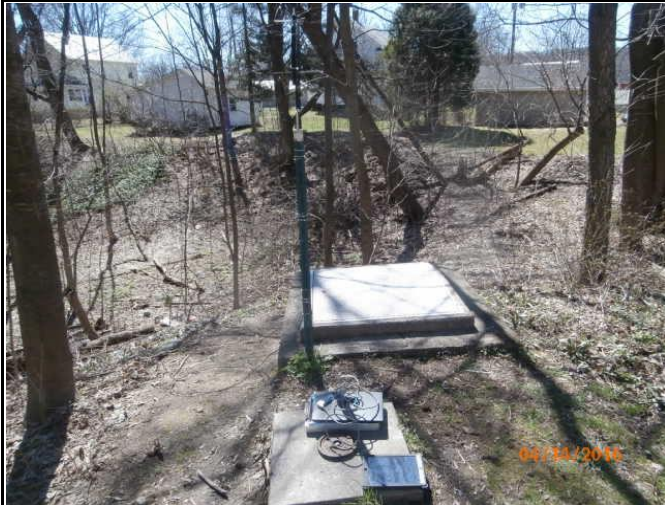
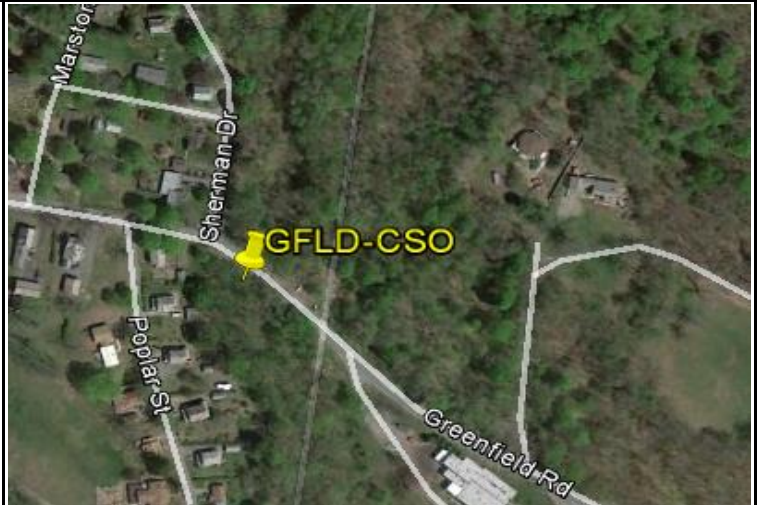
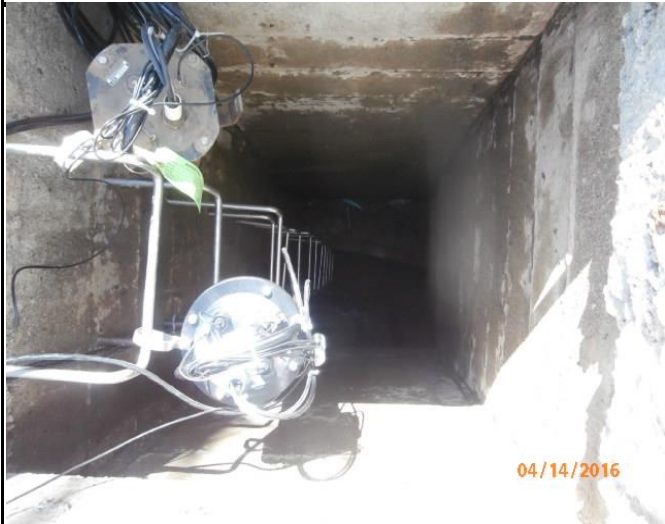
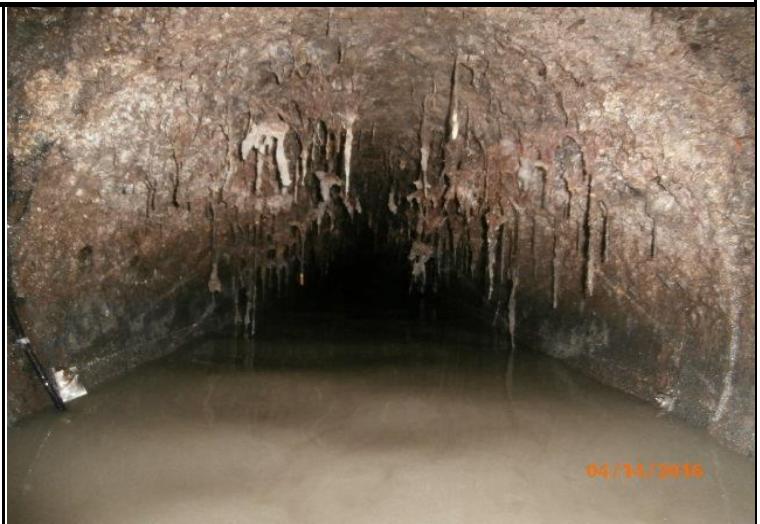
Site Name:	Montague_GFLD-CSO	Meter Type:	TRITON+	Monitor S/N:	60995	Manhole #:	n/a
Address / Location:		GREENFIELD ROAD - CSO		Map Page #:		N/A	
Access:		Type of System:	Combined	Pipe Height:		36 Inches	
Drive				Pipe Width:		36 Inches	
				Phone Number:		I.P. 107.80.17.22

Investigation Information:			Manhole Information:		
Date/Time of Investigation:	April 14, 2016	4:10 PM	Manhole Depth:	14 Feet	6 Inches
Site Hydraulics:	GOOD		Manhole Material / Condition:	PIP	Good
Upstream Input: (L/S, P/S)	N/A		Active Drop Connections?		
Upstream Manhole:	DNI		Pipe Material / Condition:	RCP	Good
Downstream Manhole:	DNI		Mini System Character:	RESIDENTIAL	
Depth of Flow (Wet Dof):	4.38		Telephone Information:		
Range (Air Dof):			Access Pole #:	N/A	
Peak Velocity:	2.04 fps		Distance From Manhole:	N/A Feet	
Silt:	0 Inches		Road Cut Length:	N/A Feet	
			Trench Length:	N/A Feet

INVERT TO TOP OF WEIR WALL 41.75. Pressure depth OF trigger Press S/N 82448 High High float set at 42" High Float set at 30" from invert at sensor

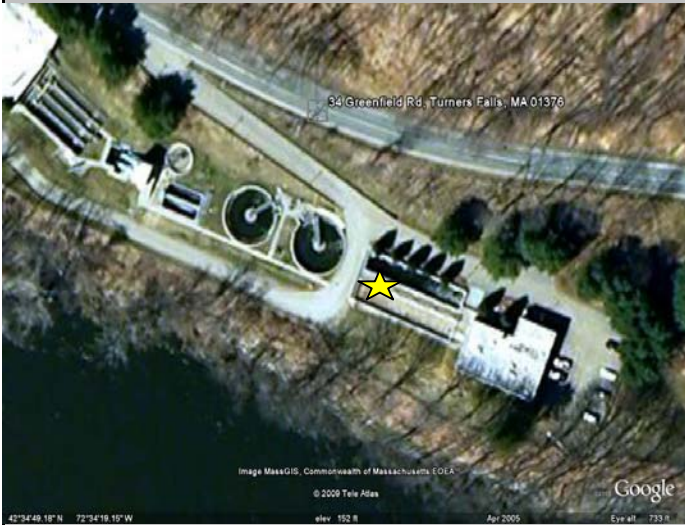
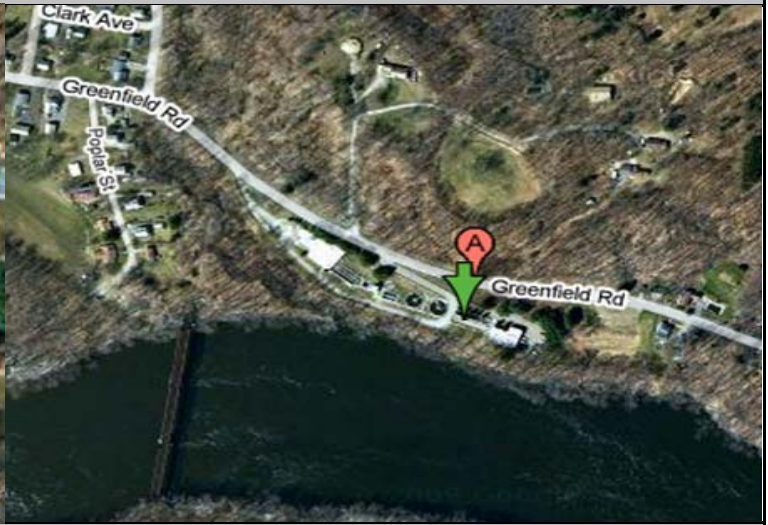
Site Name:	Montague_RG1	Meter Type:	Rain Alert	Monitor S/N:	7015	Manhole #:	N/A
Address / Location:	Located at WWTP - 34 Greenfield Rd, Montague, MA			Map Page #:	N/A		
				Pipe Height:	n/a Inches		
Access:	Drive	Type of System:	Combined	Pipe Width:	n/a Inches		
				Phone Number:	I.P. 166.219.185.190

Investigation Information:			Manhole Information:		
Date/Time of Investigation:	August 26, 2009	5:00 PM	Manhole Depth:	Feet	
Site Hydraulics:			Manhole Material / Condition:		
			Active Drop Connections?		
Upstream Input: (L/S, P/S)			Pipe Material / Condition:		
Upstream Manhole:			Mini System Character:		
Downstream Manhole:			Telephone Information:		
Depth of Flow (Wet Dof):			Access Pole #:	N/A	
Range (Air Dof):			Distance From Manhole:	N/A Feet	
Peak Velocity:		fps	Road Cut Length:	N/A Feet	
Silt:		Inches	Trench Length:	N/A Feet

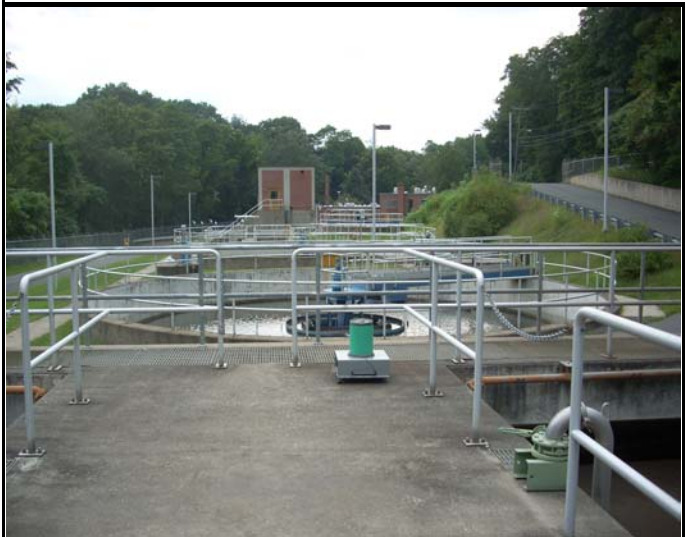
Planar N ↑

Installation Information		Backup	Yes	No	?	Distance
Installation Type:	Rain Gauge	Trunk		X		
Sensors / Devices:	Rain Gauge Tipping Bucket	Lift/Pump Station		X		
Surcharge Height:	Feet	WWTP		X		
Rain Gauge Zone:	N/A	Other		X
