ADS is pleased to submit the February 2021 report for the Montague, MA Flow Monitoring Project.

Flow Monitoring Site Installation Report

HYDROGRAPH REPORT

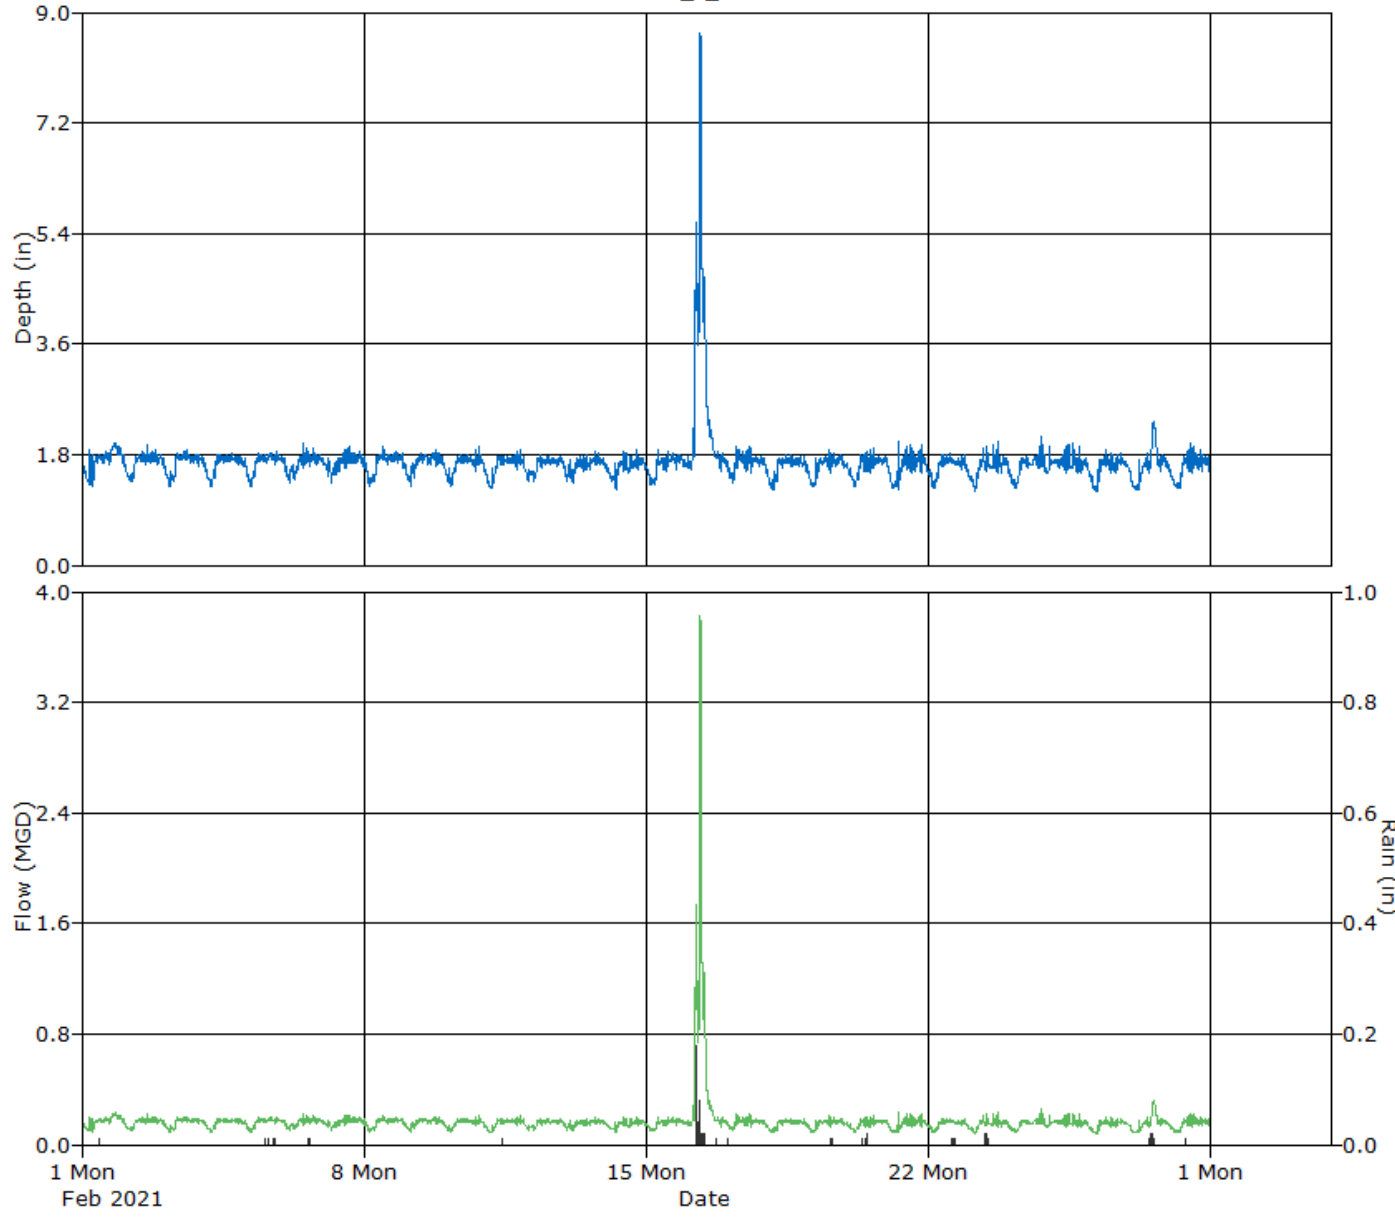
The [hydrograph](#) for location 7th_L_CS0 shows depth levels and calculated flow values recorded during the monitoring period of Monday, February 1, 2021 to Sunday, February 28, 2021 .

Flow Monitor
7th_L_CSO

Pipe Height
14.25 in

Report Period
2/1/2021
To
2/28/2021

Legend
— Depth
— Quantity
— Rain

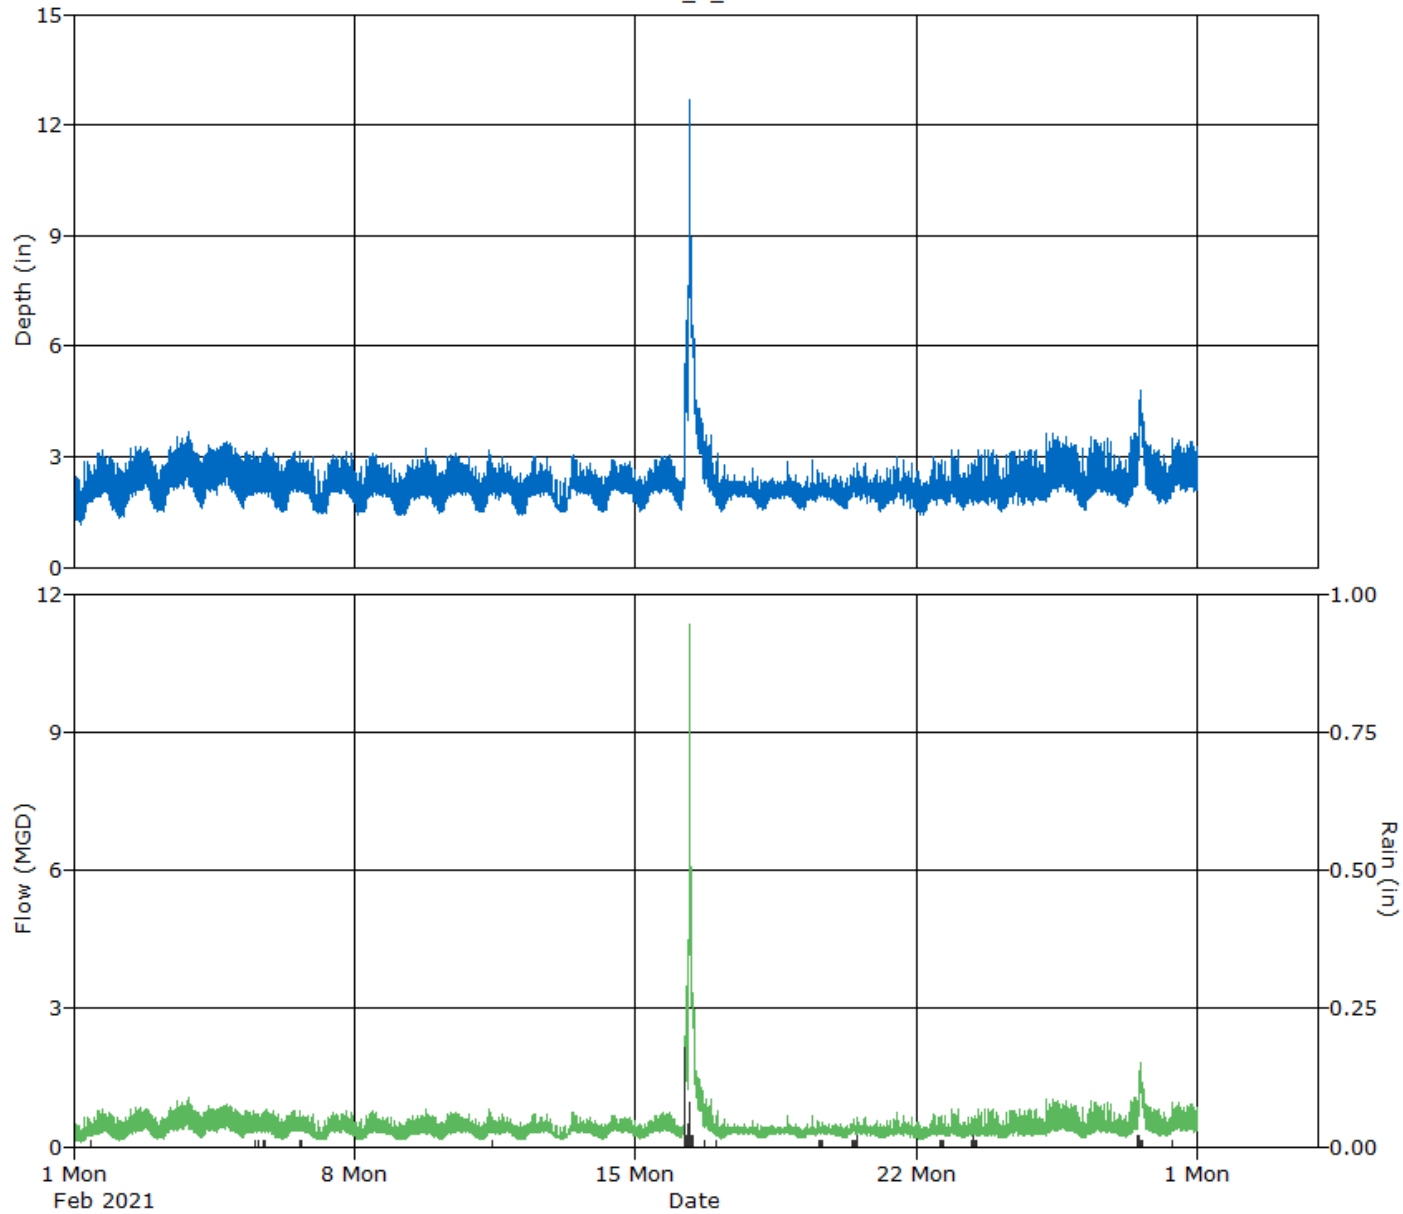
The [hydrograph](#) for location Ave_A_CSO shows depth levels and calculated flow values recorded during the monitoring period of Monday, February 1, 2021 to Sunday, February 28, 2021 .

Flow Monitor
Ave_A_CSO

Pipe Height
21.00 in

Report Period
2/1/2021
To
2/28/2021

Legend
— Depth
— Quantity
— Rain

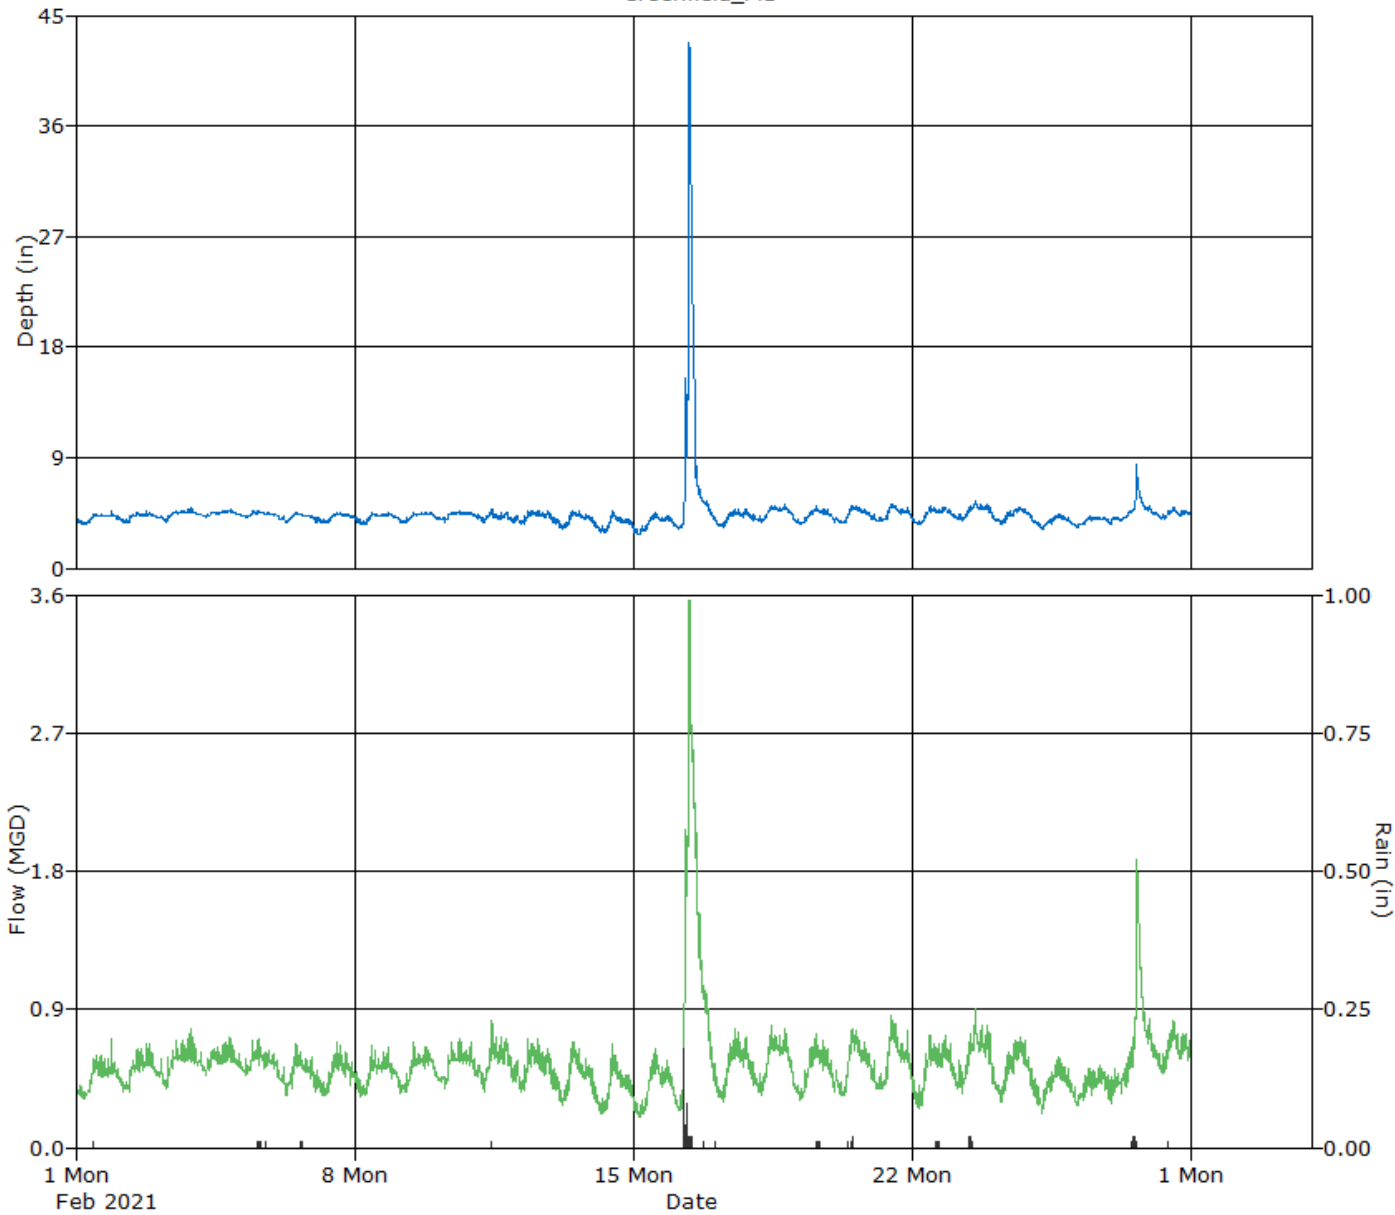
The [hydrograph](#) for location Greenfield_M1 shows depth levels and calculated flow values recorded during the monitoring period of Monday, February 1, 2021 to Sunday, February 28, 2021 .

Flow Monitor
Greenfield_M1

Report Period
2/1/2021
To
2/28/2021

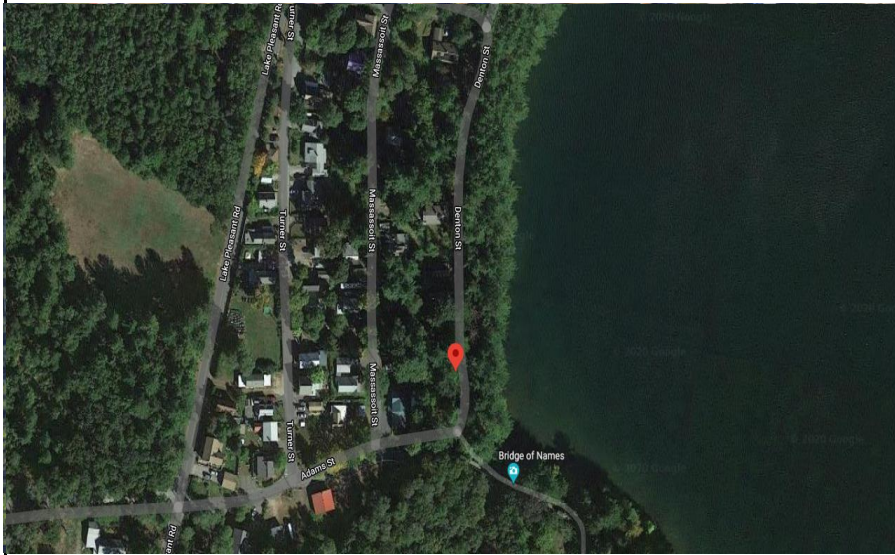
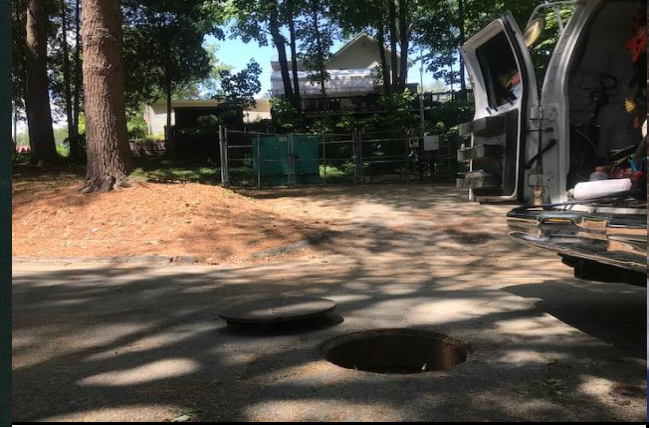
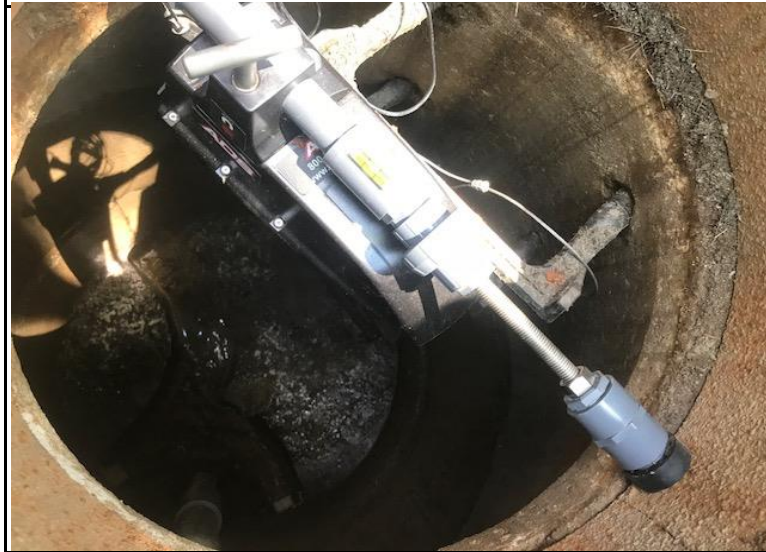
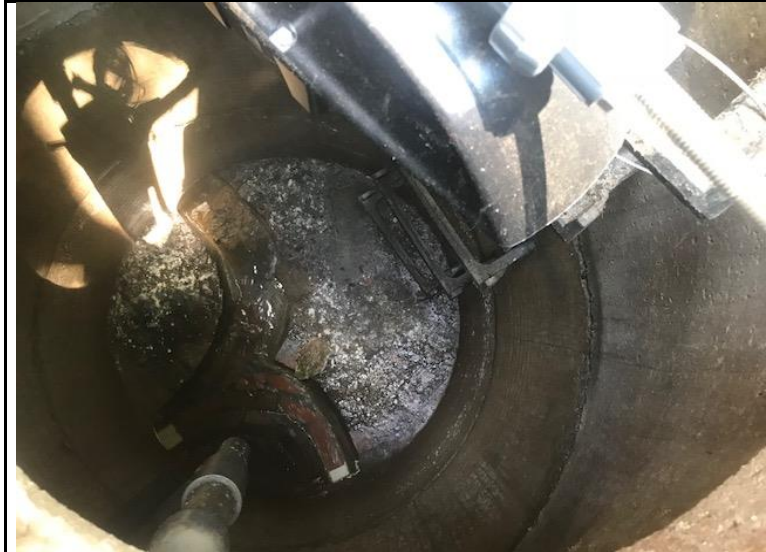
DentonSt

Site Address / Location:	3 Denton St	Monitor Series	ECHO	Location Type	Temporary
Site Access:	Drive	Pipe Size (H x W)	N/A	Pipe Shape	Circular

Installation Date:	Thursday, May 31, 2018	Installation Type:	Level Only
Monitoring Location (Sensors):		Monitor Location:	Manhole
Sensors / Devices:	ECHO Depth	Pressure Sensor Range (psi)

Manhole Depth (Approx. FT):	7	Manhole Configuration	Common Trench
Manhole Material:	Concrete	Manhole Condition:	Fair
Manhole Opening Diameter (in)	N/A	Manhole Diameter (Approx.):	N/A
Manhole Cover	Vented	Manhole Frame	Normal
Active Drop Connections	No	Air Quality:	Good
Pipe Material		Pipe Condition:	Fair

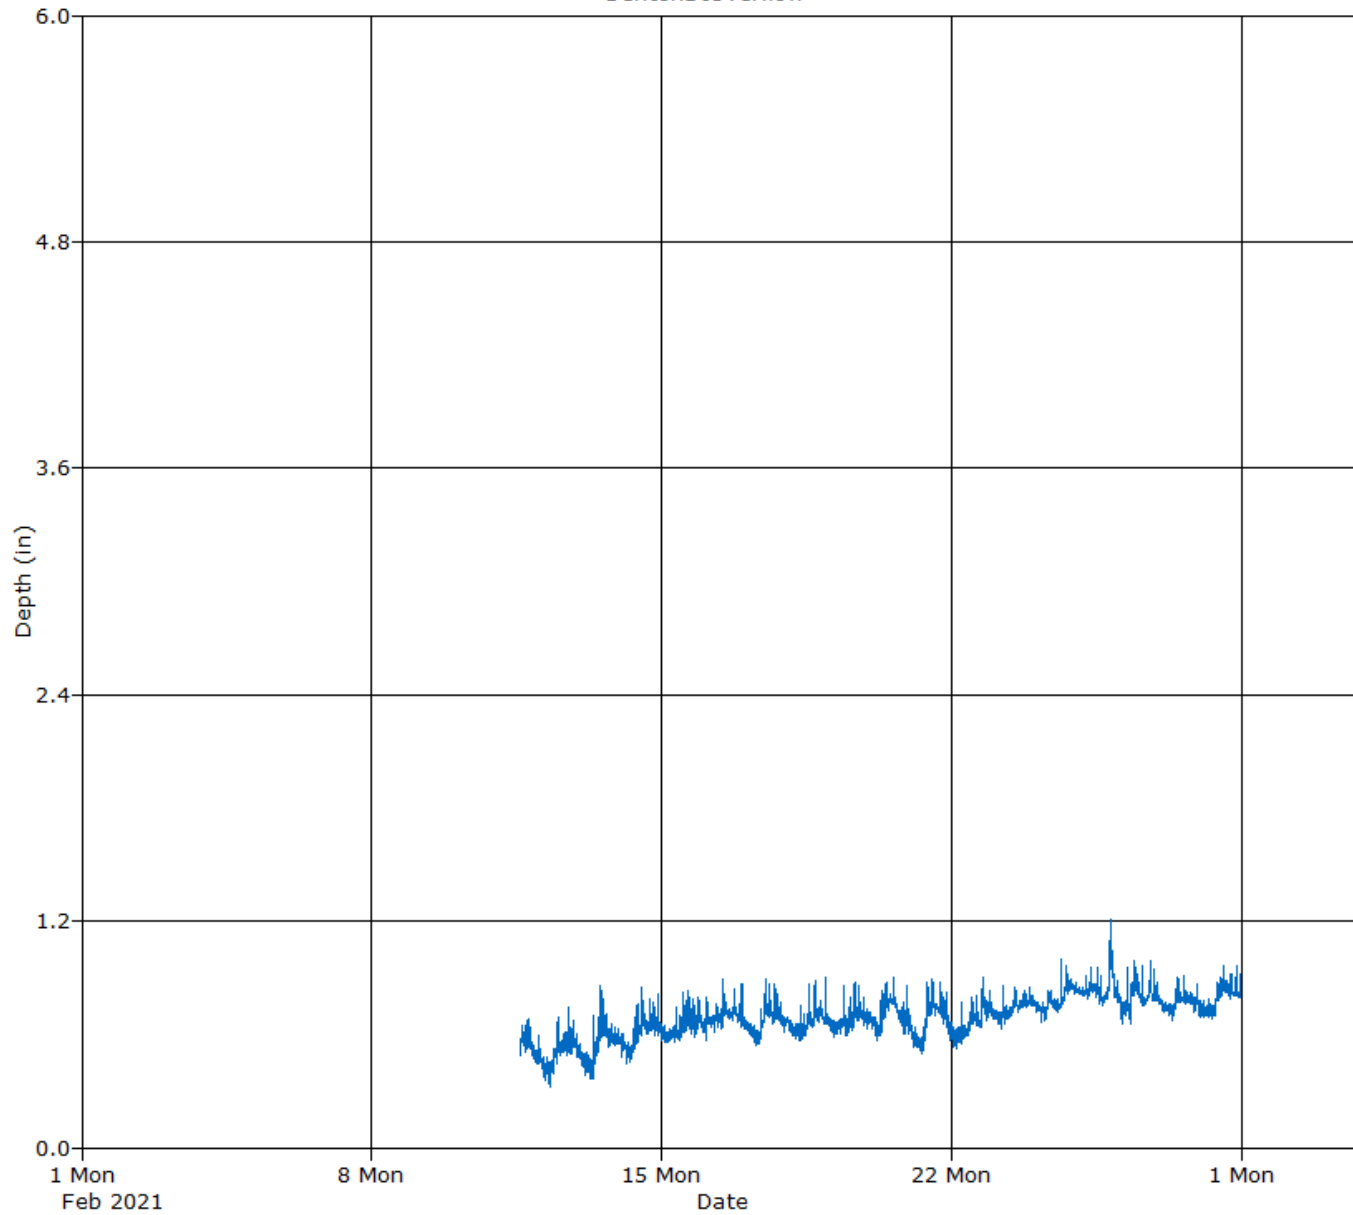
The [hydrograph](#) for location DentonStOverflow shows depth levels and calculated flow values recorded during the monitoring period of Monday, February 1, 2021 to Sunday, February 28, 2021 .

Flow Monitor
DentonStOverflow

Report Period
2/1/2021
To
2/28/2021

Legend
— Depth

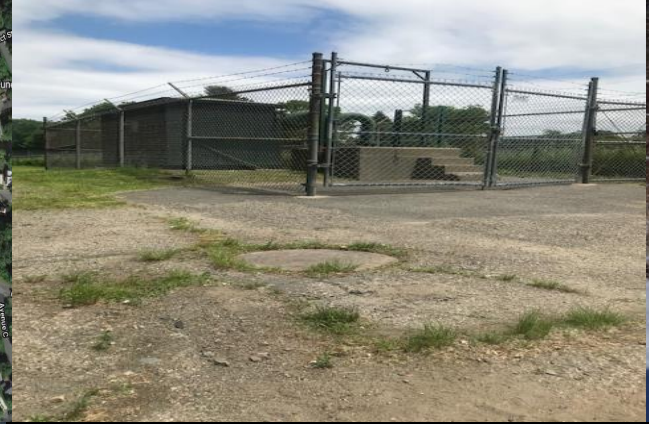
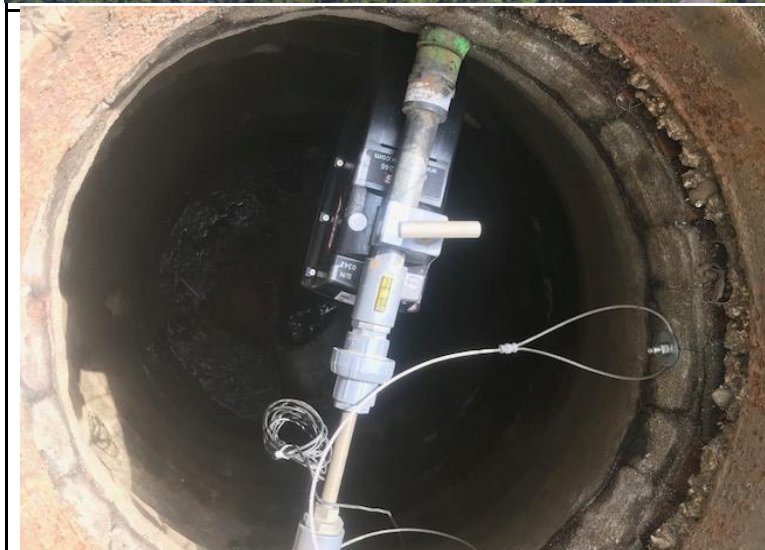
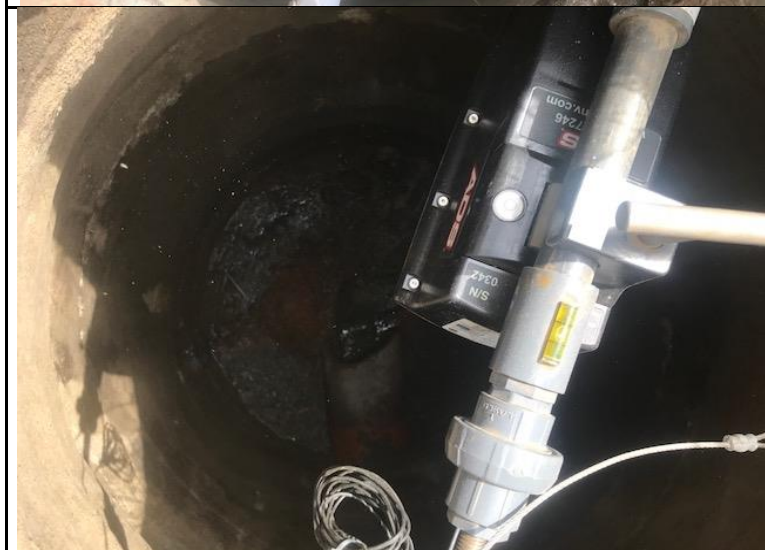
Manhole #	System Characteristics
N/A	Residential
Access	Traffic
Drive	None

Installation Information	
Installation Date:	Installation Type:
Thursday, May 31, 2018	Level Only
Monitoring Location (Sensors):	Monitor Location:
Sensors / Devices:	Pressure Sensor Range (psi)
ECHO Depth	
Installation Confirmation:	
Confirmation Time:	Pipe Size (HxW)

11:00:00 AM	N/A
Depth of Flow (Wet DOF) (in)	Range (Air DOF) (in)
N/A	N/A
Downlooker Physical Offset (in)	Measurement Confidence (in)
N/A	
Peak Velocity (fps)	Velocity Sensor Offset (in)
N/A	N/A
Silt (in)	Silt Type
0	N/A
Hydraulic Comments:	
steady flow	
Manhole / Pipe Information:	
Manhole Depth (Approx. FT):	Manhole Configuration

7.5	Common Trench
Manhole Material:	Manhole Condition:
Concrete	Fair
Manhole Opening Diameter (in)	Manhole Diameter (Approx.):
N/A	N/A
Manhole Cover	Manhole Frame
Vented	Normal
Active Drop Connections	Air Quality:
No	Good
Pipe Material	Pipe Condition:
	Fair
Communication Information:	
Communication Type	Antenna Location
Serial	
Additional Site Info. / Comments:	
S/N: 342 IP: 107.80.22.18 42.604965,-72.563304 Crew: Nick B

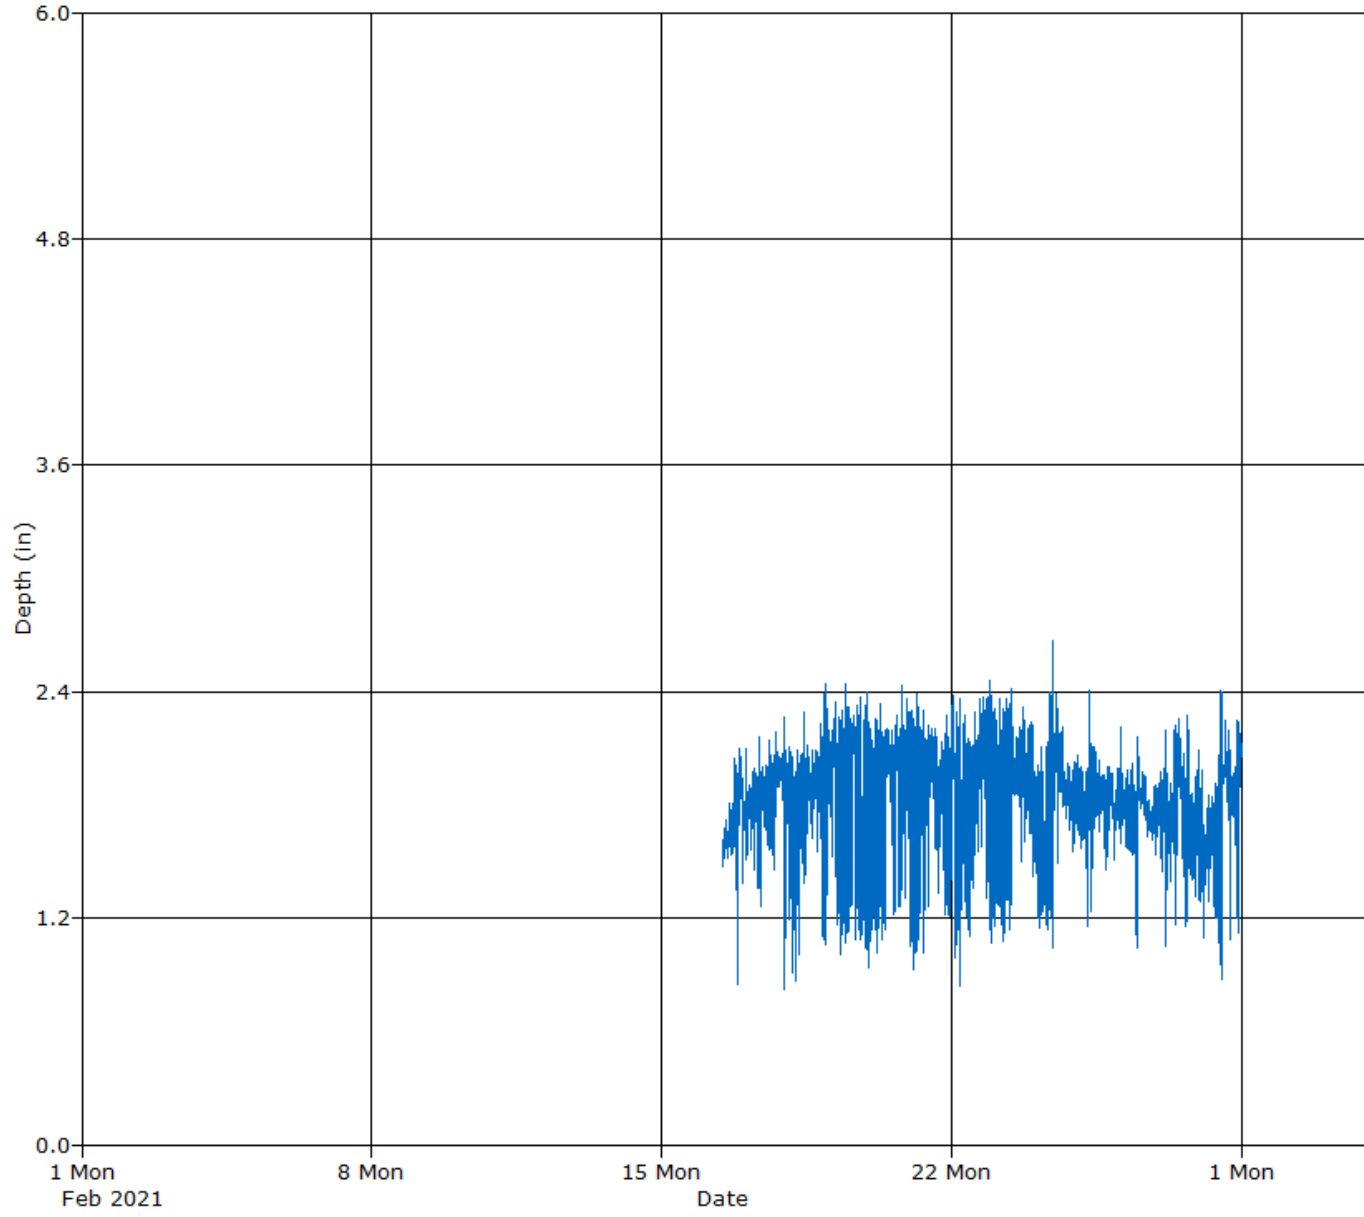
The [hydrograph](#) for location GStreetOutfall shows depth levels and calculated flow values recorded during the monitoring period of Monday, February 1, 2021 to Sunday, February 28, 2021 .

Flow Monitor
GStreetOutfall

Pipe Height
36.00 in

Report Period
2/1/2021
To
2/28/2021

Legend
— Depth

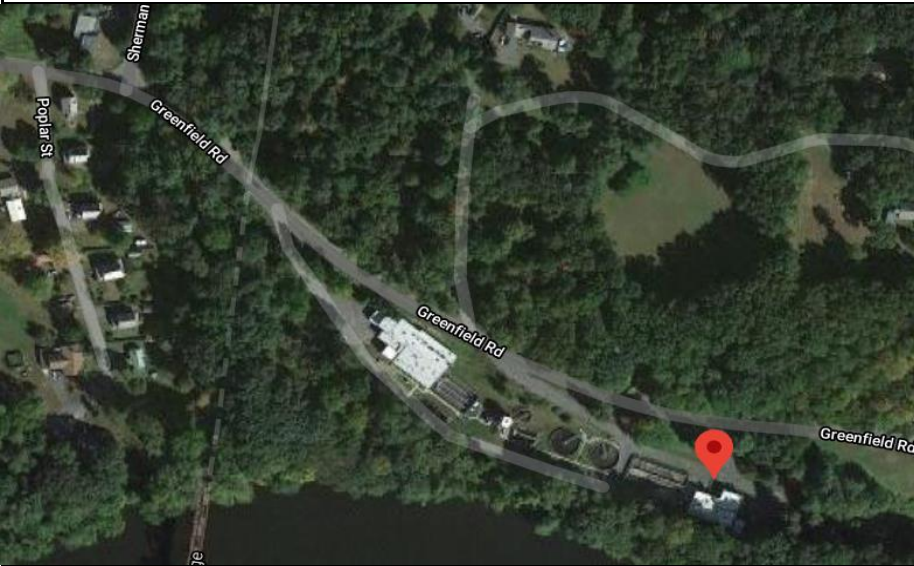
RG1

Site Address / Location:	29 Greenfield Road - WWTP	Monitor Series	Location Type
Site Access:	Drive	Rain Alert III	Permanent
		Pipe Size (H x W)	Pipe Shape

Installation Date:	Thursday, February 11, 2021	Installation Type:	Rain Gauge
Monitoring Location (Sensors):	Field	Monitor Location:	Building
Sensors / Devices:	Rain Gauge Tipping Bucket	Pressure Sensor Range (psi)

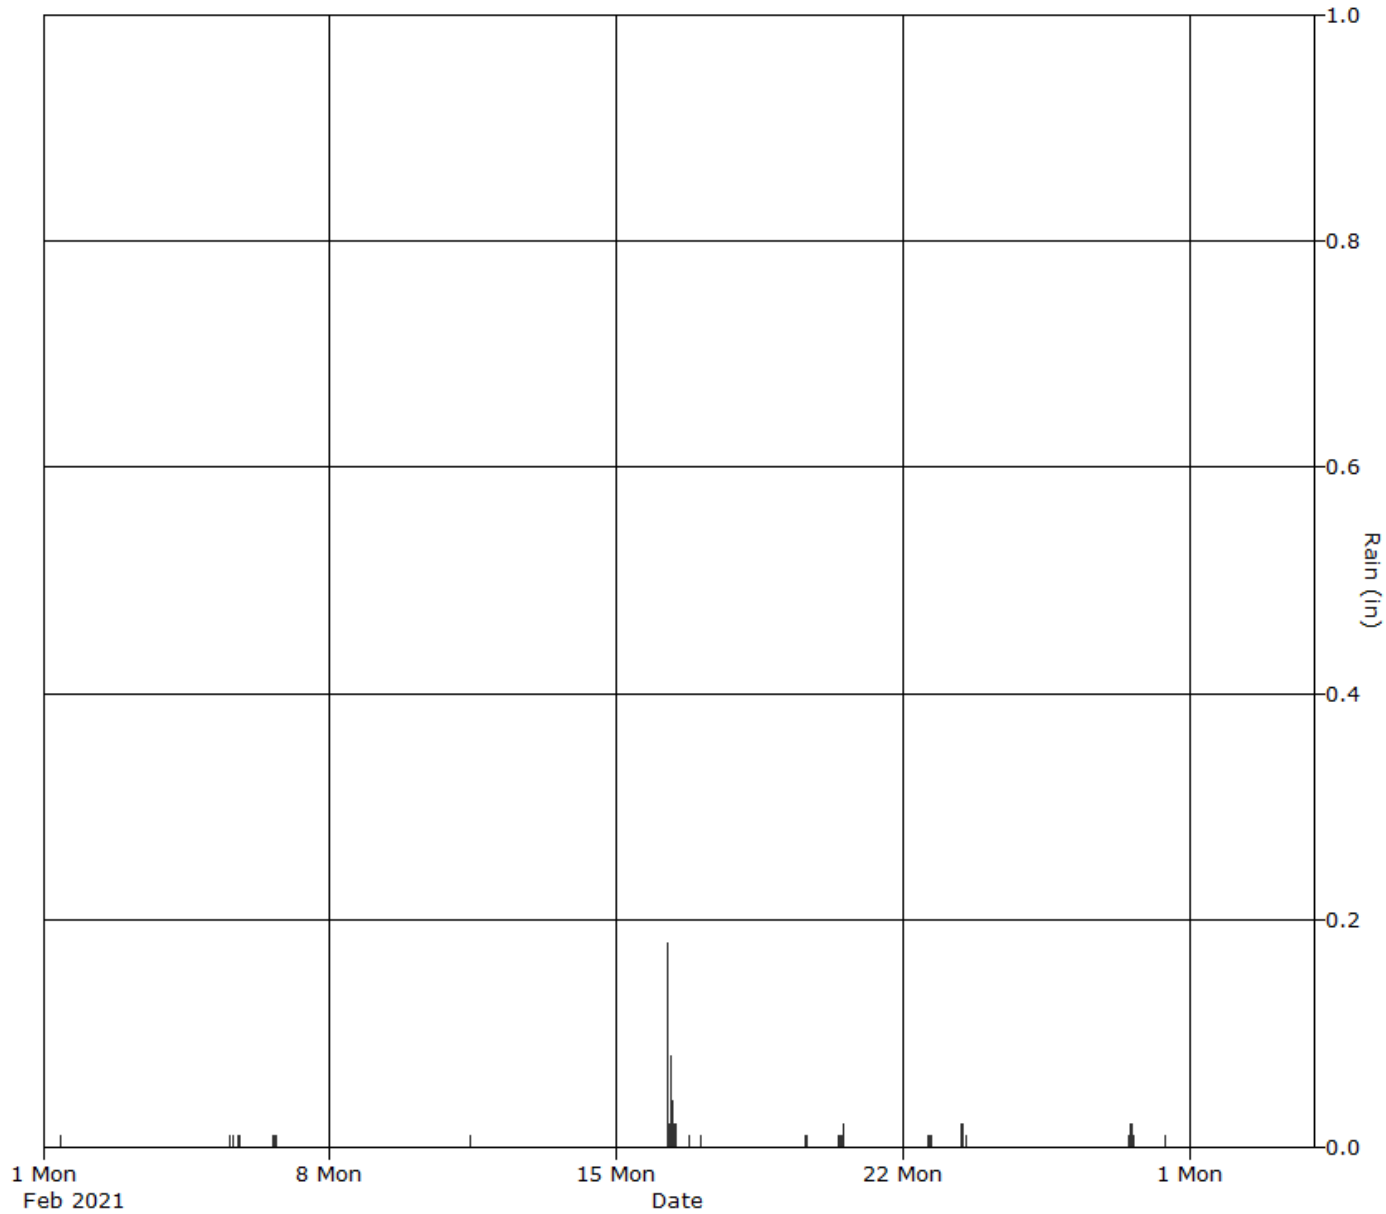
The rainfall measured at RG1 from February 01, 2021 to February 28, 2021 is 1.85 inches.

Report Period
2/1/2021
To
2/28/2021

Legend
— Rain
