ADS is pleased to submit the March 2021 report for the 2021 Flow Monitoring Project .

Montague, MA

Flow Monitoring Site Installation Report

HYDROGRAPH REPORT

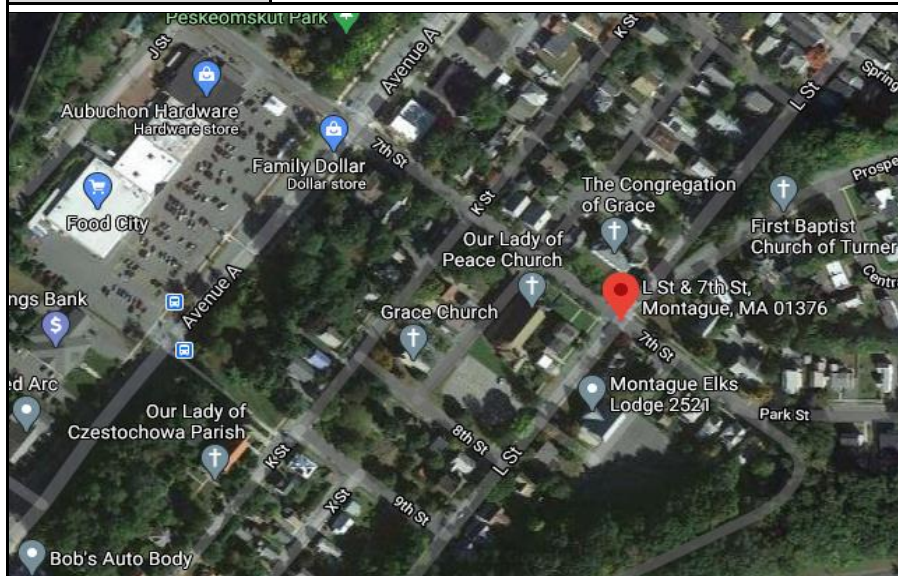
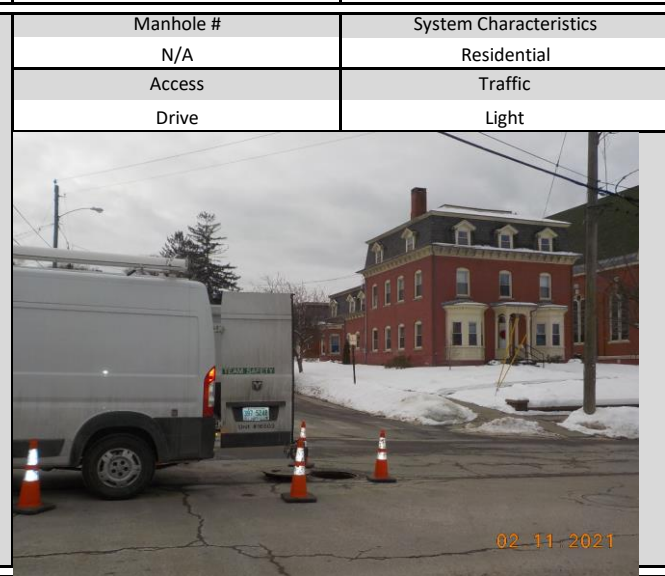
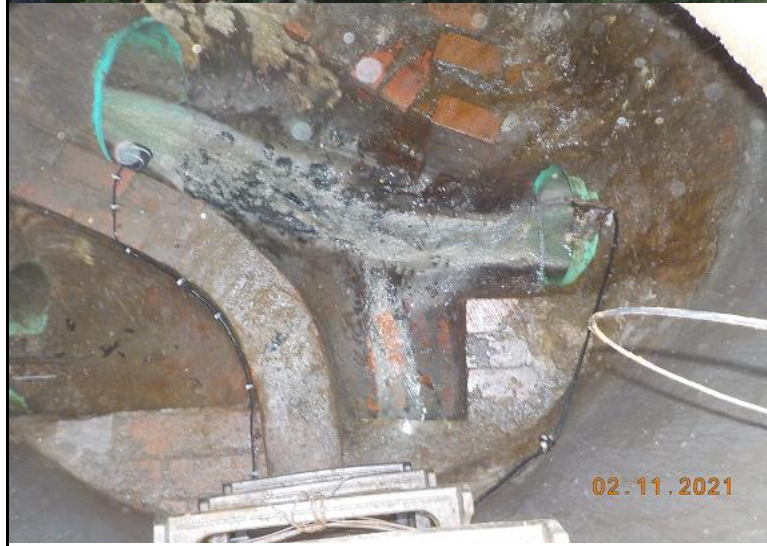
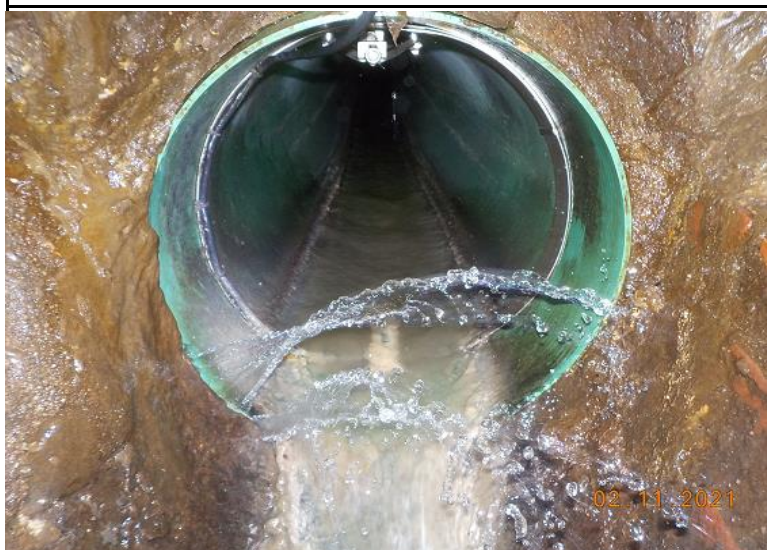
Site Address / Location:	7TH STREET AT L STREET	Monitor Series	Location Type
Site Access:	Drive- Detailed needed	TRITON+	Permanent
		Pipe Size (H x W)	Pipe Shape
		14.25x14.25	Circular

Manhole Depth (Approx. FT):	Manhole Configuration
6	Common Trench
Manhole Material:	Manhole Condition:
Concrete	Good
Manhole Opening Diameter (in)	Manhole Diameter (Approx.):
24	24
Manhole Cover	Manhole Frame
Concealed	Normal
Active Drop Connections	Air Quality:
No	Good
Pipe Material	Pipe Condition:
PVC	Good

N. 42.60349 W. -72.55722 S / N: 64109 I/P: 166.219.169.91 Site Overflows at Depth of 8.0 Inches

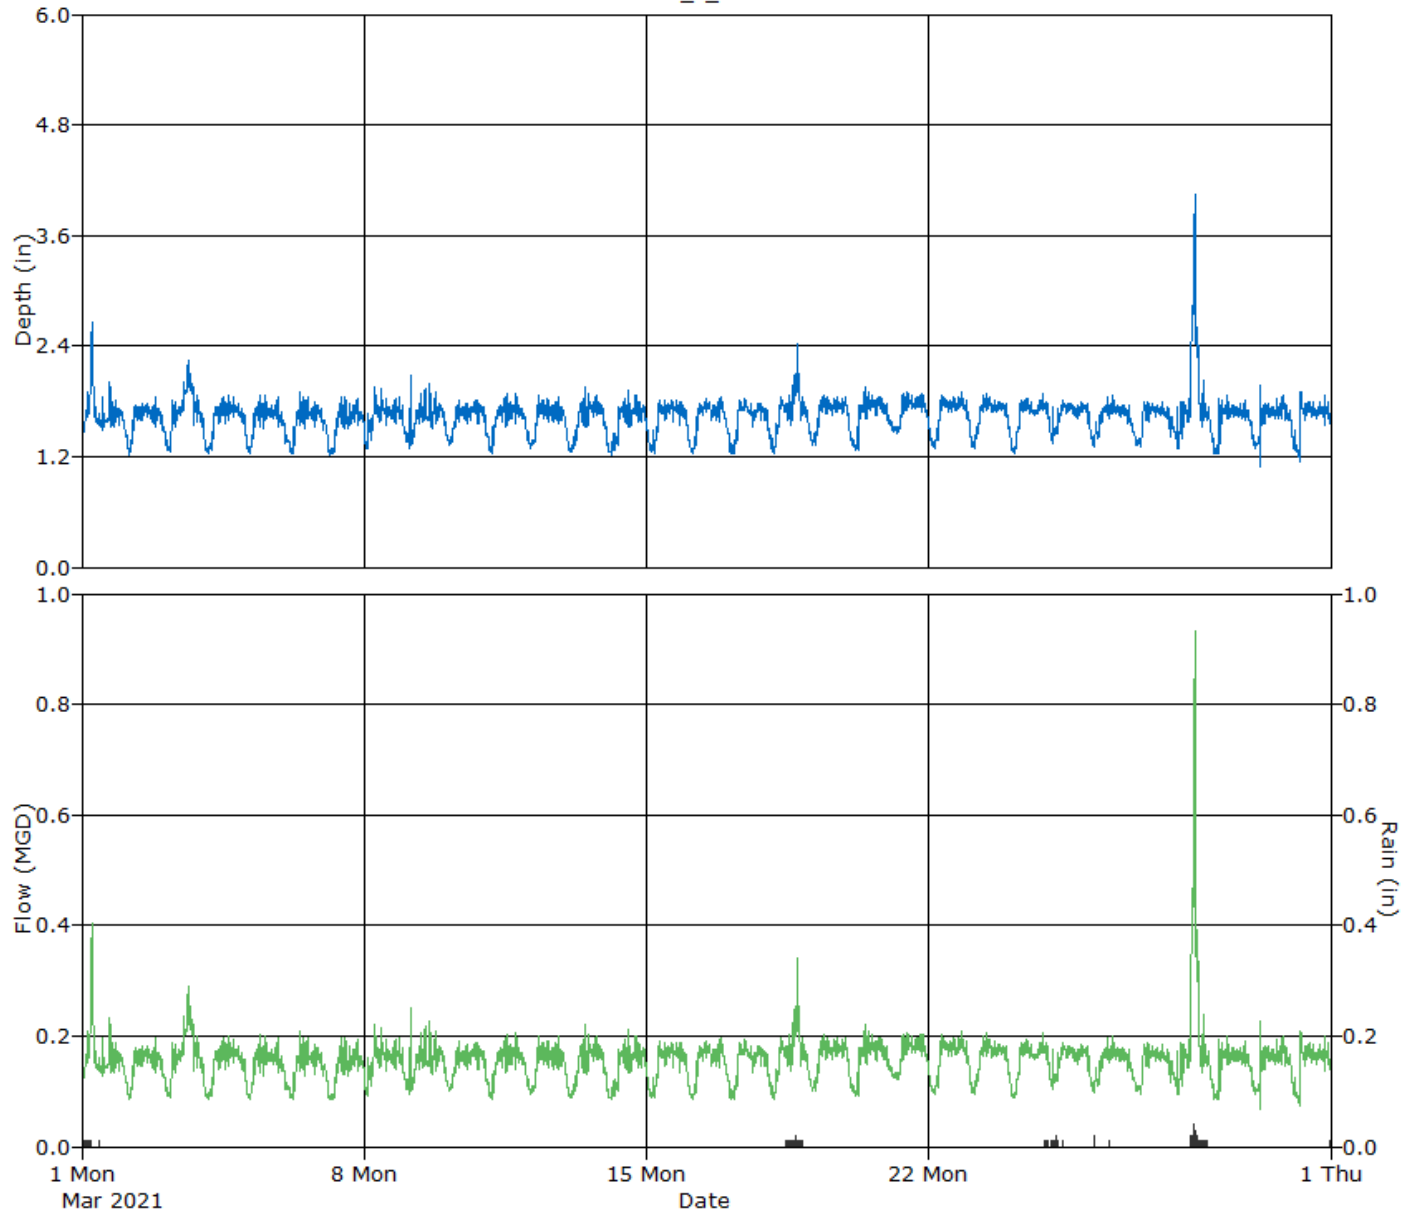
One overflow event occurred during the monitoring period.

Observed Flow Conditions		
Item	Depth (in)	Quantity (MGD)
Average	1.63	0.155
Minimum	1.10	0.068
Maximum	4.05	0.934
Time of Minimum	3/30/2021 6:05 AM	3/30/2021 6:05 AM
Time of Maximum	3/28/2021 3:00 PM	3/28/2021 3:00 PM

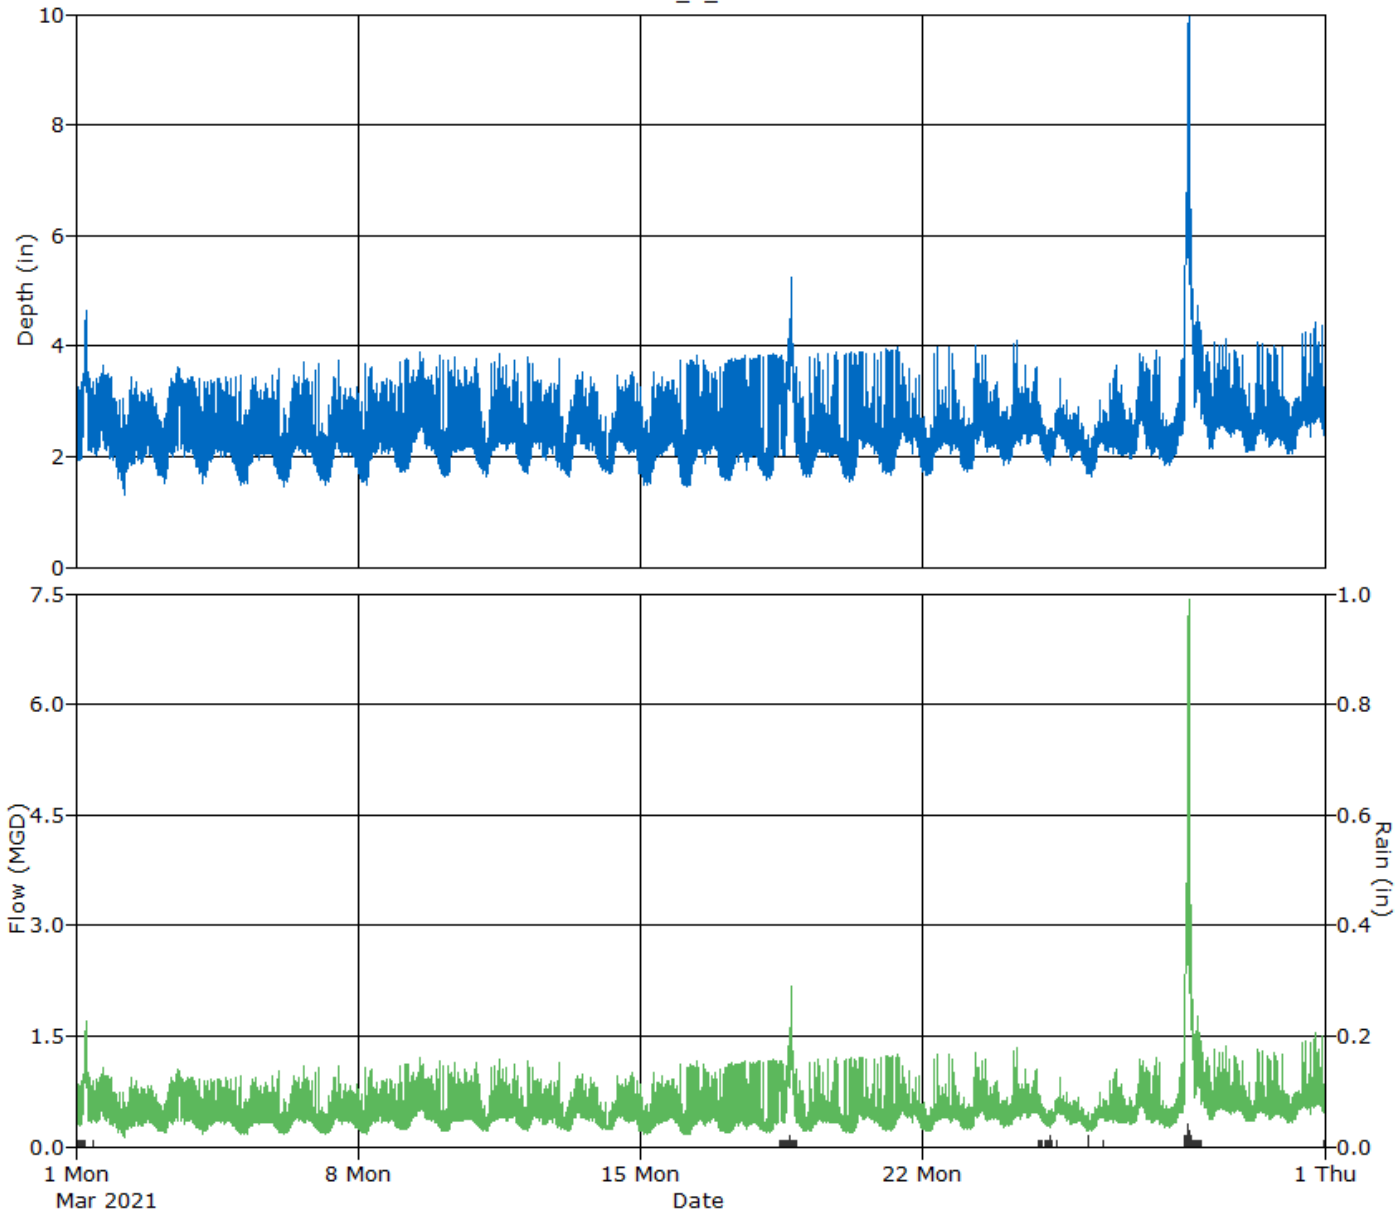
HYDROGRAPH REPORT

No overflow events occurred during the monitoring period.

Observed Flow Conditions		
Item	Depth (in)	Quantity (MGD)
Average	2.44	0.500
Minimum	1.29	0.128
Maximum	9.99	7.430
Time of Minimum	3/2/2021 4:45 AM	3/2/2021 4:45 AM
Time of Maximum	3/28/2021 3:05 PM	3/28/2021 3:05 PM

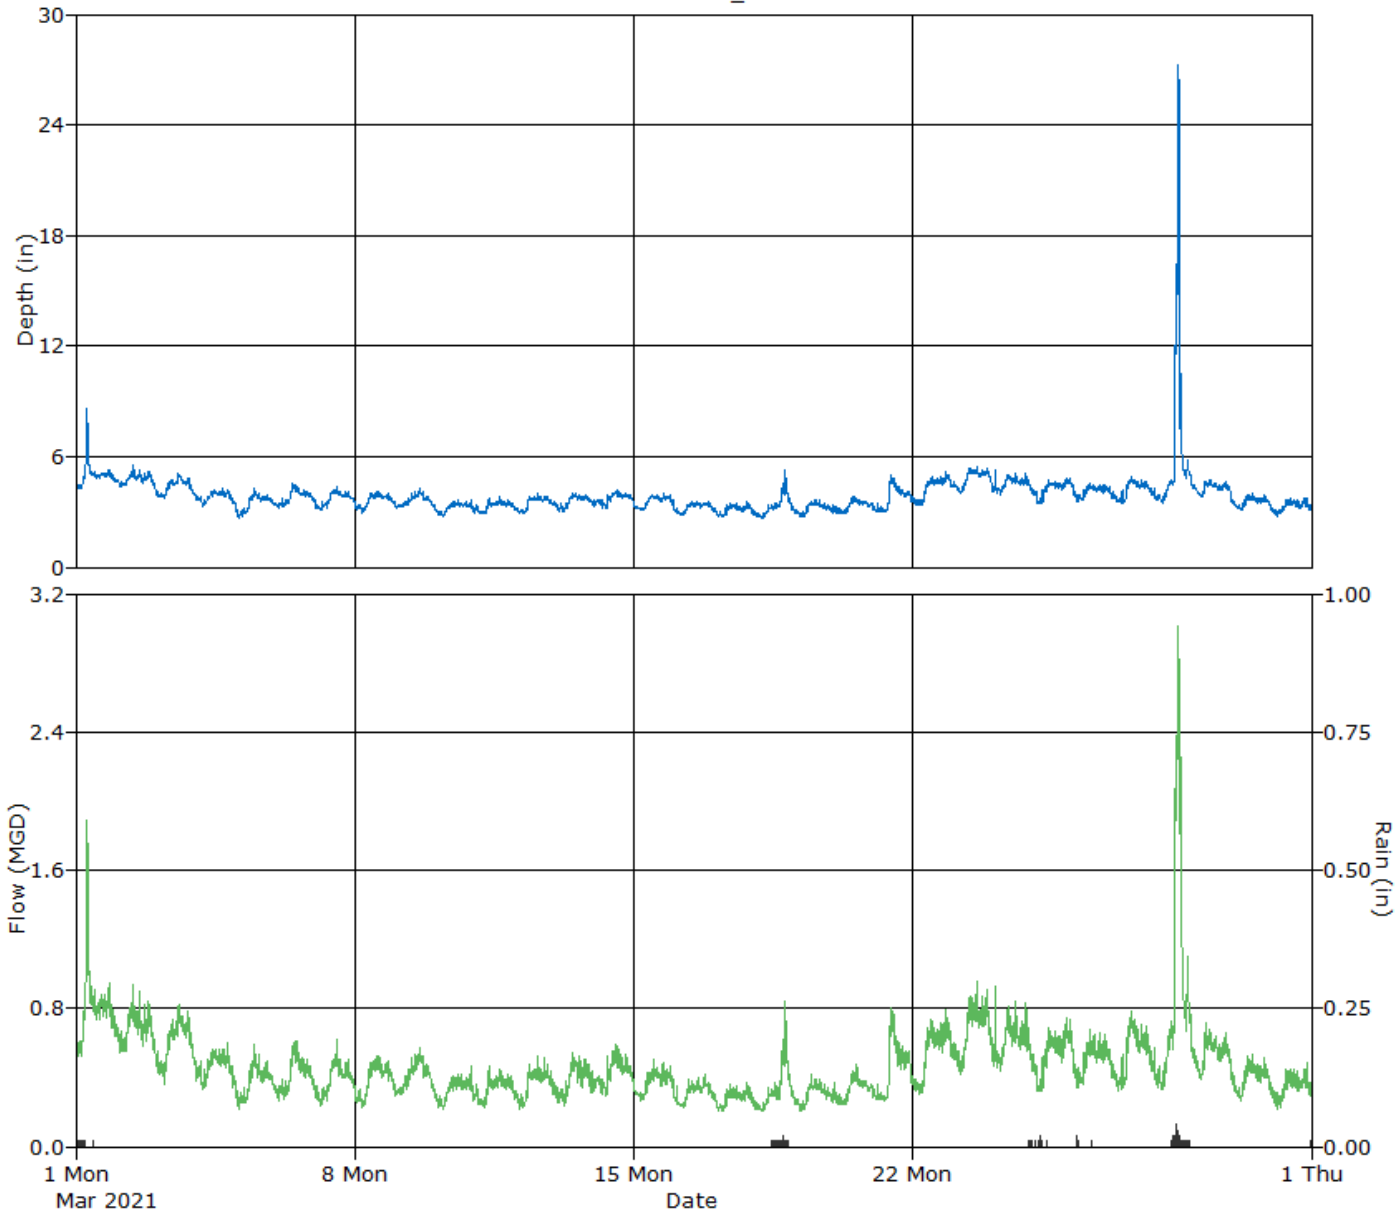
HYDROGRAPH REPORT

One overflow event occurred during the monitoring period.

Observed Flow Conditions		
Item	Depth (in)	Quantity (MGD)
Average	3.89	0.461
Minimum	2.69	0.205
Maximum	27.27	3.009
Time of Minimum	3/18/2021 5:20 AM	3/18/2021 5:20 AM
Time of Maximum	3/28/2021 3:55 PM	3/28/2021 4:00 PM

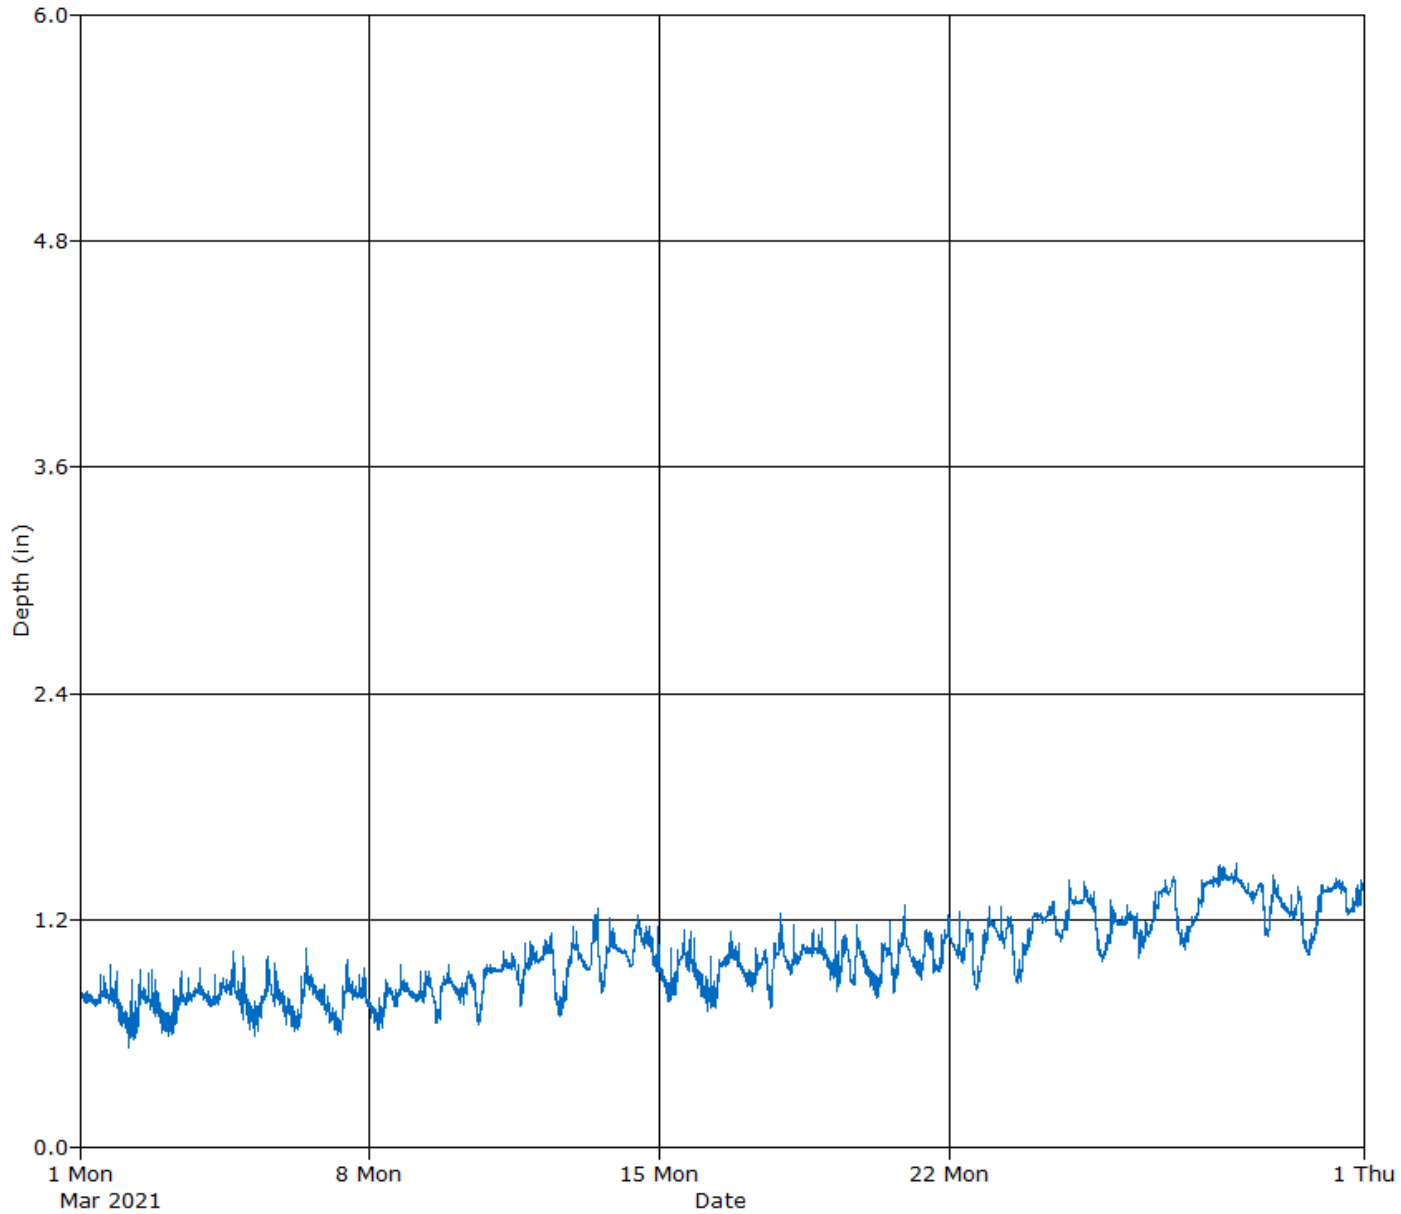
HYDROGRAPH REPORT

One overflow event occurred during the monitoring period.

Observed Flow Conditions		
Item	Depth (in)	Quantity (MGD)
Average	0.99	
Minimum	0.52	
Maximum	1.50	
Time of Minimum	3/2/2021 4:40 AM	
Time of Maximum	3/28/2021 10:20 PM

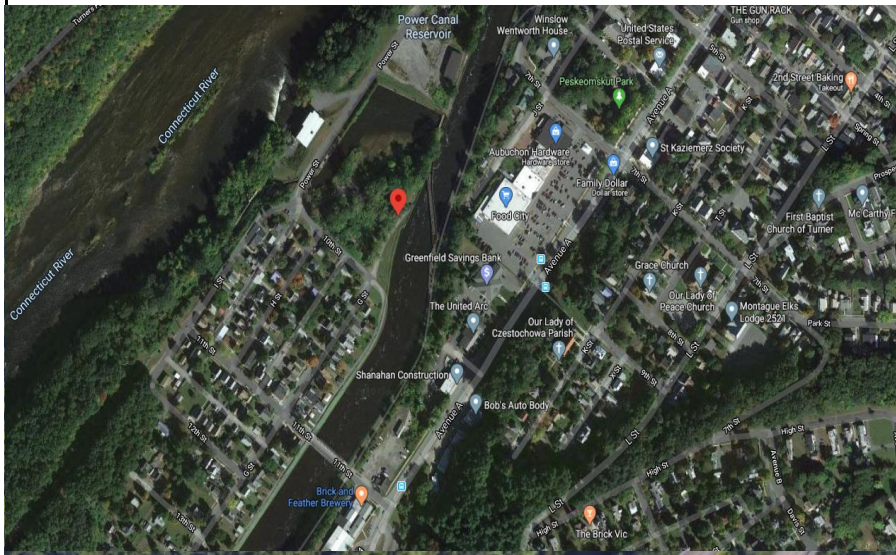
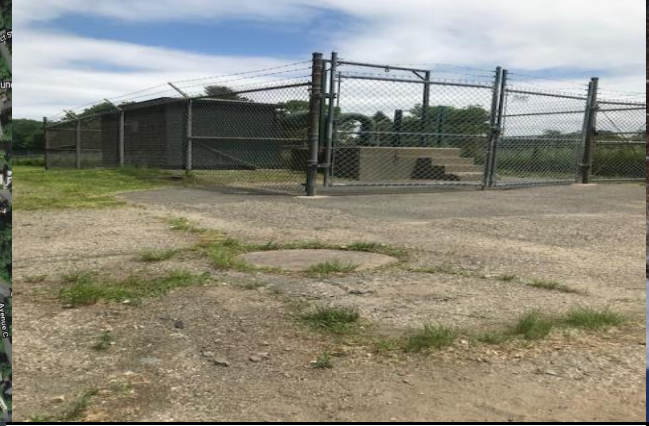
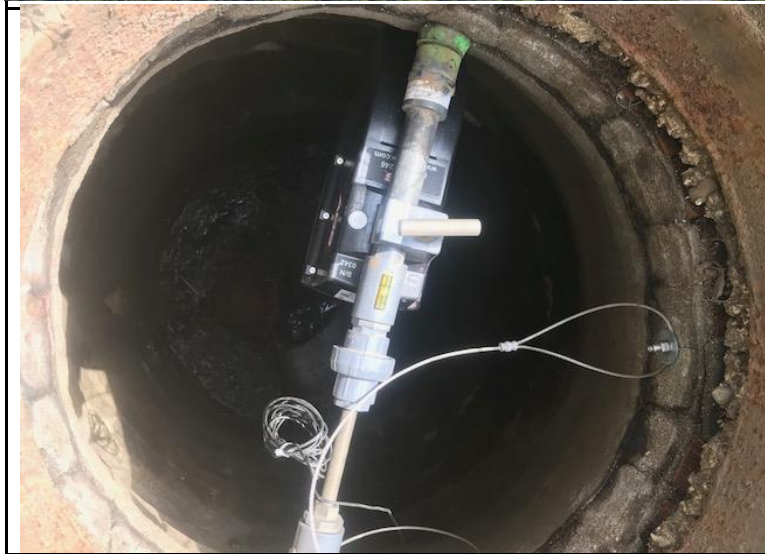
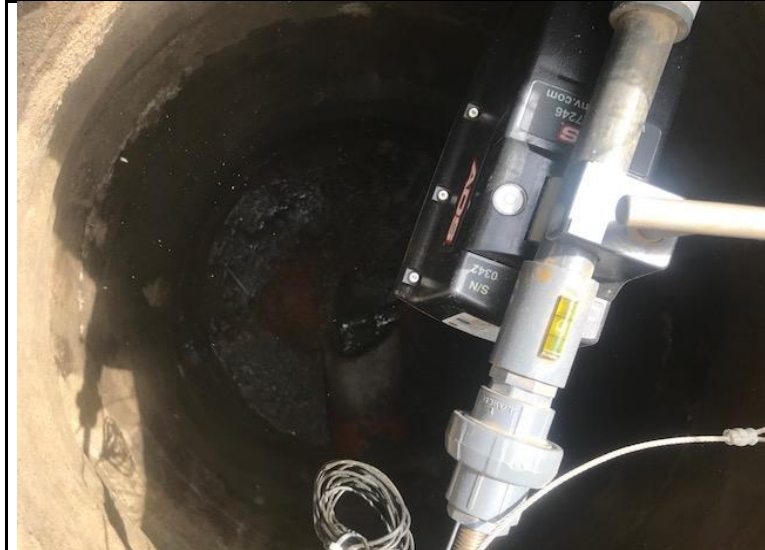
Flow Monitoring Site Installation Report

Site Address / Location:	G Street at 11th St (dirt road)	Monitor Series	Location Type
Site Access:	Drive	ECHO	Temporary
		Pipe Size (H x W)	Pipe Shape
		N/A	Circular

Manhole Depth (Approx. FT):	Manhole Configuration
7.5	Common Trench
Manhole Material:	Manhole Condition:
Concrete	Fair
Manhole Opening Diameter (in)	Manhole Diameter (Approx.):
N/A	N/A
Manhole Cover	Manhole Frame
Vented	Normal
Active Drop Connections	Air Quality:
No	Good
Pipe Material	Pipe Condition:
	Fair

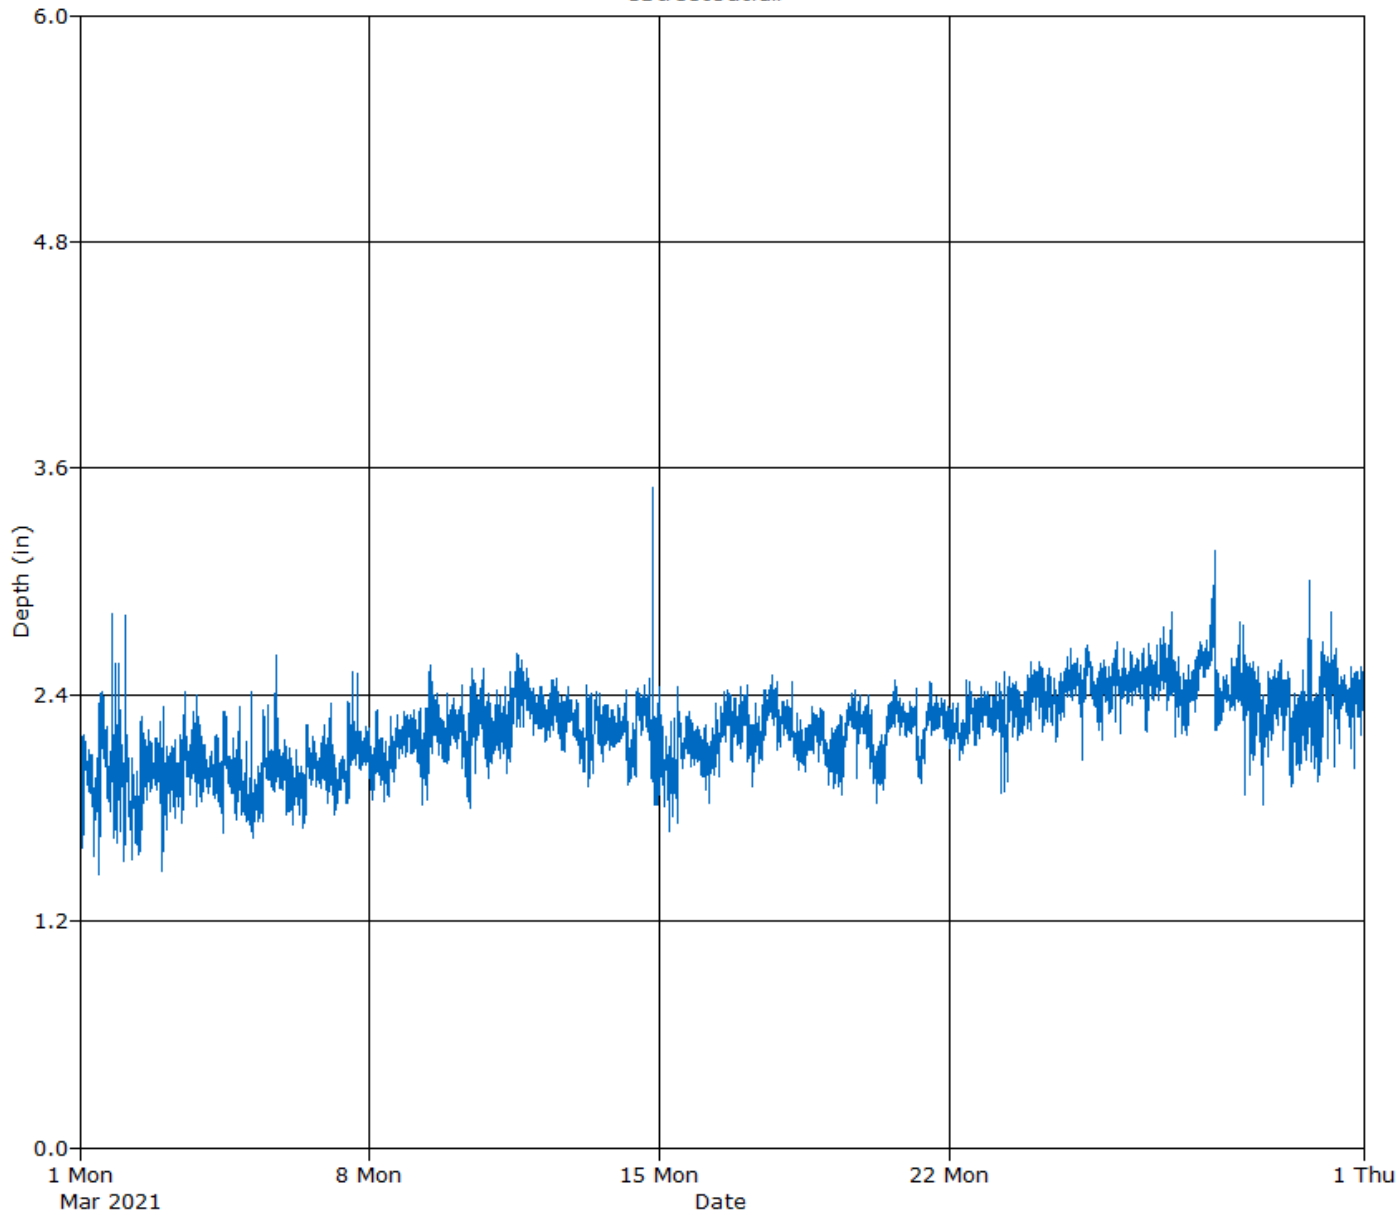
HYDROGRAPH REPORT

One overflow event occurred during the monitoring period.

Observed Flow Conditions		
Item	Depth (in)	Quantity (MGD)
Average	2.22	
Minimum	1.44	
Maximum	3.50	
Time of Minimum	3/1/2021 11:05 AM	
Time of Maximum	3/14/2021 8:25 PM

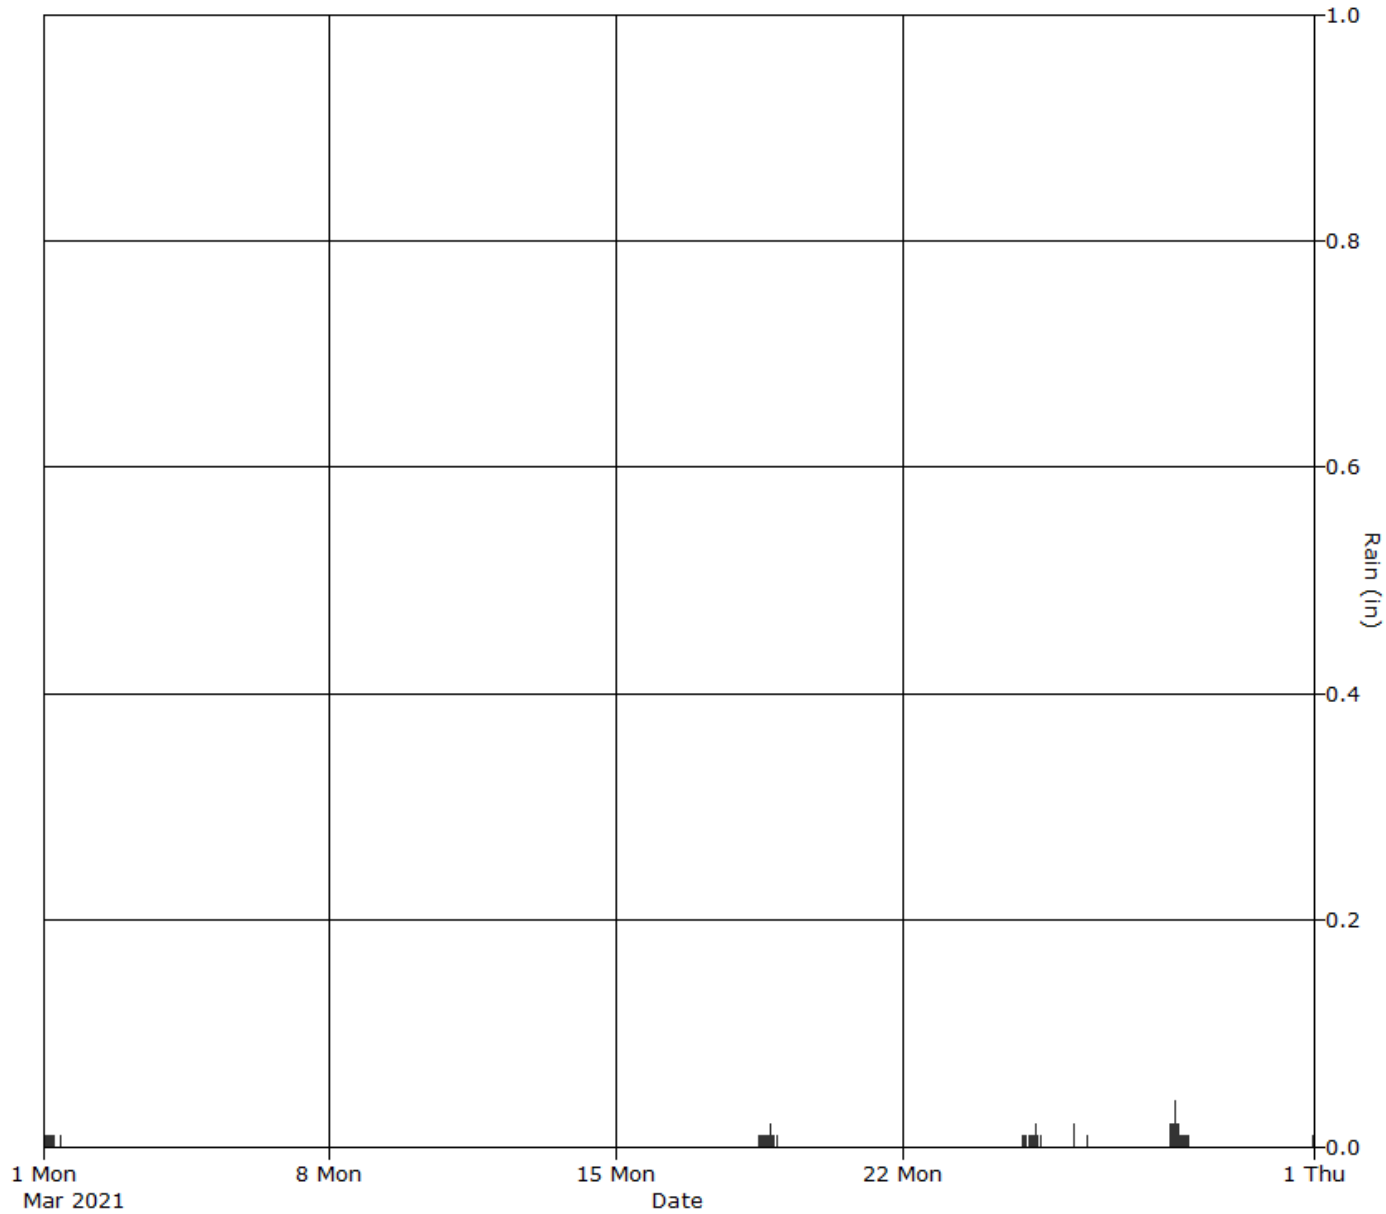
HYDROGRAPH REPORT

The rainfall measured at RG1 from March 01, 2021 to March 31, 2021 is 1.87 inches.

<u>Date / Time</u>	<u>Maximum Rainfall (in.)</u>
3/28/2021 2:50 PM	0.04
