August Report Submitted to Montague, MA
September 15, 2021

ADS is pleased to submit the report for the Montague, MA completed on behalf of Montague, MA. The metering was conducted at three (3) locations. The study was conducted during the period of Sunday, August 1, 2021 to Tuesday, August 31, 2021.

Flow Monitoring Site Installation Report

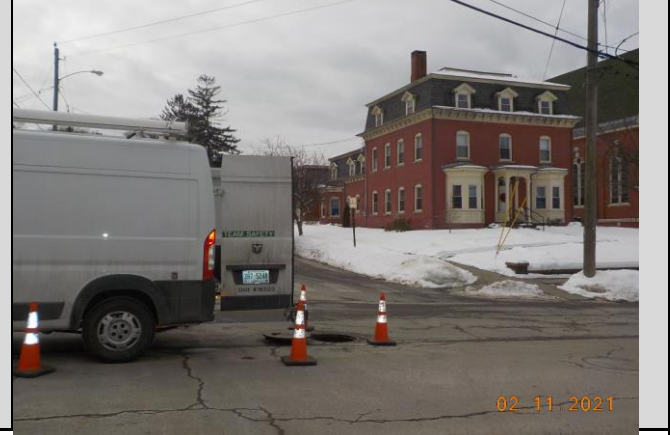
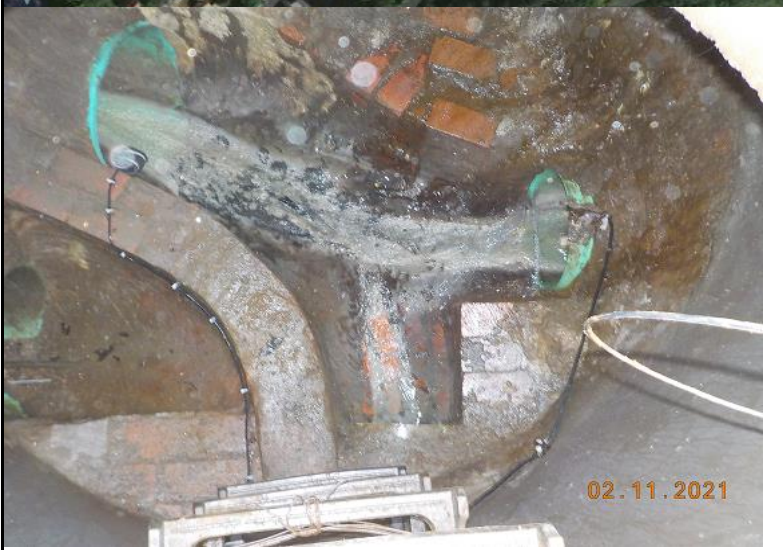
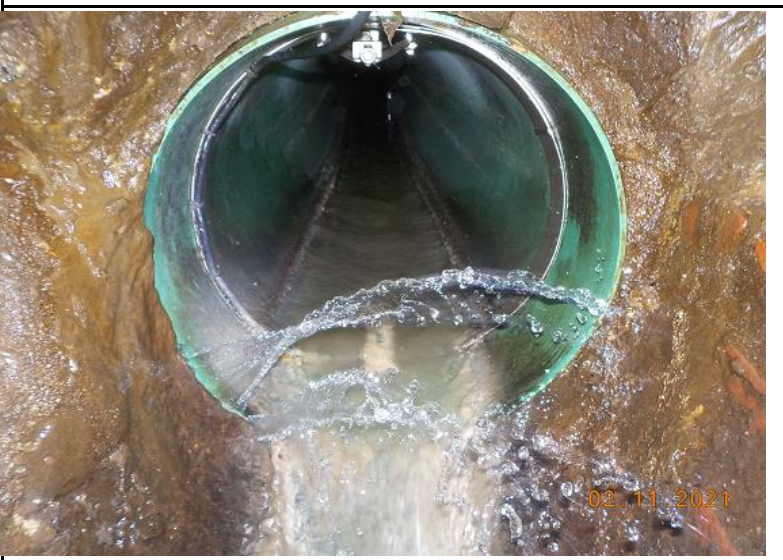
7th_L_CSO

Site Address / Location:	7TH STREET AT L STREET
Site Access:	Drive- Detailed needed

Installation Date:	Thursday, February 11, 2021	Installation Type:	Doppler Standard Ring and Crank
Monitoring Location (Sensors):		Monitor Location:	Manhole
Sensors / Devices:	Peak Combo (CS4)	Pressure Sensor Range (psi)

Confirmation Time:	11:41:00 AM	Pipe Size (HxW)	14.25x14.25
Depth of Flow (Wet DOF) (in)	1.5	Range (Air DOF) (in)	
Downlooker Physical Offset (in)		Measurement Confidence (in)	0.25"
Peak Velocity (fps)	2.5	Velocity Sensor Offset (in)	N/A
Silt (in)	0	Silt Type	N/A

Manhole Depth (Approx. FT):	6	Manhole Configuration	Common Trench
Manhole Material:	Concrete	Manhole Condition:	Good
Manhole Opening Diameter (in)	24	Manhole Diameter (Approx.):	24
Manhole Cover	Concealed	Manhole Frame	Normal
Active Drop Connections	No	Air Quality:	Good
Pipe Material	PVC	Pipe Condition:	Good

N. 42.60349 W. -72.55722 S / N: 64109 I/P: 166.219.169.91 Site Overflows at Depth of 8.0 Inches

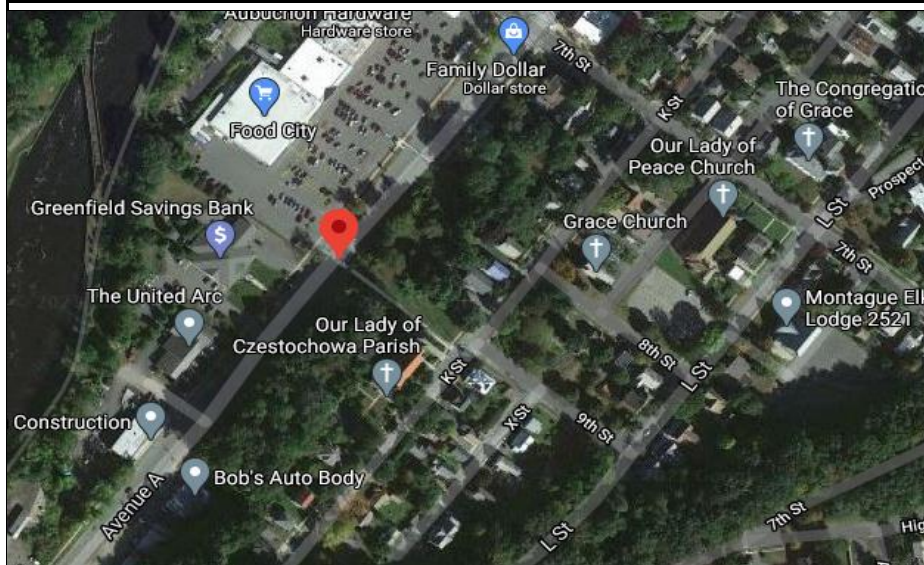
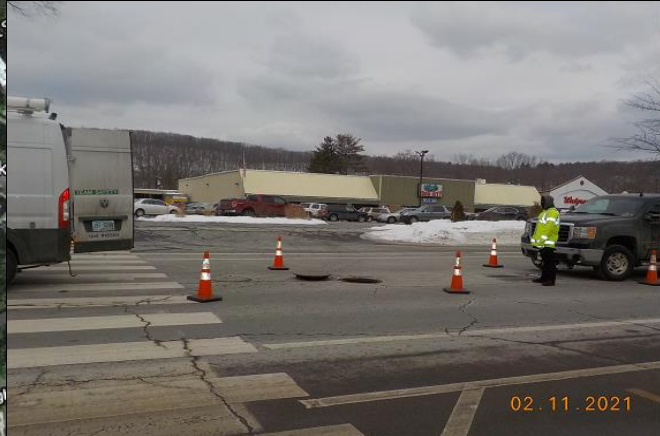
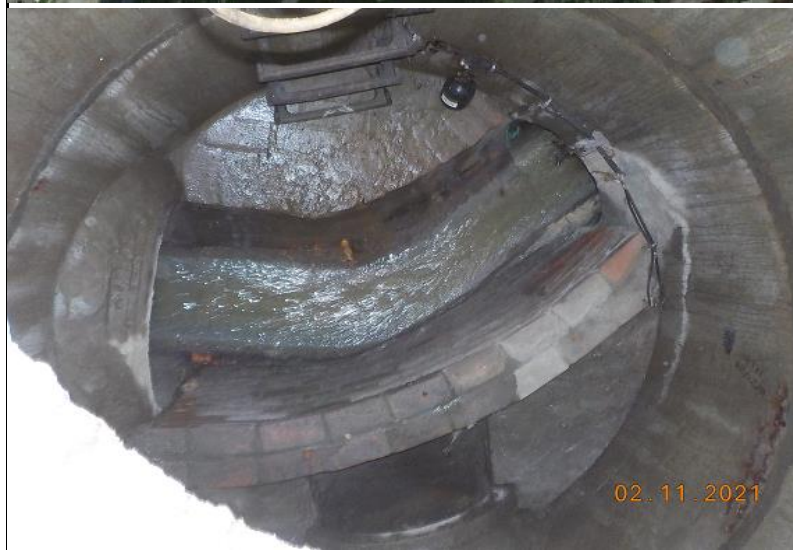
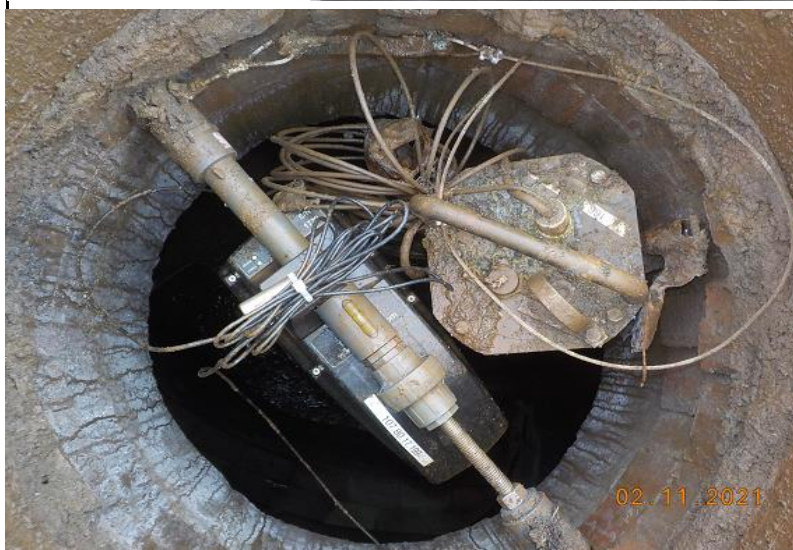
Ave_A_CSO

Site Address / Location:	250 Avenue A	Monitor Series	ECHO	Location Type	Permanent
Site Access:	Drive- Detailed needed	Pipe Size (H x W)	21x21	Pipe Shape	Circular

Installation Information	
Installation Date:	Thursday, February 11, 2021
Monitoring Location (Sensors):	Manhole
Sensors / Devices:	Peak Combo (CS4)
Installation Type:	Level Only
Monitor Location:	Manhole
Pressure Sensor Range (psi)

Installation Confirmation:	
Confirmation Time:	11:15:00 AM
Depth of Flow (Wet DOF) (in)	0.5
Downlooker Physical Offset (in)	
Peak Velocity (fps)	
Silt (in)	0
Pipe Size (HxW)	21x21
Range (Air DOF) (in)	
Measurement Confidence (in)	0.25"
Velocity Sensor Offset (in)	N/A
Silt Type	N/A

Manhole / Pipe Information:	
Manhole Depth (Approx. FT):	10.75
Manhole Material:	Concrete
Manhole Opening Diameter (in)	24
Manhole Cover	Concealed
Active Drop Connections	No
Pipe Material	PVC
Manhole Configuration	Common Trench
Manhole Condition:	Good
Manhole Diameter (Approx.):	24
Manhole Frame	Normal
Air Quality:	Good
Pipe Condition:	Good

Additional Site Info. / Comments:
N. 42.60422 W. -72.56094 S /N: 1729 I/P: 107.80.17.199 Site Overflows at Depth of 27.0 Inches

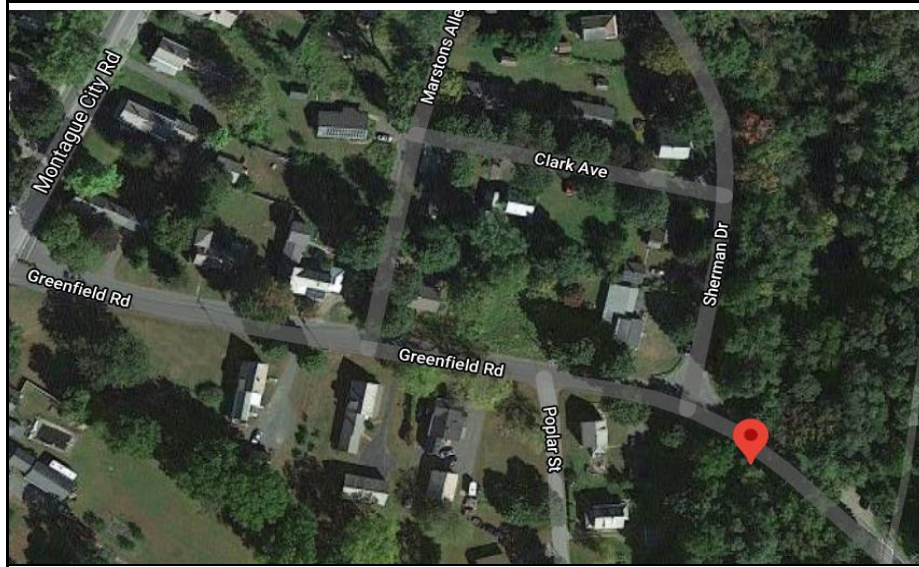
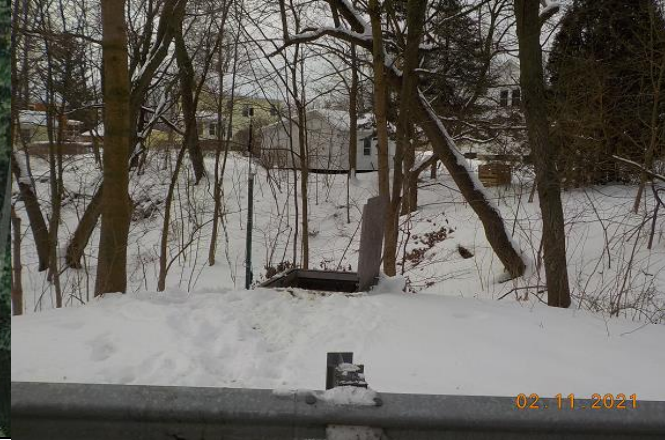
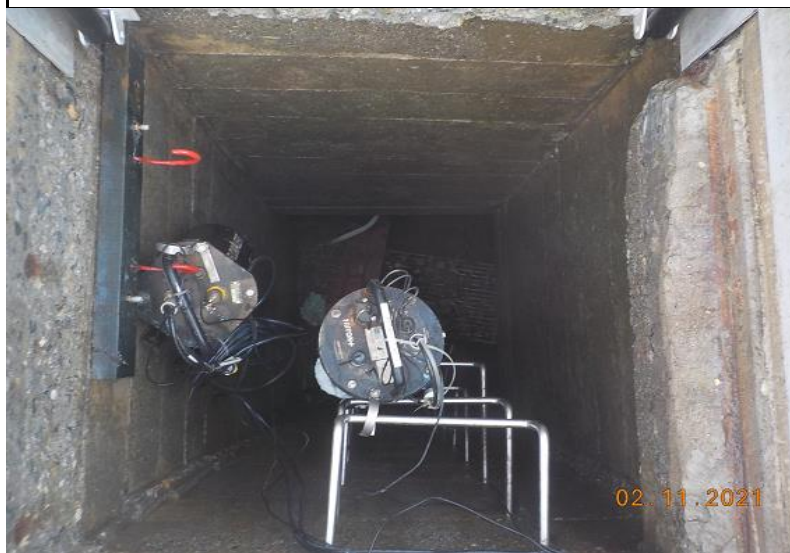
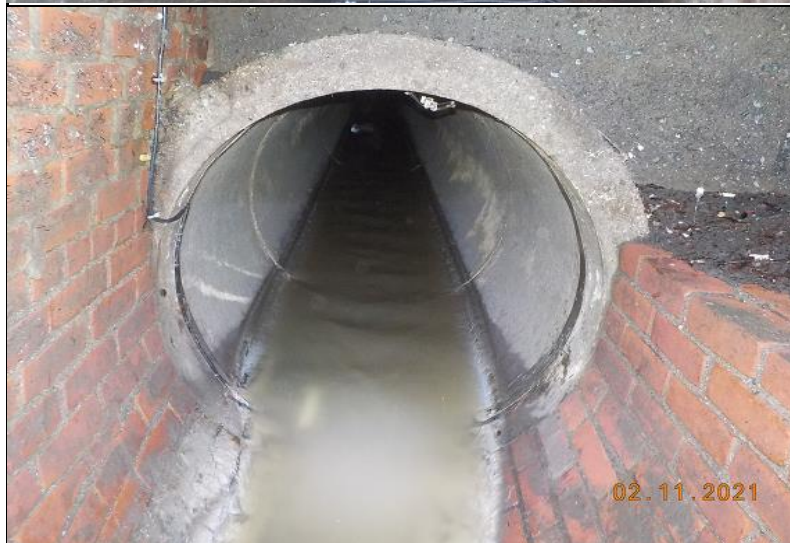
Greenfield_M1

Site Address / Location:	GREENFIELD ROAD - CSO	Monitor Series	TRITON+	Location Type	Permanent
Site Access:	Drive	Pipe Size (H x W)	36x36	Pipe Shape	Circular

Installation Date:	Thursday, February 11, 2021	Installation Type:	Doppler Standard Ring and Crank
Monitoring Location (Sensors):		Monitor Location:	Manhole
Sensors / Devices:	Peak Combo (CS4)	Pressure Sensor Range (psi)

Confirmation Time:	10:21:00 AM	Pipe Size (HxW)	36x36
Depth of Flow (Wet DOF) (in)	4.63	Range (Air DOF) (in)	
Downlooker Physical Offset (in)		Measurement Confidence (in)	0.25"
Peak Velocity (fps)	2.5	Velocity Sensor Offset (in)	N/A
Silt (in)	0	Silt Type	N/A

Manhole Depth (Approx. FT):	14	Manhole Configuration	Common Trench
Manhole Material:	Concrete	Manhole Condition:	Good
Manhole Opening Diameter (in)	24	Manhole Diameter (Approx.):	24
Manhole Cover	Concealed	Manhole Frame	Normal
Active Drop Connections	No	Air Quality:	Good
Pipe Material	Concrete	Pipe Condition:	Good

N. 42.58211 W. -72.57486 S / N: 52143 I/P: 107.80.17.22 Site Overflows at Depth of 42.0 Inches
