ENVIRONMENTAL SUMMARY REPORT

Immediate Response Actions (RTN 1-53064)

Project: Turners Falls Dam Hydraulic Fluid Release

Turners Falls Dam

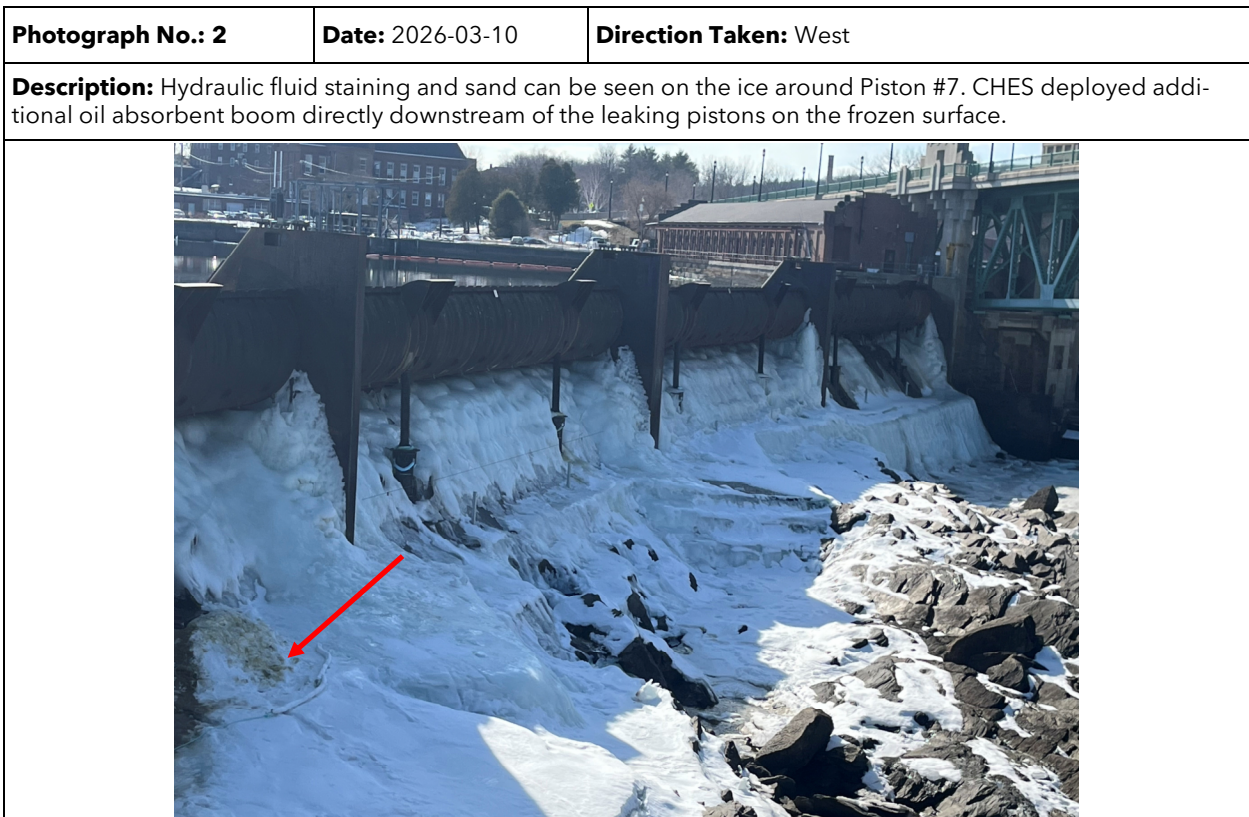
Photograph No.: 4	Date: 2026-03-11	Direction Taken: Southwest
Description: View of Site conditions following significant ice melt. Hydraulic fluid and sand can be seen on the ice and in the water below the dam. Additionally, the oil absorbent booms shifted with the ice melt.

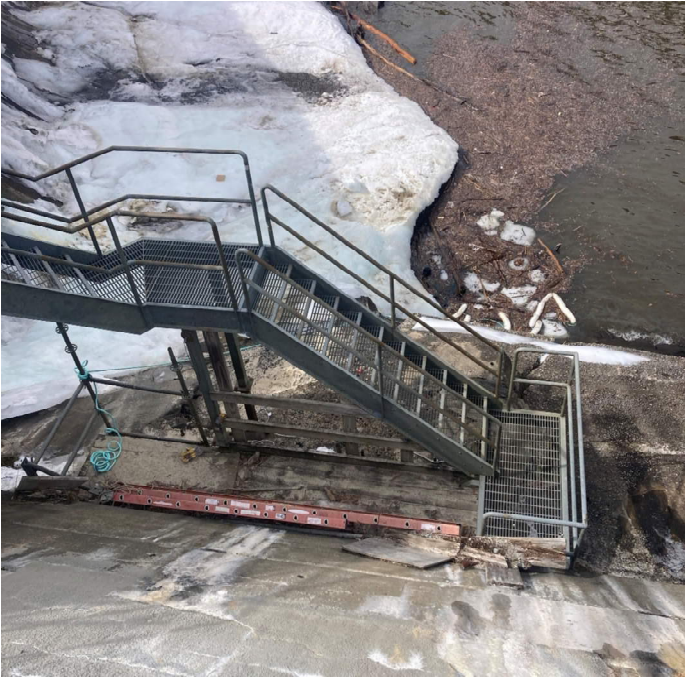
Photograph No.: 3	Date: 2026-03-18	Direction Taken: N/A
Description: View of remaining sand beneath Pistons #7 and #8.

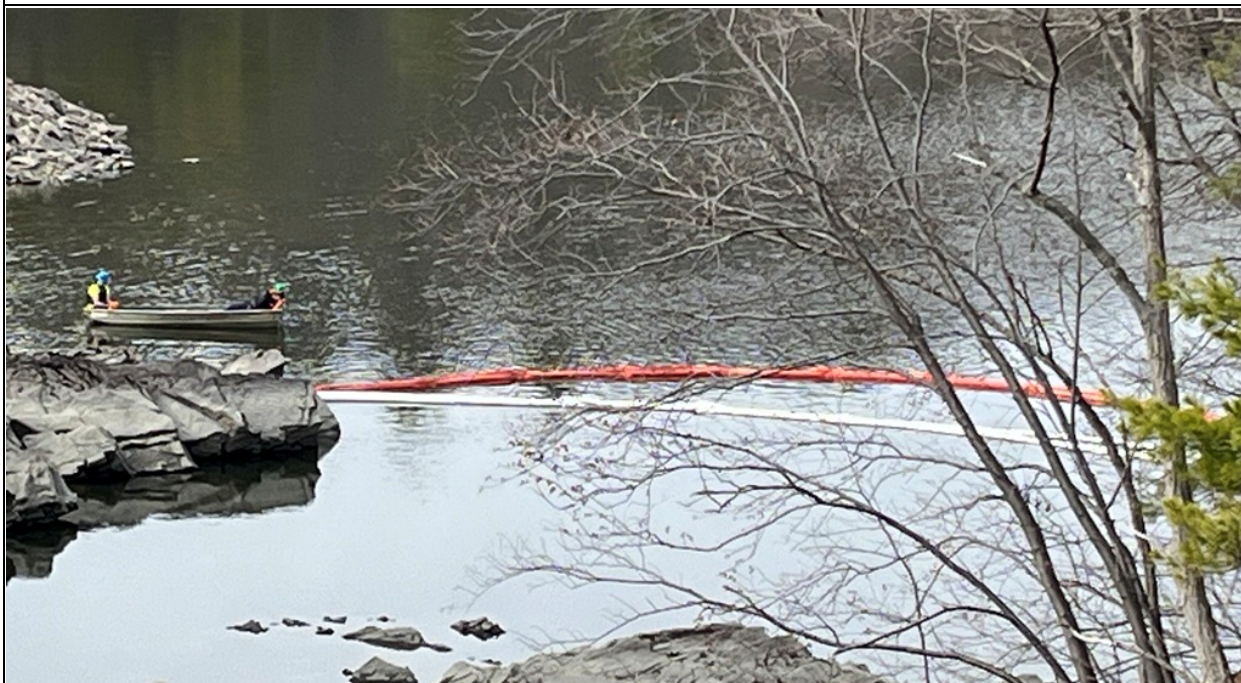
Photograph No.: 3	Date: 2026-03-26	Direction Taken: North
--------------------------	-------------------------	-------------------------------

Description: View of the containment boom and oil absorbent boom below Bascule Gate #4 following repairs and replacement by CHES.

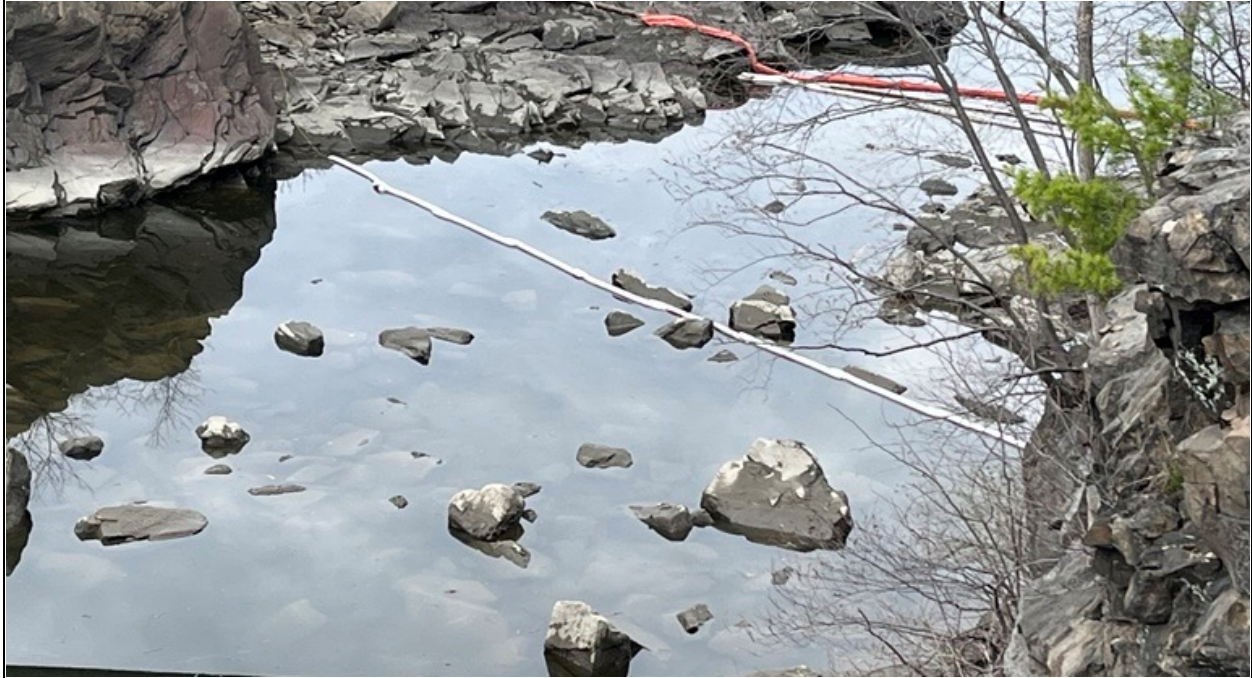
Photograph No.: 3	Date: 2026-04-15	Direction Taken: North
Description: Clean Harbors replaced the absorbent booms along the orange rigid containment boom. An additional line of absorbent boom was deployed closer to bascule Gate #4.

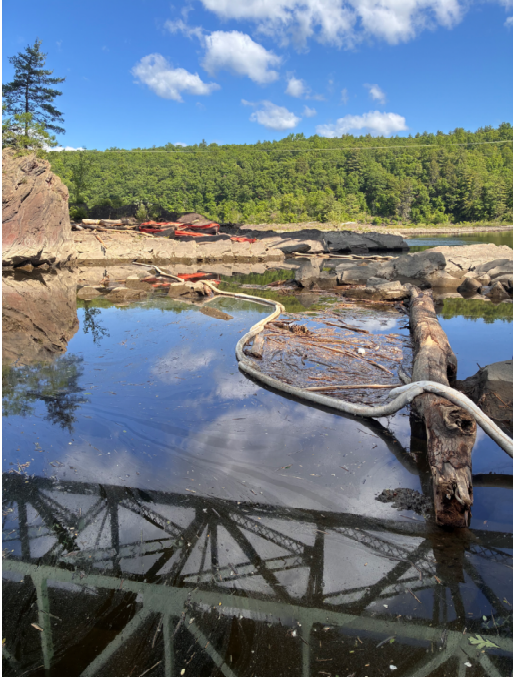
Photograph No.: 1	Date: 2026-05-29	Direction Taken: Northwest
Description: View of the release area prior to boom replacement.

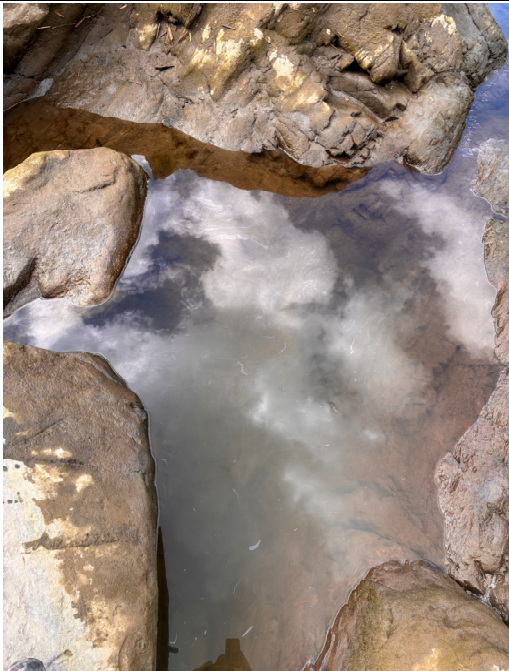
Photograph No.: 4	Date: 2026-05-29	Direction Taken: N/A
Description: View of the rocky area from Photograph No. 3 following skimming using an oil absorbent pad.
