Energy Infrastructure Assessment Report FINAL

Montague, Massachusetts

May 8, 2018

UMass Clean Energy Extension

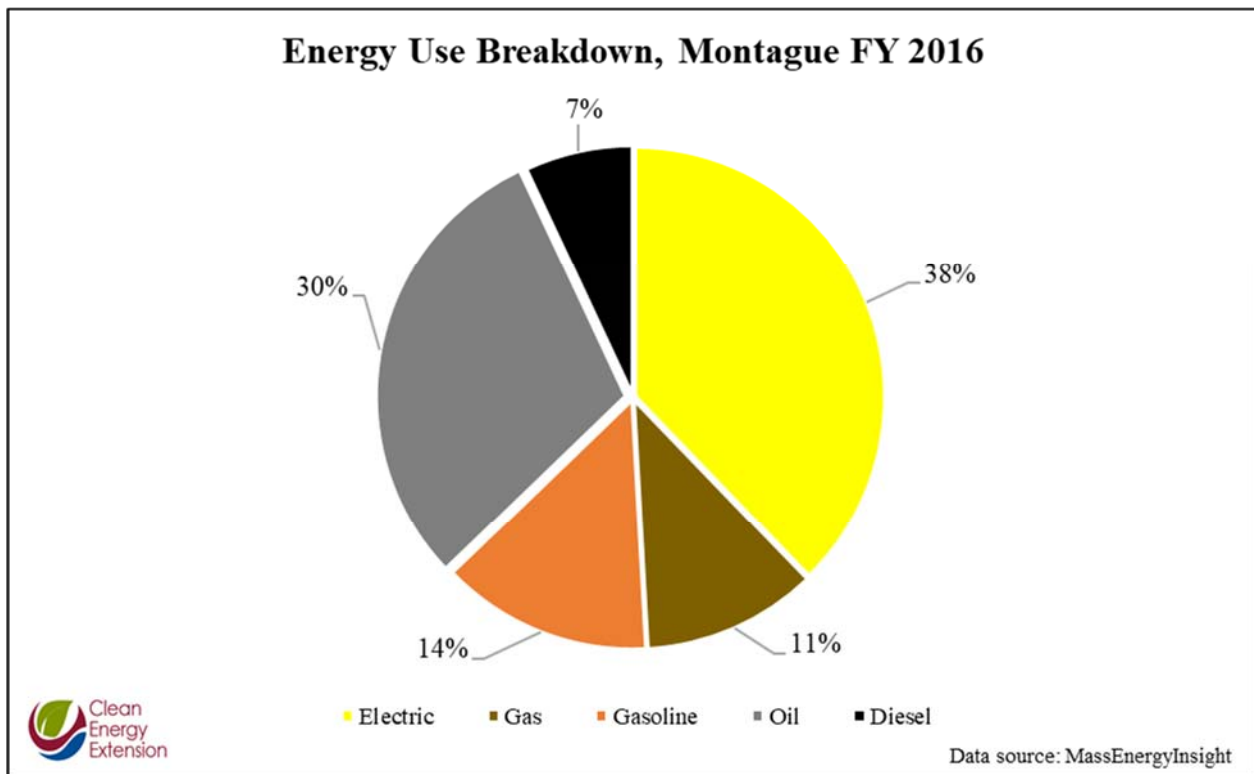
The following graphs illustrate Montague’s total energy consumption in FY 2016 and provide comparisons of the town’s facilities and their individual utility accounts. Energy consumption by fuel type is shown in **Figure 8**. Heating oil accounts for 30% of the town’s total energy consumption, suggesting that heated buildings may be an important focus area for energy efficiency efforts. Transportation fuels account for 21% of Montague’s total energy consumption.

Figure 8. Total consumption of each energy type and its percentage of the town’s total energy consumption.
*Diesel from FY 2017

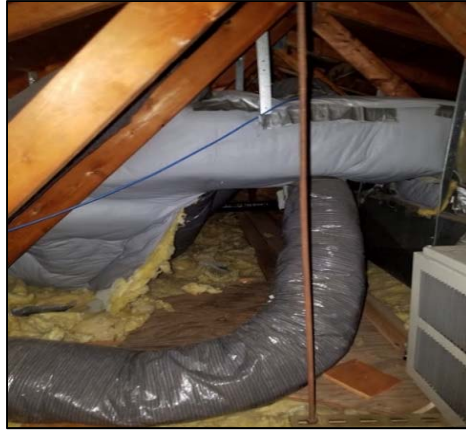
Figure 11. Uninsulated Ductwork

Review of the attic insulation indicated there are opportunities for envelope improvement. In certain areas, the attic lacks an ideal amount of insulation, and the ductwork responsible for supplying heated air is exposed outside of the envelope (**Figures 11 & 12**). The building does not have a basement, as it was constructed on a concrete slab.

- Add insulation to areas with insufficient cover on the attic floor, and ensure all ductwork is properly covered. Montague should fabricate an insulated wooden box that can be placed over the furnace. The box can be easily removed for servicing, and can help improve efficiency, as the furnace would no longer be outside of the envelope (**Figure 13**).
- Install a remotely accessible thermostat (e.g., Nest or Ecobee).
- Replace main room (**Figure 10**) window AC unit with heat pump for cooling purposes; continue using window AC unit in Manager's office. The Town could also further explore de-commissioning the existing furnace system and using a mini-split for heating and cooling purposes year round.
- Replace all outside flood-lighting on airport building with efficient LED lights if not already done so.

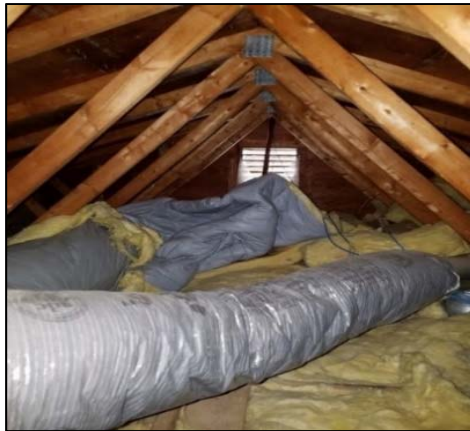
Figure 12. Attic Insulation

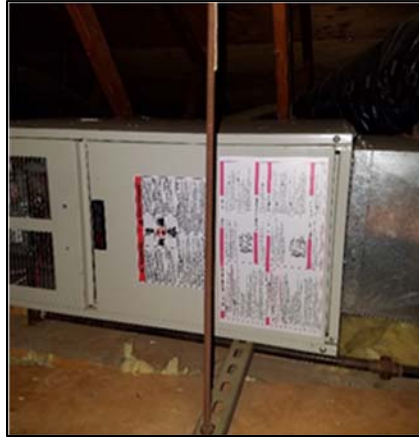
The furnace (**Figure 13**), located in the attic, can be accessed via the airport communications-equipment storage room directly next to the manager's office. The furnace appears to be in good condition and properly sized.

Figure 13. Airport building furnace

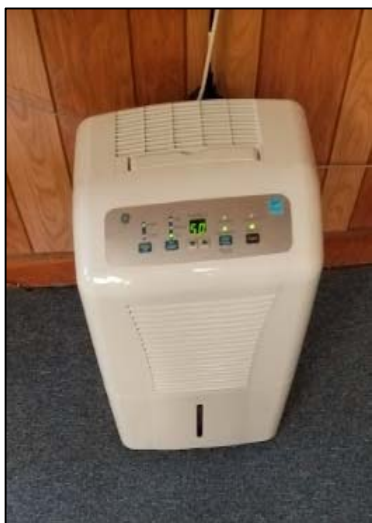
The building’s heating needs are supplied by an oil-fired forced hot air distribution system, paired with a five-ton condensing unit for cooling needs. Air-quality issues have been noted within the library, especially for employees working in the basement. Based on the findings of a state-conducted study, the employees have been advised against using the existing basement systems that circulate air as part of their operation. Aside from the inefficient heating and cooling systems discussed further on, high energy costs can in part be explained by the continual operation of multiple dehumidifiers to help mitigate air quality issues (**Figure 16**).

Figure 16. One of the many dehumidifiers utilized

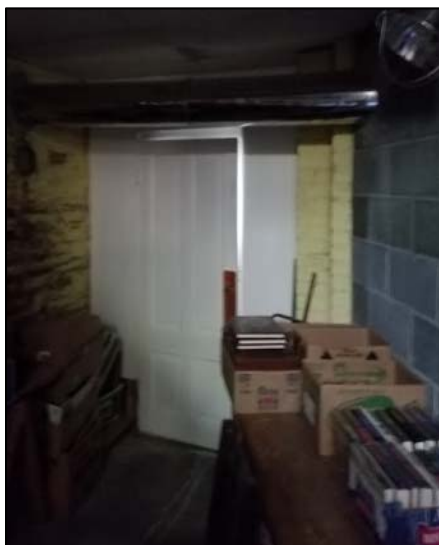
Figure 17. Area where water pools from ADA ramp

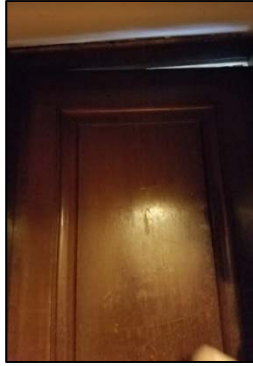
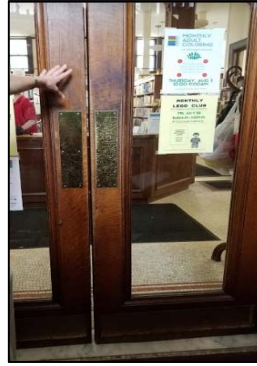
Figure 19. View of drafty double-door from main entranceway

CEE was unable to analyze the condition of the attic insulation. A potential areas from envelope improvements is the main entrance, which is neither heated nor cooled. Within this entranceway is a bathroom, main doorway to basement employee offices (**Figure 18**), and stairway to third floor. The main entranceway acts as an uninsulated stack, reducing delivery of conditioned air to the insulated portions of the building. The original double doors that from the entranceway into the 1st floor of the library are very drafty (**Figure 19**). To reduce the loss of conditioned air, these doors remain closed except when users walk through them. These doors are quite heavy and children often have fingers “pinched” by the doors.

- Once air quality issues have been addressed and documented, all exterior doors, as well as the main double-doors should be weather-stripped.
- Explore the introduction of window inserts⁷ to help retain conditioned air.

- Montague should decide whether or not the main entranceway will be a conditioned space. Keeping the entranceway a non-conditioned space would require the doors shown in **Figure 19** to remain closed at all times and weather-stripped, thereby moving the envelope to the limits of the conditioned area.

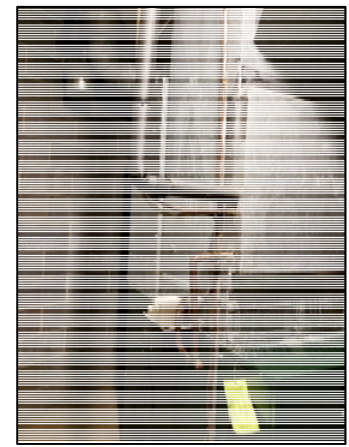
According to the B2Q Associates, Inc. Turnkey Replacement Proposal, the 10-year-old heating system is undersized and underperforming, with an estimated AFUE efficiency of 82% (**Figure 20**). The lack of heat and cooling power to the third floor, and poor temperature regulation throughout the building can in part be explained by the under sizing of the furnace and cooling unit. The consultants proposed replacing the existing furnace with two new propane-fired furnaces equipped with variable-speed blowers. Doing so will increase capacity by upwards of 20%, provide some redundancy, and allow the building to be split into different zones. Furthermore, each furnace will have its own 3.5-ton condensing units. To improve occupants' comfort, the consultants proposed the introduction of automated zone dampers, each paired with a programmable thermostat. Montague will move forward with the consultant's proposal using funding awarded 2017 Green Communities competitive grant cycle.

Figure 20. Current undersized boiler in Library

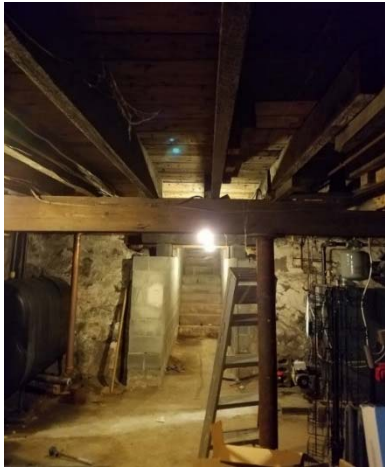
Figure 25. View of library basement

Inspection of the open-earth basement indicates that the site suffers from water and moisture-management problems, as a stream runs directly under the property. Because of these issues, dehumidifiers are placed throughout the library.

- The existing boiler should be replaced with a condensing boiler or modern wood-heat boiler, and related smart system controls.
- To clearly establish the building envelope, the ceiling of the basement should be entirely insulated. As the boiler would still be outside of the envelope, a mechanical room should be erected. The framing of the mechanical-room wall should start two or so feet to the right of the boiler shown in **Figure 27**, and extend across to two feet past the left side of the stairway (**Figure 25**). Another section should be added to be flush against the retaining wall. The rest of the basement can be used for storage; a door should be installed in-line with the existing stairwell to connect the mechanical room with the basement. The interior door at the top of the stairwell leading to the basement should be replaced with an exterior-grade door.

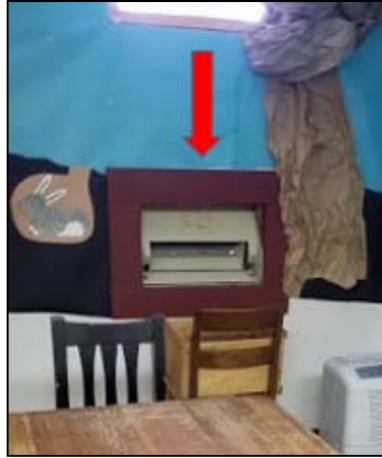
Other envelope issues were observed in the dropped ceiling and with the book-drop (**Figure 24**) within the addition. The ceiling is adequately insulated; however, there is no visible air barrier in the examined section. Conditioned air escapes through the book-drop, especially when users open the slot. The once drafty windows in the addition have been retrofitted with window inserts to improve the envelope. According to the Director of Montague’s Public Libraries, Linda Hickman, the Libraries hosted a public workshop to teach residents how to create their own “winderst”.

Figure 24. Functional book drop indicated by red arrow.

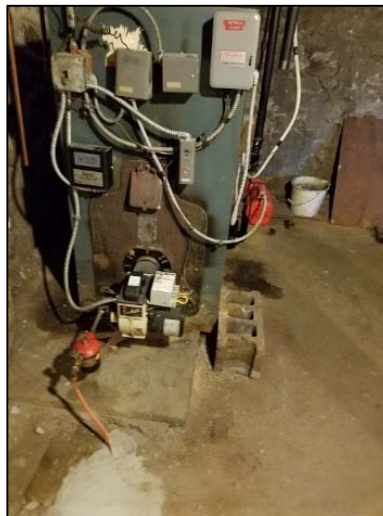
Figure 27. Inadequate boiler with unused components

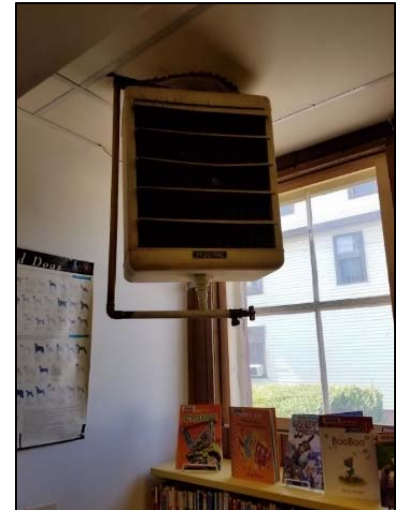
Figure 26. Hydronic unit heater

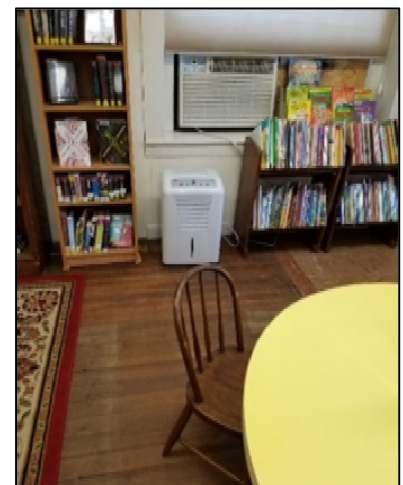
Figure 31. Conflicting electrical needs

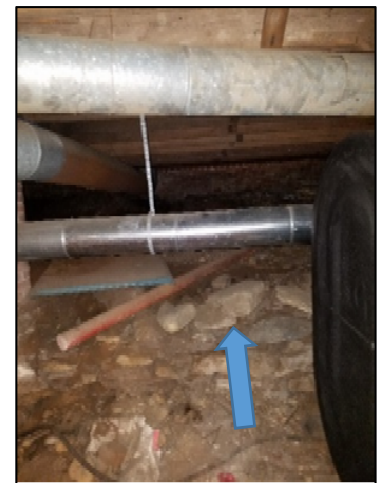
Figure 33. Open-earth basement and proposed alterations.

- Add an air barrier, insulate ceiling and around ductwork, and introduce vapor retarder to entire area outside new envelope as discussed. As shown in **Figure 33**, install vertical insulated wooden barrier where the open-earth basement is held back by retaining walls on both sides of the basement to

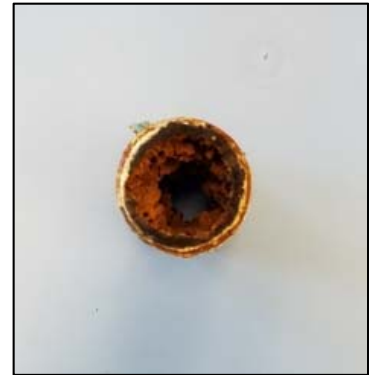
Figure 36. Removed piece of piping from Hillcrest illustrating impact of hard water.

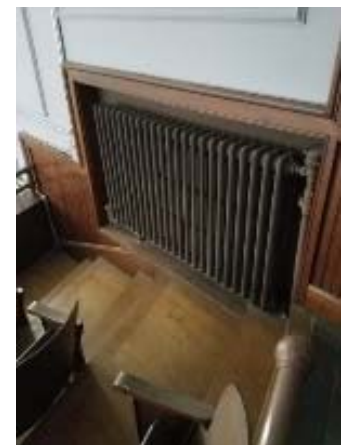
Figure 38. Auditorium radiator in balcony

The boiler-generated steam is either used directly by steam radiators located in the gymnasium and auditorium (**Figure 38**), or converted to hot water via a steam-to-hot-water heat exchanger. Heating hot water is supplied to the classroom unit ventilators, hallway convectors, and baseboard radiation systems located in the cafeteria.

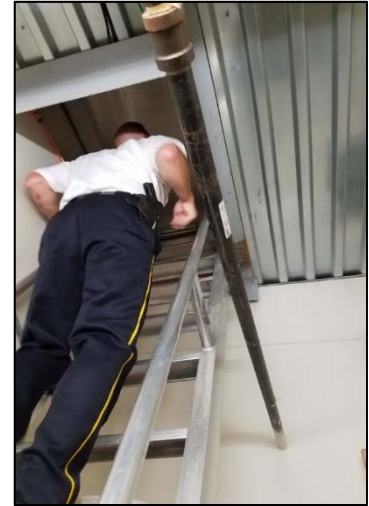
Figure 41. Former police chief Chip Dodge Climbing roof access hatch

- The building could greatly benefit from the establishment of HVAC controls to manage occupied hours and set points.
- The orientation and large surface area of the roof makes it a prime candidate for a PV system; however, the structural capacity of the roof should be further investigated. The introduction of a PV system would help to offset the facility's large electrical consumption. Based on the information provided to CEE it is unclear whether the Fire Department and Fire Station are on separate electrical accounts. If not, the buildings should be separately metered.
- Insulate the roof access hatch as indicated in **Figure 41**.

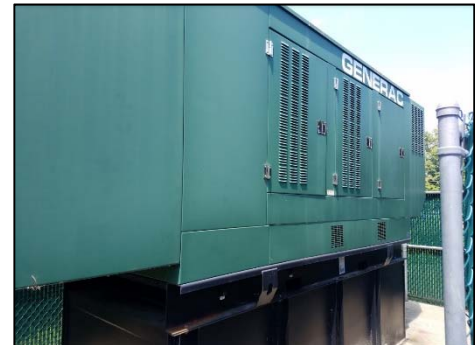
Discussions with the Public Safety Complex administrative staff indicated that the GSHP system has not functioned as intended. The system was designed to provide heating and cooling services to occupied rooms as indicated by installed motion sensors. However, due to insufficient and irregular temperature regulation throughout the building, the motion detection function has since been disabled. Running the system 24 hours a day, seven days a week, has made a noticeable difference in terms of distribution consistency and temperature regulation across the facility. It was suggested by service technicians that lower-quality installed ductwork during the construction of the complex contributes to distribution issues. The building is also equipped with a rooftop unit (RTU) air handler that provides ventilation to the building. On the west side of the building there is a diesel powered generator that has been recently serviced (**Figure 42**).

Figure 42. Public Safety Complex diesel generator

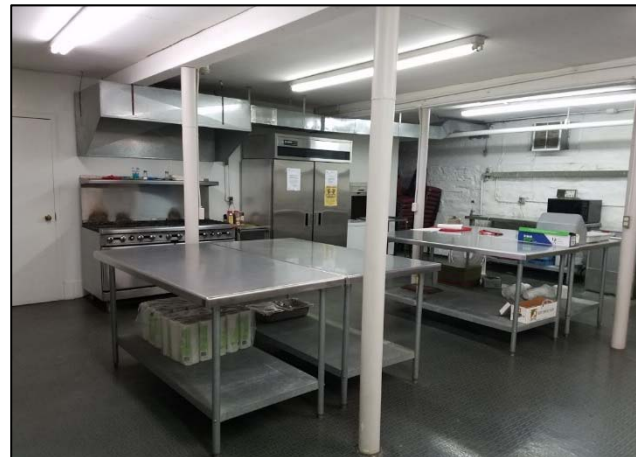
Figure 44. Senior Center basement full-kitchen

The facility is also equipped with a full kitchen (**Figure 44**) in the basement that generates a significant amount of heat from the equipment and gas stove pilots running throughout the day and night. Domestic hot water needs are supplied by a free-standing electric hot water tank.

- Install an ECM¹² motor in fridge if not already equipped with one.
- Further explore the feasibility of utilizing excess heat created by the fridge and stove in the basement to replace domestic hot water needs via an air-source heat pump.
- Insulate all exposed piping infrastructure indicated in **Figure 46**, or frame mount and insulate the building's original foundation (left wall of **Figure 46**) to include the boiler room within the building envelope.

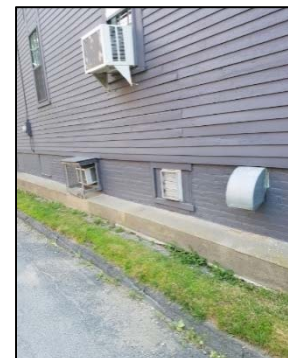
Figure 45. AC units on western side of building

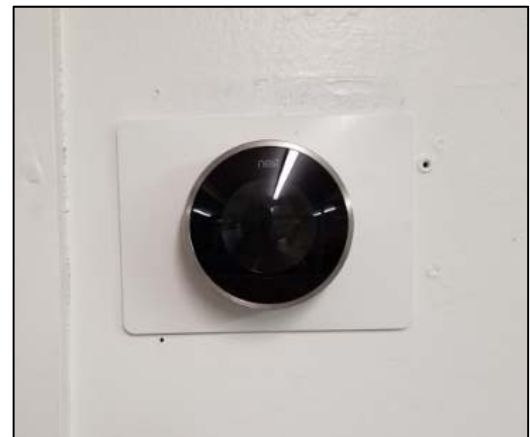
Figure 48. Remotely adjustable thermostat

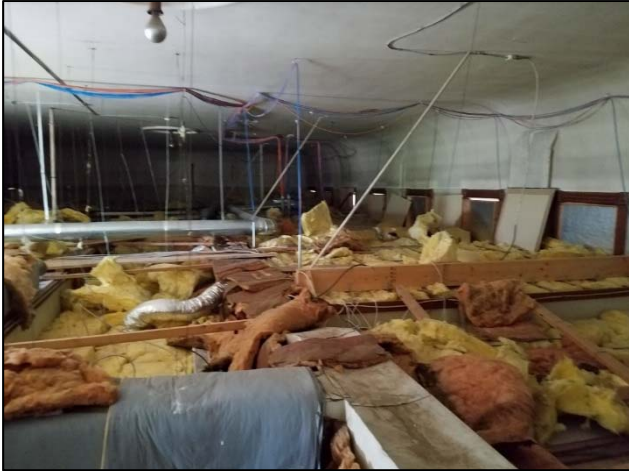
The largest envelope improvement opportunities noticed during the walk-through pertained to the attic and basement. Within the attic, there appeared to be no evidence of an air barrier. Visible light from the second floor could be seen through the uninsulated light fixtures in the attic floor. Both the ductwork circulating conditioned air and the attic floor lack adequate insulation in certain areas. CEE was not able to inspect the attic space above the level indicated in **Figure 52**. Therefore, the true thermal envelope is therefore unclear.

Figure 52. Condition of attic insulation

- **Town Hall** – The Town Hall is a large energy consumer and has a relatively average energy intensity. Overall, the Town Hall has the third highest electric and heating fuel consumption. Montague should consider further air sealing, and add additional insulation within the attic to improve the envelope once the roof has been replaced.

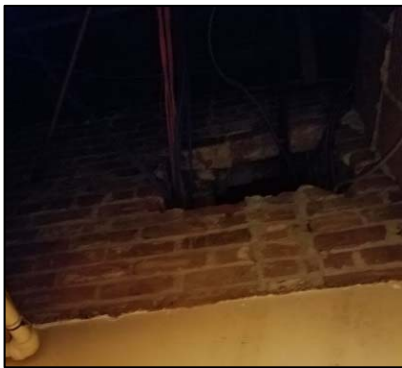
Furthermore, other prominent envelope and air sealing issues were observed throughout the basement. Particularly, these opportunities were most prominent in the bike storage room. Gaps in the wall of the storage room (**Figure 53**), among others (**Figure 55**) allow conditioned air to be disbursed throughout the building or expelled from the building directly. For example, conditioned air is lost through the leaky generator room exhaust infrastructure (**Figure 54**).

Figure 55. Additional wall gaps in basement

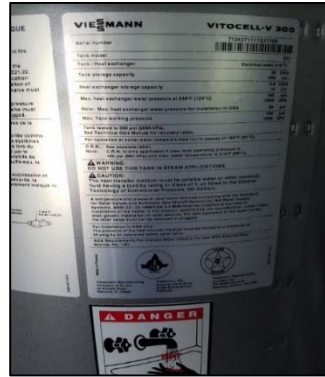
The building's heating and cooling needs are currently controlled by a remotely accessible Ecobee thermostat. The recently installed hydronic distribution systems includes two 350,000 BTU condensing boilers and a 200-liter natural gas-fire domestic hot water heater (**Figure 56**). Currently the system is not equipped with variable frequency drives (VFDs) for the distribution pumps.

Figure 56. VIESSMANN indirect fired domestic hot water storage tank

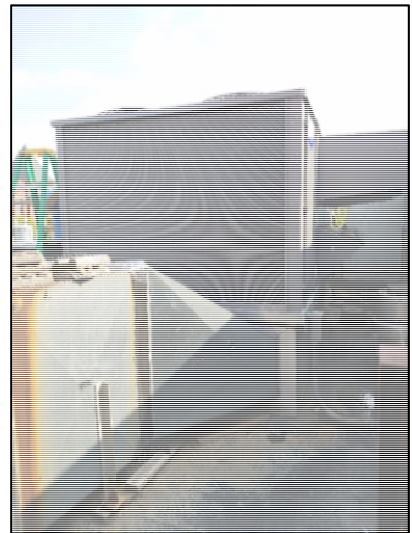
Figure 59. Recently installed two-phase Carrier HVAC System

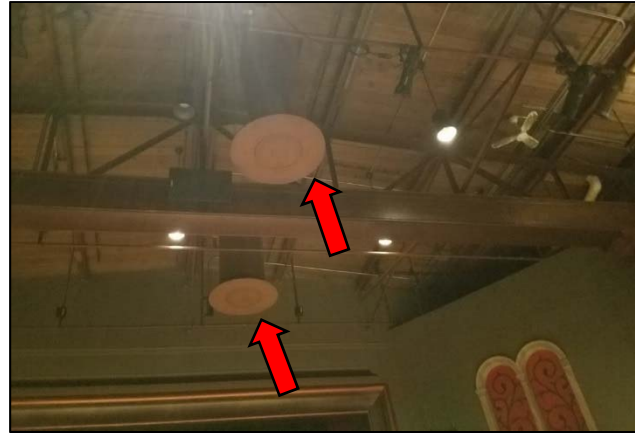
Figure 61. Theater vent infrastructure

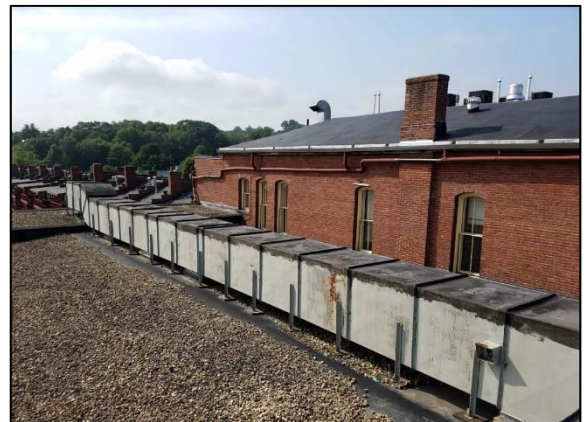
Figure 62. Original HVAC ductwork scheduled for replacement

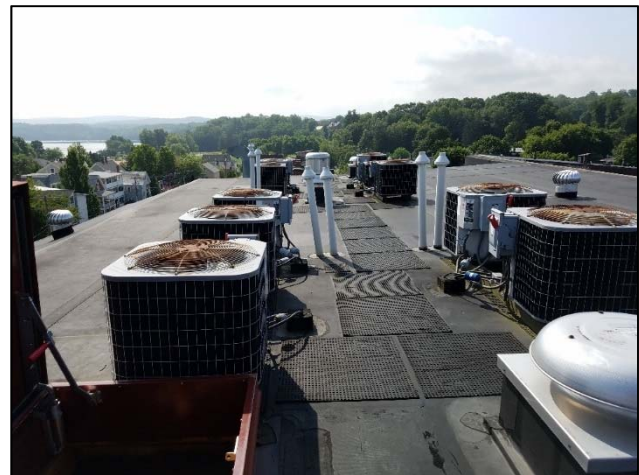
Figure 63. Ten separate units on Colle Building rooftop

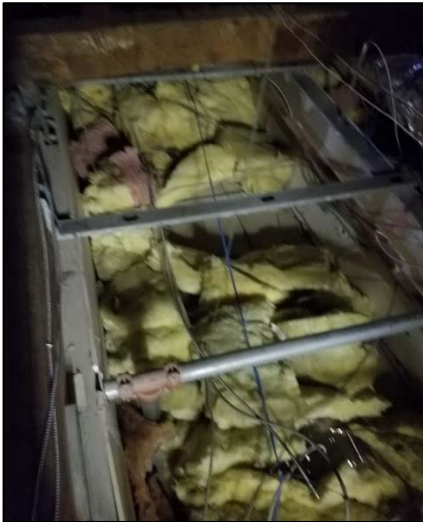
Figure 66. Roof insulation configuration

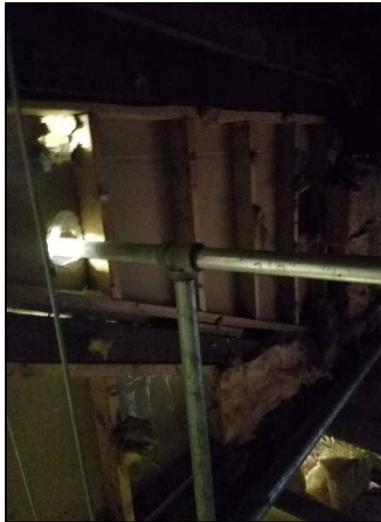
Figure 65. Visible light through insulation

A brief review of the Colle's roof envelope confirmed the absence of an air barrier and inadequate amount and/or placement of insulation for optimal energy efficiency (**Figure 66**). There are significant air gaps and varying levels of insulation quality, as shown by the exterior light entering the building in (**Figure 65**). The access hatch to the roof is also uninsulated. Several sections of ductwork are exposed with deteriorated or penetrated insulation. Spray foam has been applied to the rafters in one section above the insulation. Although this acts as an air barrier, it is in the incorrect location as it does not stop air from wind washing the insulation below it.

- The envelope would benefit from ensuring that existing insulation (**Figure 66**) is distributed evenly, or added too in areas insufficient coverage.
- Increase air sealing of envelope in the attic (**Figure 65**).

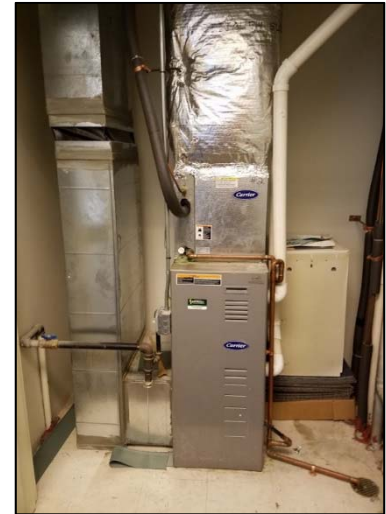
Figure 67. One of 10 Individual furnaces

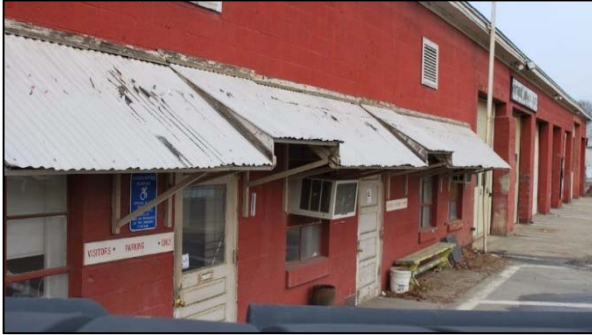
Figure 70. View of DPW facility

The 1948 DPW facility (**Figure 70**) no longer is able to accommodate Montague's vehicle fleet and related equipment. Vehicles currently have to be parked with equipment in close proximity of each other to fit with the building. Similarly, the vehicle maintenance area is undersized, inefficient, and unsafe as equipment cannot be properly raised for maintenance. Furthermore, the building's small footprint requires components of the fleet (i.e., snow plows) to be stored outside (**Figure 69**), affecting the life expectancy of the equipment and operations logistics. The building is currently non-compliant with current building, plumbing, and mechanical code.

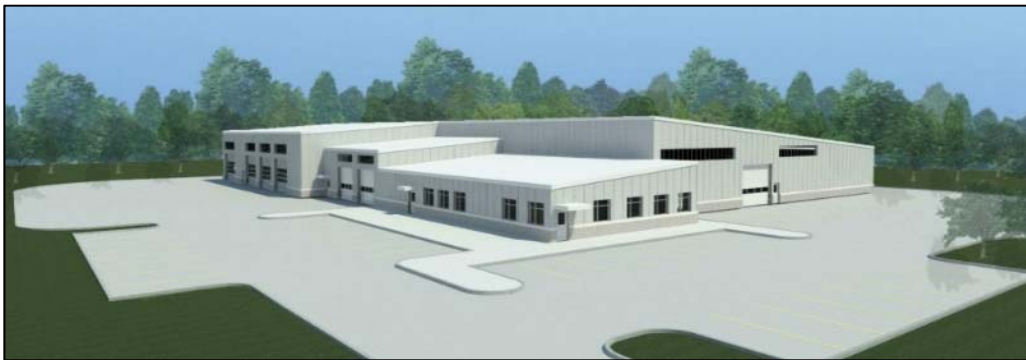
Figure 71. Rendering of new facility

The Town of Montague has proposed the construction of a new 27,000 ft² pre-engineered metal building on land owned by the town located off Sandy Lane (**Figures 71 & 72**).

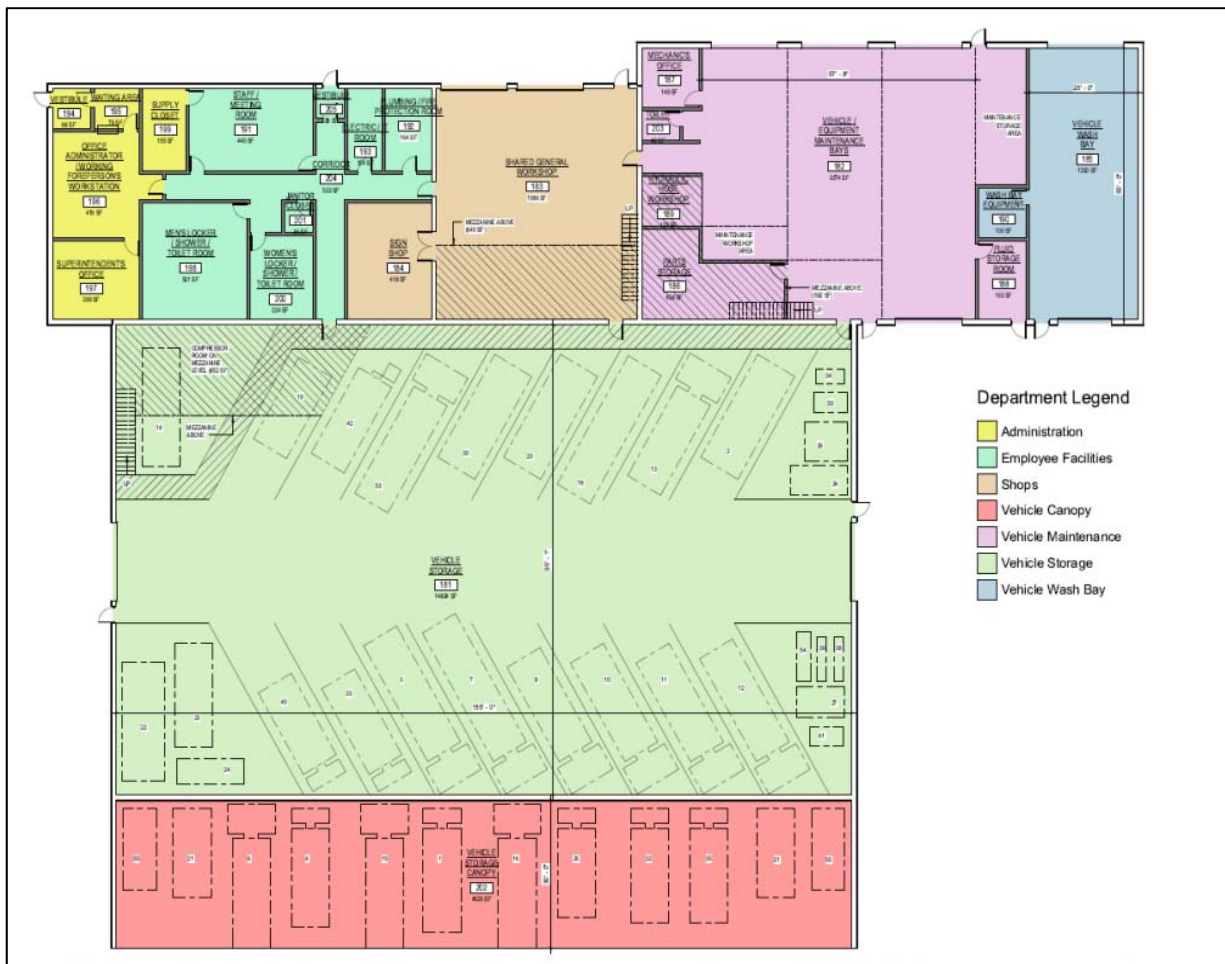
Figure 72. Conceptual floor plan
