## Notice of Intent Application

# Montague-Fairmont Structure Replacement Project Montague, Massachusetts

**RE: Notice of Intent Application  
Eversource Energy  
Montague-Fairmont Structure Replacement Project (MFRP)  
Montague, MA**

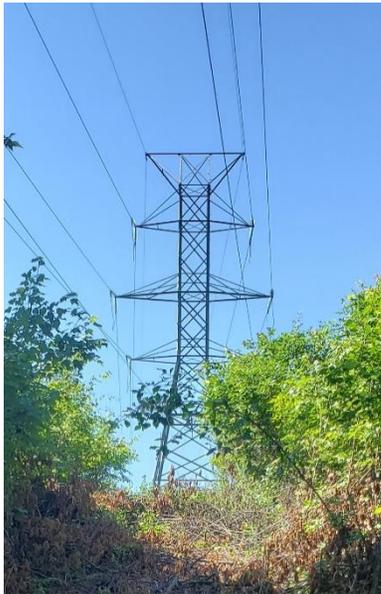
The proposed work involves replacement of the metal lattice frame structures with new monopole type structures, in locations as shown on the Project Plans in Appendix B. The removal of the lattice structures will include the removal of the concrete footings to below grade with restoration of the ground surface.

Typical metal lattice frame structure

The replacement of the structures is maintenance work and will not substantially change or enlarge the facility used in the service of the public to provide electric service. The change from a lattice structure to a monopole is a change in style and design but not a substantial change or enlargement of the existing utility. The new structures will be placed in the vicinity of the current structures; no mid-span poles will be installed. Therefore, the replacement activities in resource areas, including RA, meet the criteria of an exempt maintenance activity stated at 310 CMR 10.02(2)(a)2. The difference in the pole size (diameter) in BVW and RA will be addressed in this NOI because the size of the pole, although not significantly greater, is larger than what the Amended ACO allows as an exemption under the WPA Regulations.

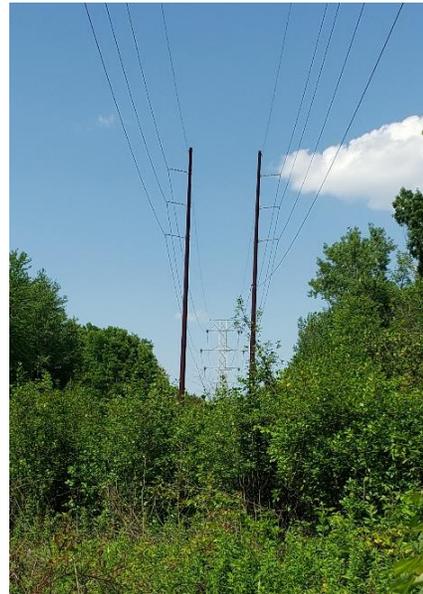
Typical double monopole type structure

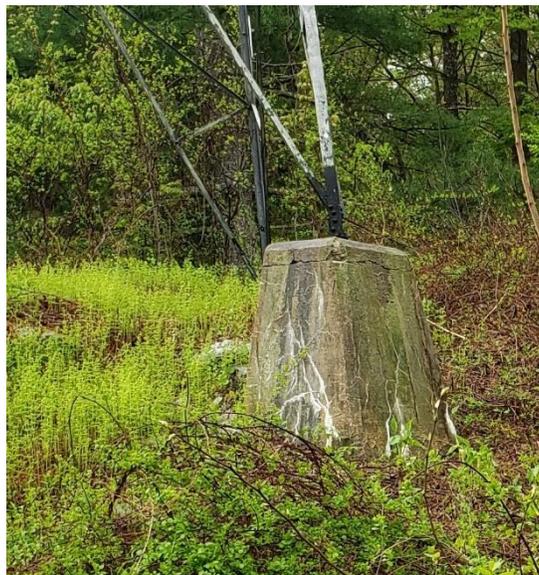
To mitigate for wetland loss, Eversource plans to remove the concrete footings in the wetlands at least one (1) foot below grade and restore the wetland surface, in accordance with the Eversource BMP Manual. Based on a conservative estimate of the concrete footing size, each footing to be removed is approximately 9 square feet or 36 square feet per structure or BVW restoration.

Typical lattice structure footing

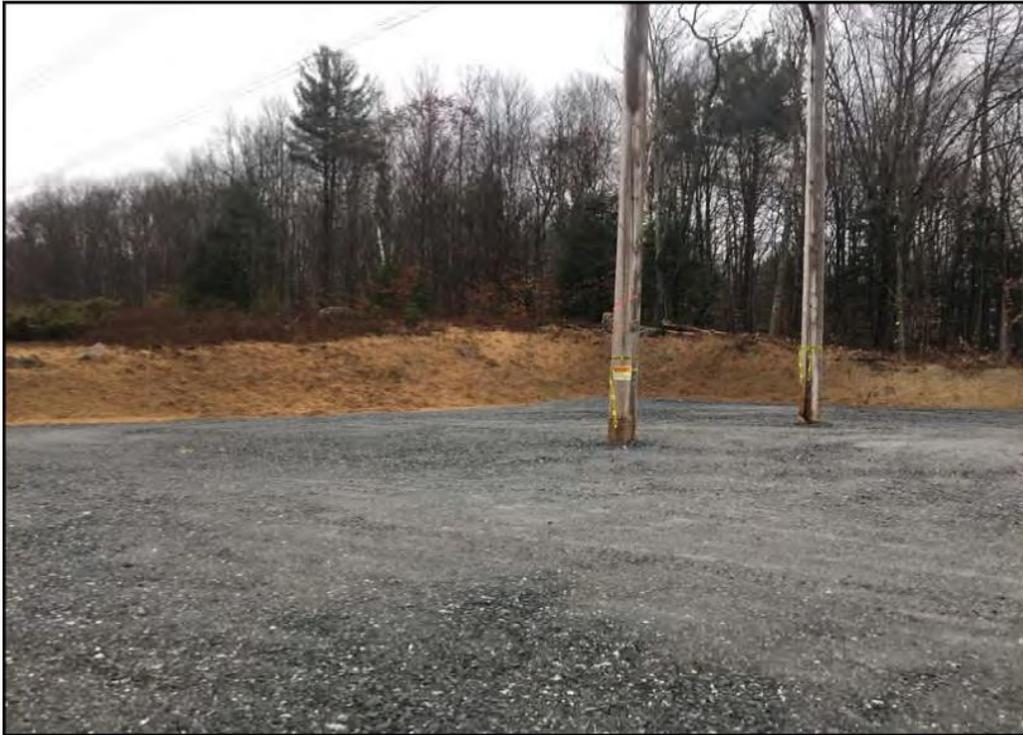
The following photographs depict typical gravel construction pads and the equipment used for structure replacement activities.

Typical gravel work pad needed for ROW maintenance activities.

To safely replace and provide continued access to the proposed structures, Eversource intends to establish gravel work pads and access roads in portions of wetland Buffer Zones within the ROW to create a stable work area to support the equipment necessary for structure replacement activities. Once constructed, the gravel work pads and access roads are considered permanently stable. To avoid and minimize impacts to sensitive resource areas, temporary construction mats will be utilized to supplement the work pads and access roads at BVW/Buffer Zone boundaries, as necessary. At the conclusion of the replacement activities, the matting will be removed.

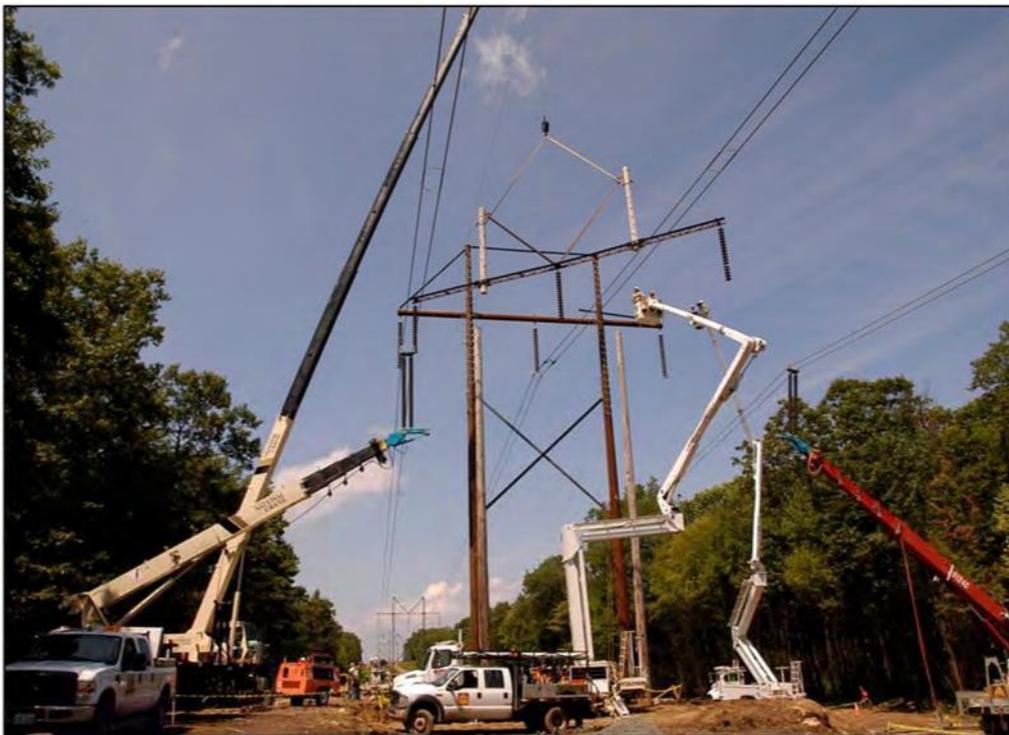
Typical construction set up for ROW maintenance activities during live line work.

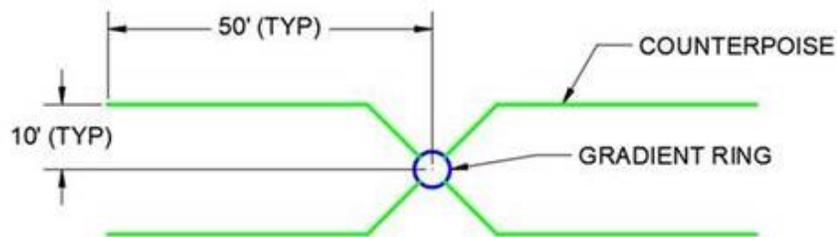
Counterpoise (an electrical grounding system) will be installed at each structure location, unless otherwise determined by Eversource engineering or in sensitive environmental areas. The counterpoise is an underground wire that extends approximately 50 feet from the structure. The counterpoise is connected to the gradient ring, which is an underground metal ring centered on the pole at each structure. Eversource proposes to install counterpoise within areas which will already be disturbed from structure replacement activities. The impacts from the counterpoise installation are temporary and present no new net increase in disturbance. Typical layouts of the counterpoise are shown in the following sketches:

Typical layout for single pole structure standard counterpoise.

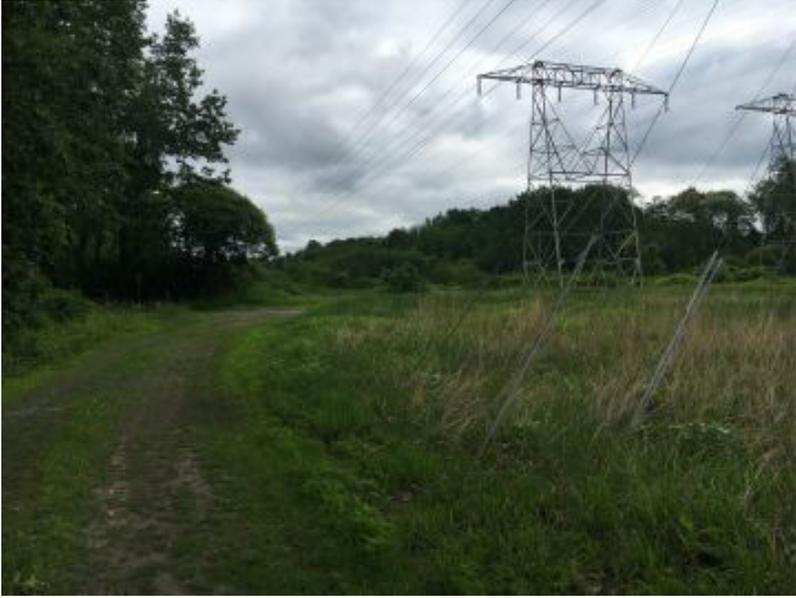
<b>Client Name:</b> Eversource		<b>Site Location:</b> Montague to Fairmont Structure Replacement Project (MRFP)	<b>Project No.</b> 15.0166637.09.
<b>Photo No.</b> 1	<b>Date:</b> 06/19/19

<b>Direction Photo Taken:</b> Northeast			
<b>Description:</b> Montague Wetland W-22.

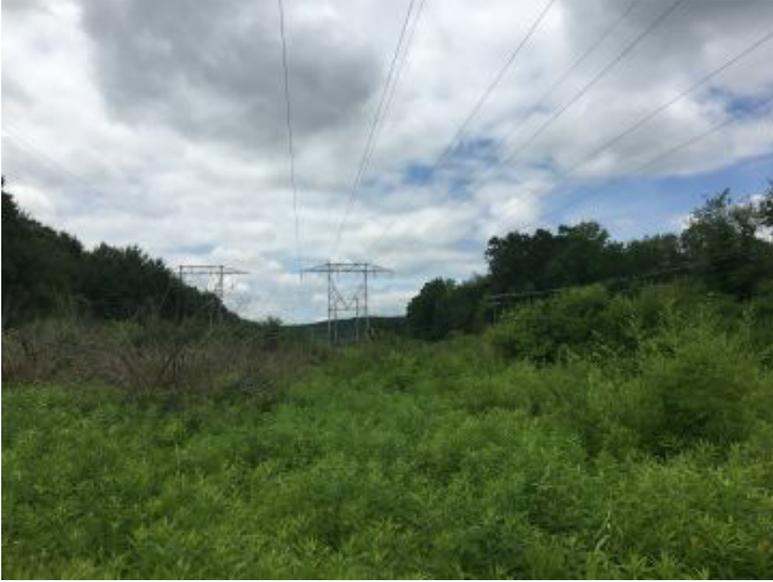
<b>Photo No.</b> 2	<b>Date:</b> 06/19/19

<b>Direction Photo Taken:</b> Northwest			
<b>Description:</b> Montague Wetland W-23

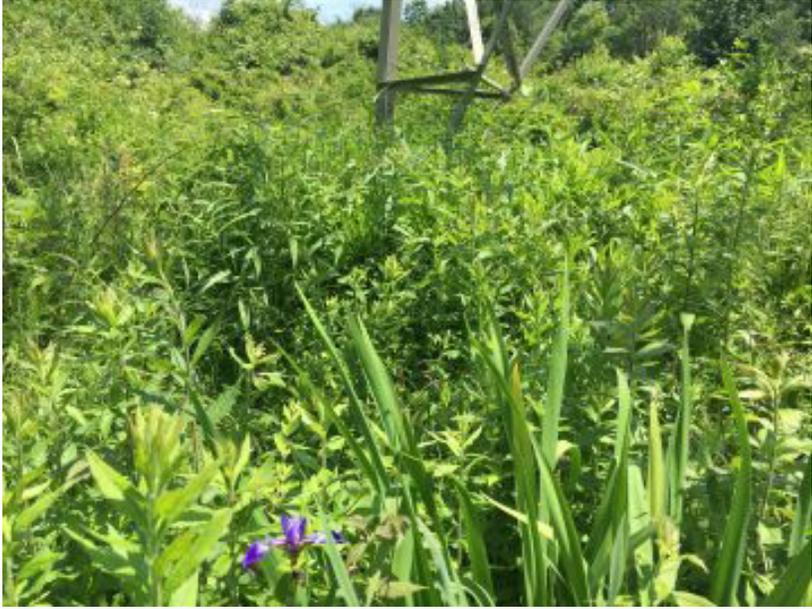
<b>Client Name:</b> Eversource		<b>Site Location:</b> Montague to Fairmont Structure Replacement Project (MRFP)	<b>Project No.</b> 15.0166637.09.
<b>Photo No.</b> 3	<b>Date:</b> 06/19/19

<b>Direction Photo Taken:</b> Northeast			
<b>Description:</b> Montague Wetland W-24

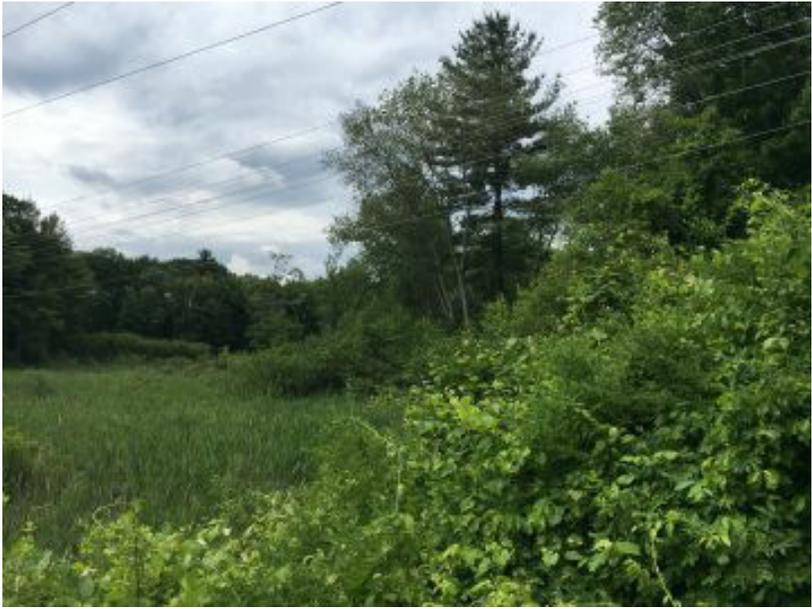
<b>Photo No.</b> 4	<b>Date:</b> 06/19/19

<b>Direction Photo Taken:</b> Northwest			
<b>Description:</b> Montague Wetland W-27

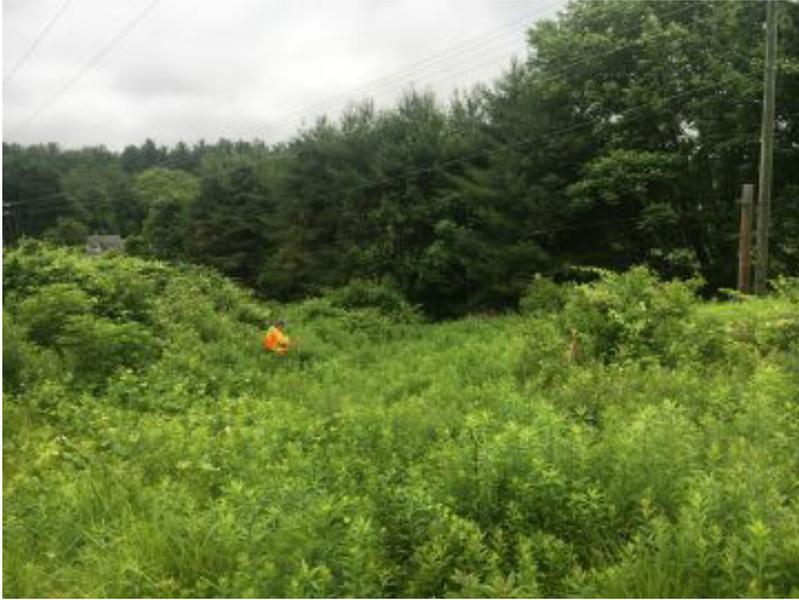
<b>Client Name:</b> Eversource		<b>Site Location:</b> Montague to Fairmont Structure Replacement Project (MRFP)	<b>Project No.</b> 15.0166637.09.
<b>Photo No.</b> 5	<b>Date:</b> 06/20/19

<b>Direction Photo Taken:</b> Northwest			
<b>Description:</b> Montague Wetland W-30

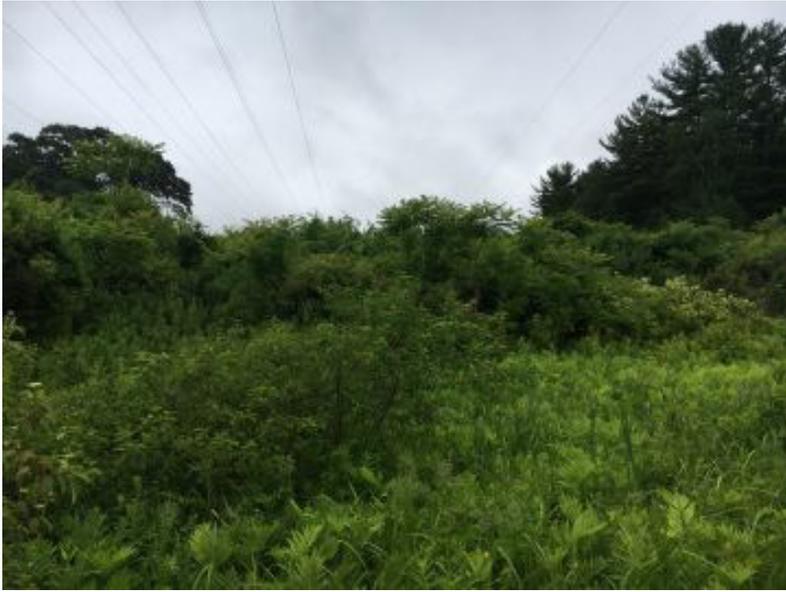
<b>Photo No.</b> 6	<b>Date:</b> 06/20/19

<b>Direction Photo Taken:</b> East			
<b>Description:</b> Montague Wetland W-31

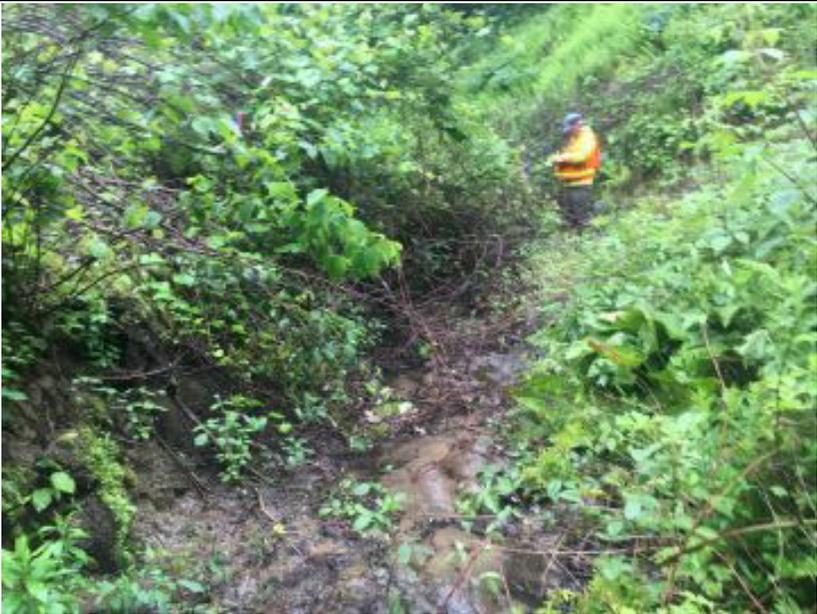
<b>Client Name:</b> Eversource		<b>Site Location:</b> Montague to Fairmont Structure Replacement Project (MRFP)	<b>Project No.</b> 15.0166637.09.
<b>Photo No.</b> 7	<b>Date:</b> 06/20/19

<b>Direction Photo Taken:</b> West			
<b>Description:</b> Montague Wetland W-34 which borders the unnamed perennial stream near Structure 10018.

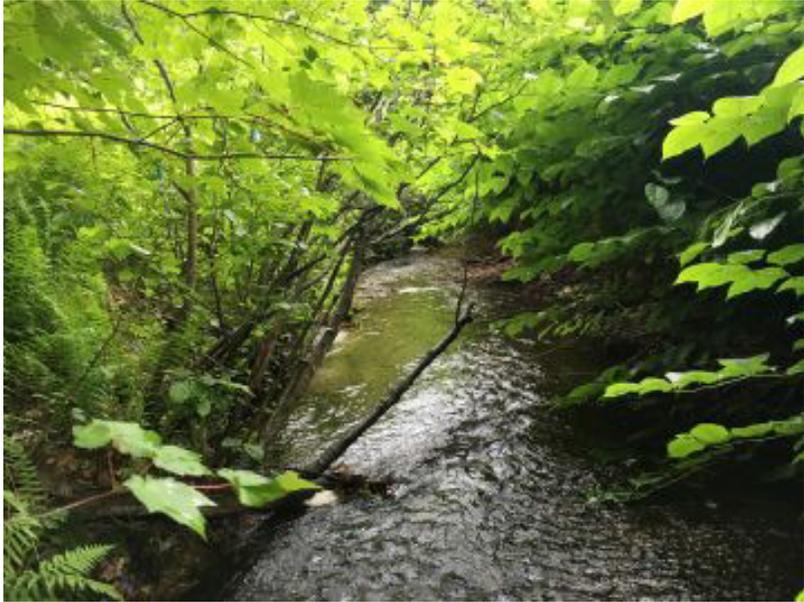
<b>Client Name:</b> Eversource		<b>Site Location:</b> Montague to Fairmont Structure Replacement Project (MRFP)	<b>Project No.</b> 15.0166637.09.
<b>Photo No.</b> 9	<b>Date:</b> 06/21/19

<b>Direction Photo Taken:</b> Southwest			
<b>Description:</b> Montague Wetland W-38 which is adjacent to Pond Brook, a perennial watercourse.

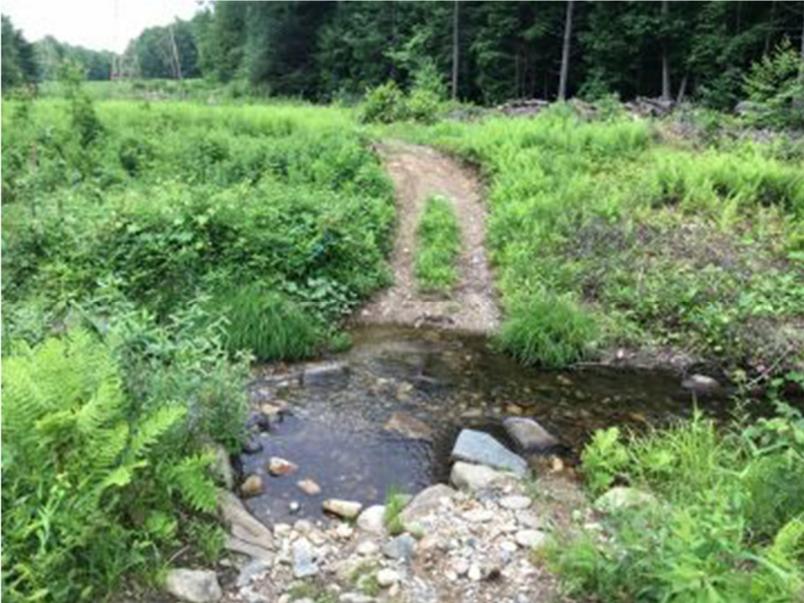
<b>Photo No.</b> 10	<b>Date:</b> 06/21/19

<b>Direction Photo Taken:</b> North northeast			
<b>Description:</b> Montague Wetland W-39 which is adjacent to Goddard Brook, a perennial watercourse.

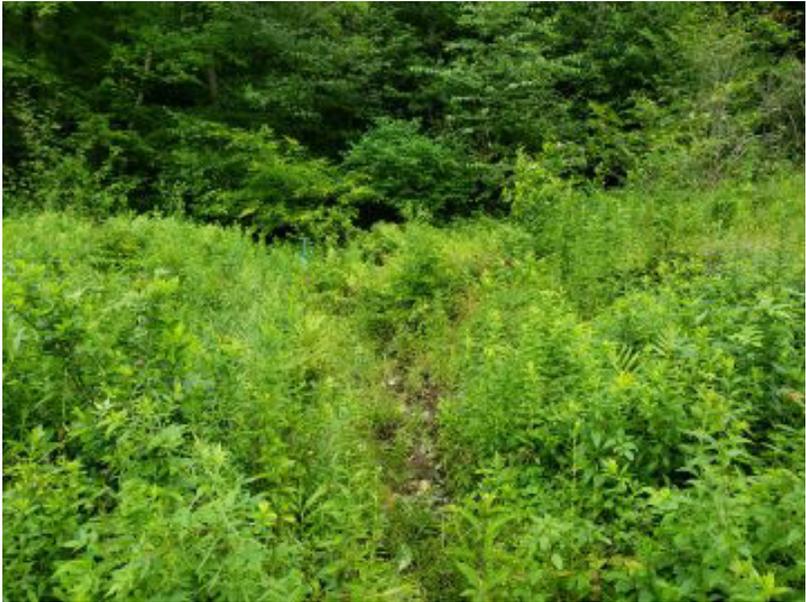
<b>Client Name:</b> Eversource		<b>Site Location:</b> Montague to Fairmont Structure Replacement Project (MRFP)	<b>Project No.</b> 15.0166637.09.
<b>Photo No.</b> 11	<b>Date:</b> 07/22/19

<b>Direction Photo Taken:</b> North			
<b>Description:</b> Montague Wetland W-43

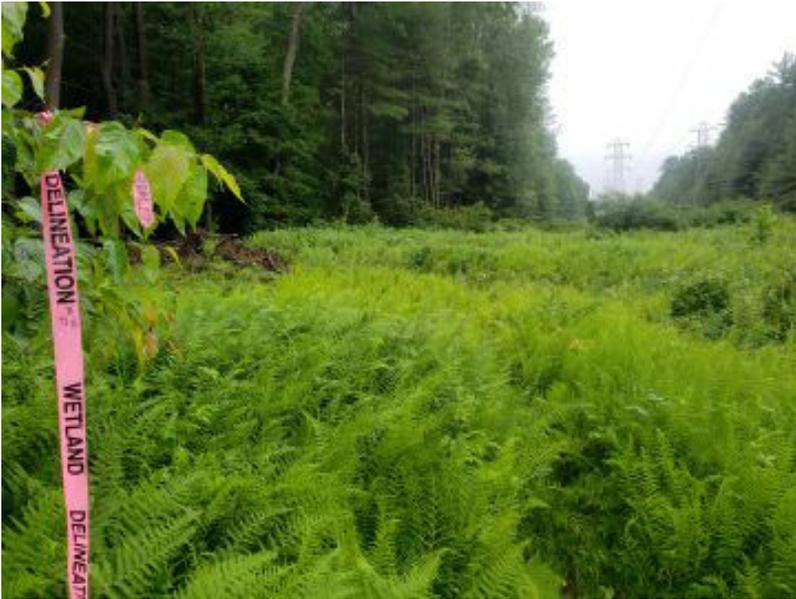
<b>Photo No.</b> 12	<b>Date:</b> 07/23/19

<b>Direction Photo Taken:</b> South			
<b>Description:</b> Montague Wetland W-45

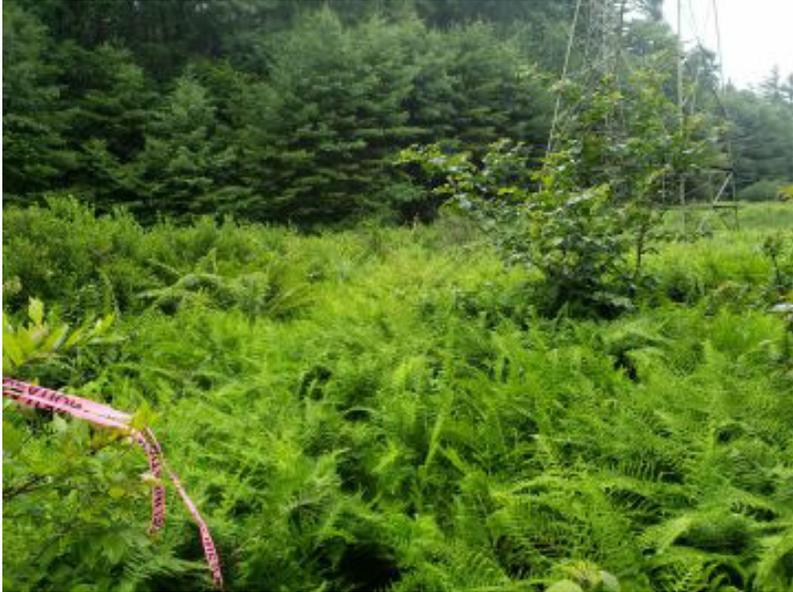
<b>Client Name:</b> Eversource		<b>Site Location:</b> Montague to Fairmont Structure Replacement Project (MRFP)	<b>Project No.</b> 15.0166637.09.
<b>Photo No.</b> 13	<b>Date:</b> 07/23/19

<b>Direction Photo Taken:</b> Southeast			
<b>Description:</b> Montague Wetland W-46

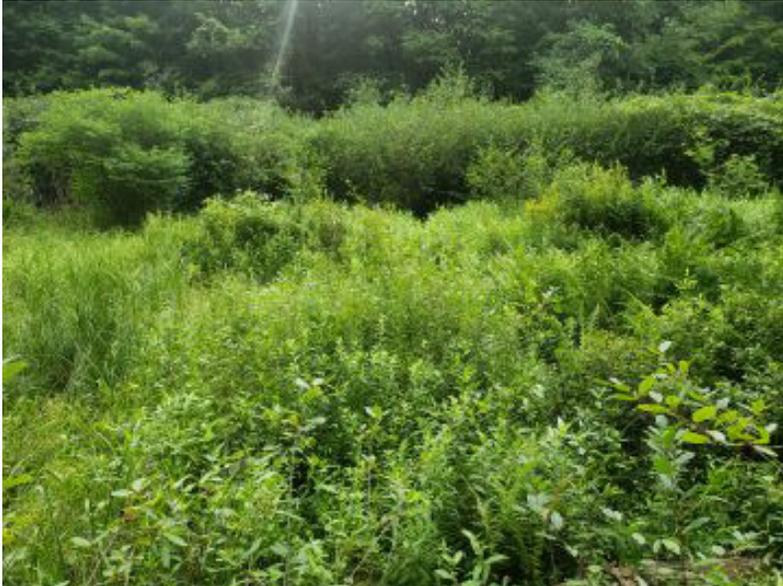
<b>Photo No.</b> 14	<b>Date:</b> 07/23/19

<b>Direction Photo Taken:</b> North			
<b>Description:</b> Montague Wetland W-48

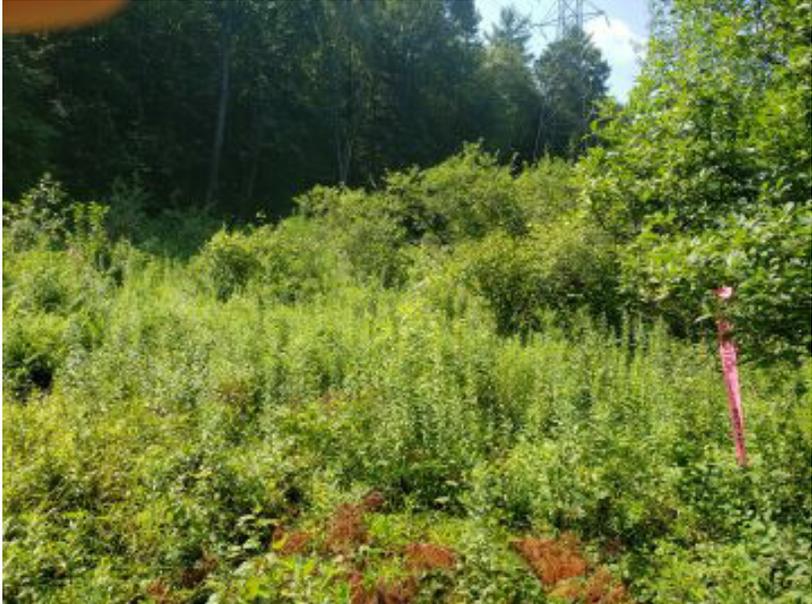
<b>Client Name:</b> Eversource		<b>Site Location:</b> Montague to Fairmont Structure Replacement Project (MRFP)	<b>Project No.</b> 15.0166637.09.
<b>Photo No.</b> 15	<b>Date:</b> 07/29/19

<b>Direction Photo Taken:</b> East			
<b>Description:</b> Montague Wetland W-49

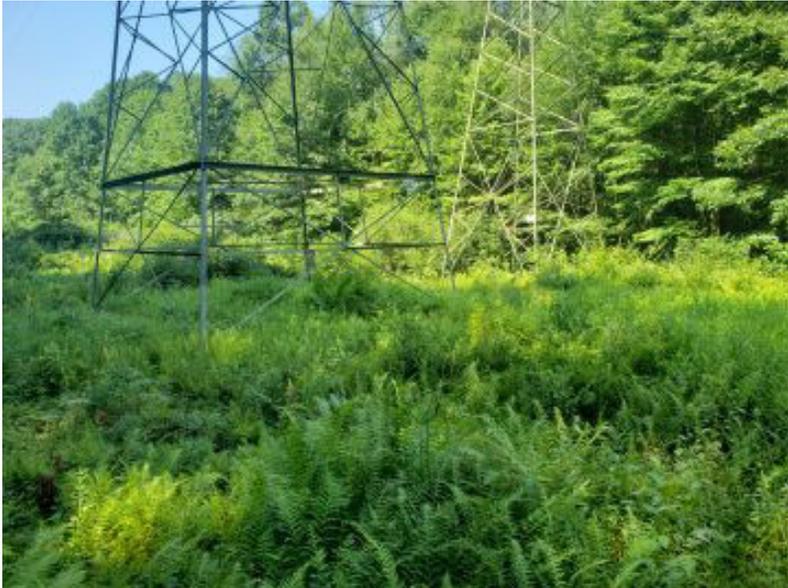
<b>Photo No.</b> 16	<b>Date:</b> 07/29/19

<b>Direction Photo Taken:</b> North			
<b>Description:</b> Montague Wetland W-50

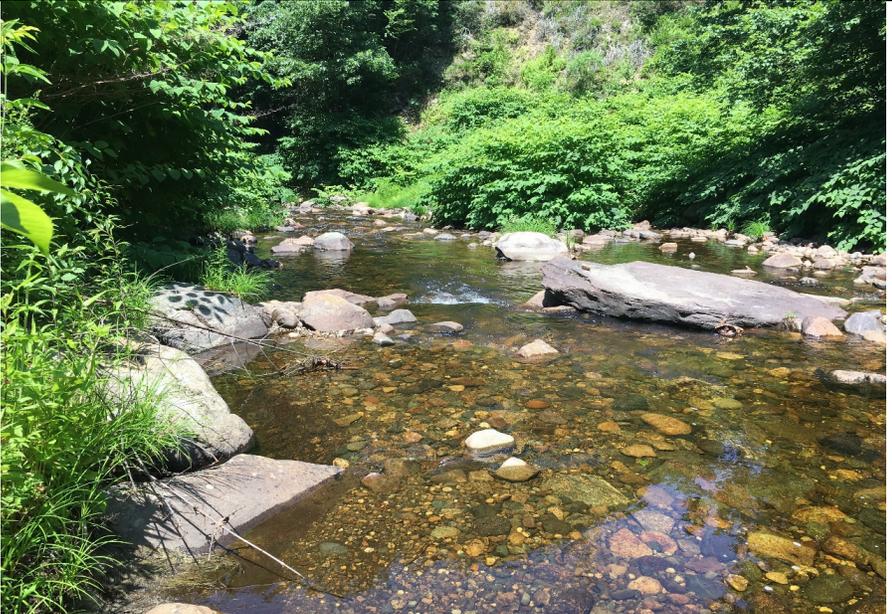
<b>Client Name:</b> Eversource		<b>Site Location:</b> Montague to Fairmont Structure Replacement Project (MRFP)	<b>Project No.</b> 15.0166637.09.
<b>Photo No.</b> 17	<b>Date:</b> 07/09/19

<b>Direction Photo Taken:</b> East			
<b>Description:</b> Sawmill River near proposed replacement Structure 10071.

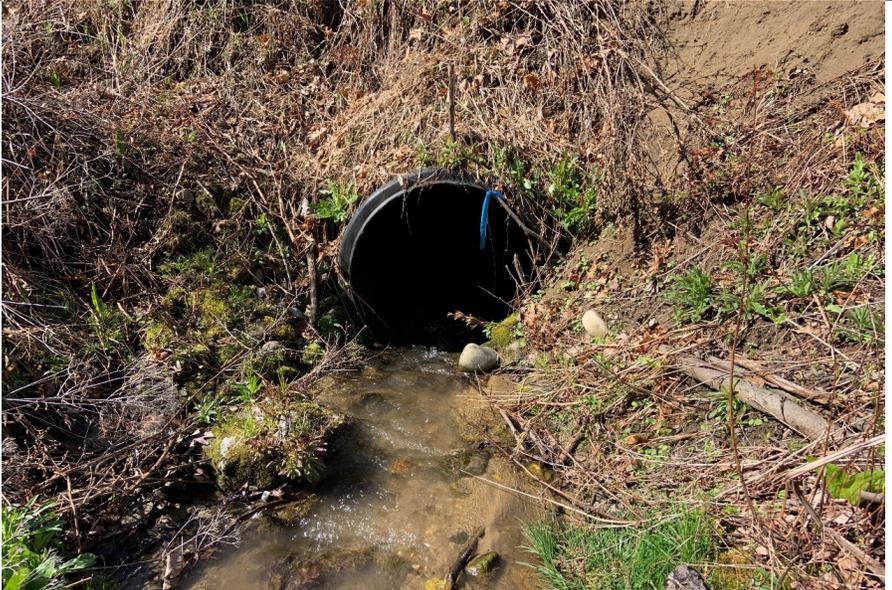
<b>Photo No.</b> 18	<b>Date:</b> 4/28/20

<b>Direction Photo Taken:</b> East			
<b>Description:</b> Outfall of culvert near STR 10017

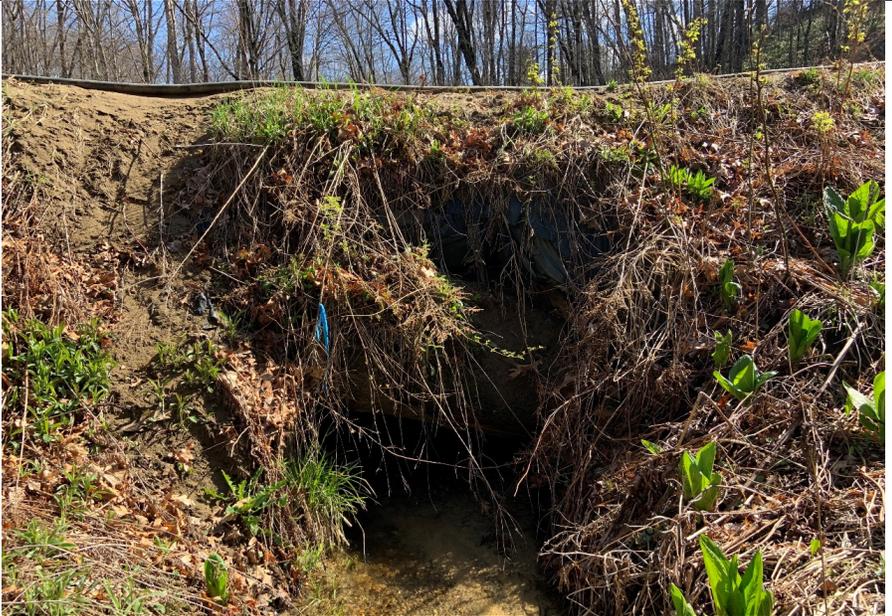
<b>Photo No.</b> 19	<b>Date:</b> 4/28/20

<b>Direction Photo Taken:</b> West		
<b>Description:</b> Inlet of culvert near STR 10017

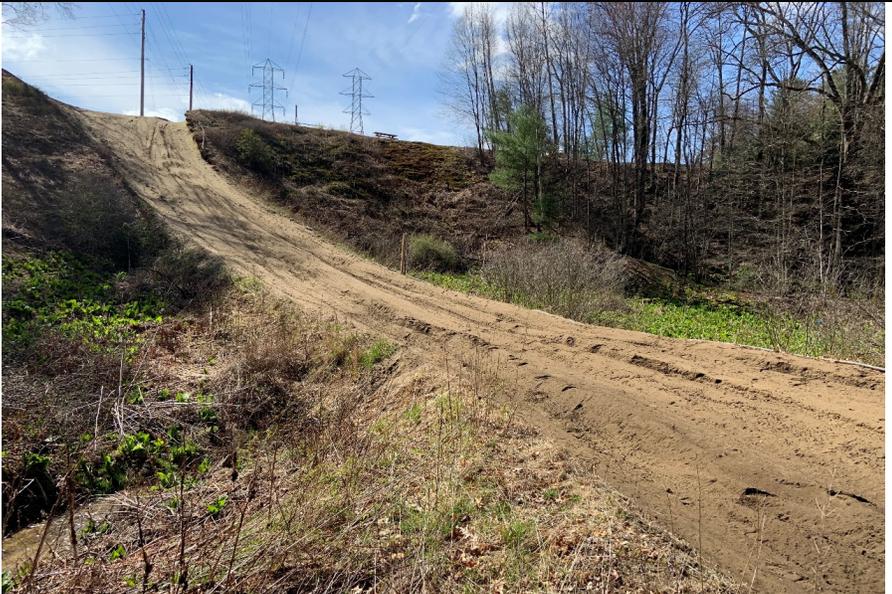
<b>Photo No.</b> 20	<b>Date:</b> 4/28/20

<b>Direction Photo Taken:</b> North		
<b>Description:</b> Existing access road over existing culvert
