TOWN OF MONTAGUE CULVERT ASSESSMENT

September 2021

Town of Montague Culvert Assessment

Project Summary

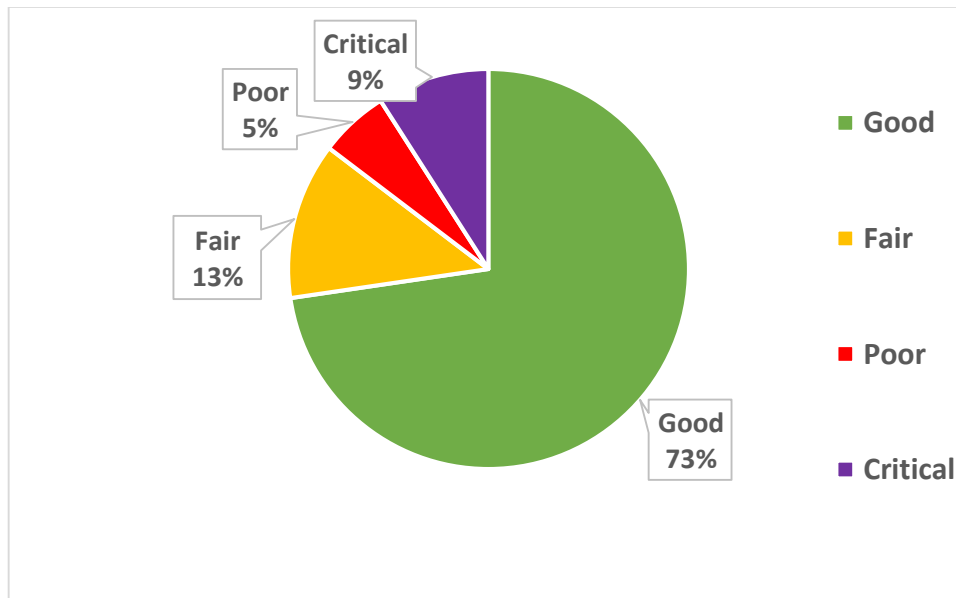
Figure 1: Condition of Montague's Culverts as of August 2021

Of these drainage structures, 73% were assessed as being in Good condition, while another 9% were identified as being in Critical condition needing immediate attention for either replacement or maintenance. The remaining 19% of culverts were in either Fair or Poor condition. Figure 1 below shows the condition breakdown of the condition of the Town's culverts.
