SITE DEVELOPMENT ASSESSMENT

Strathmore Mills Redevelopment

Town of Montague

August 12, 2008

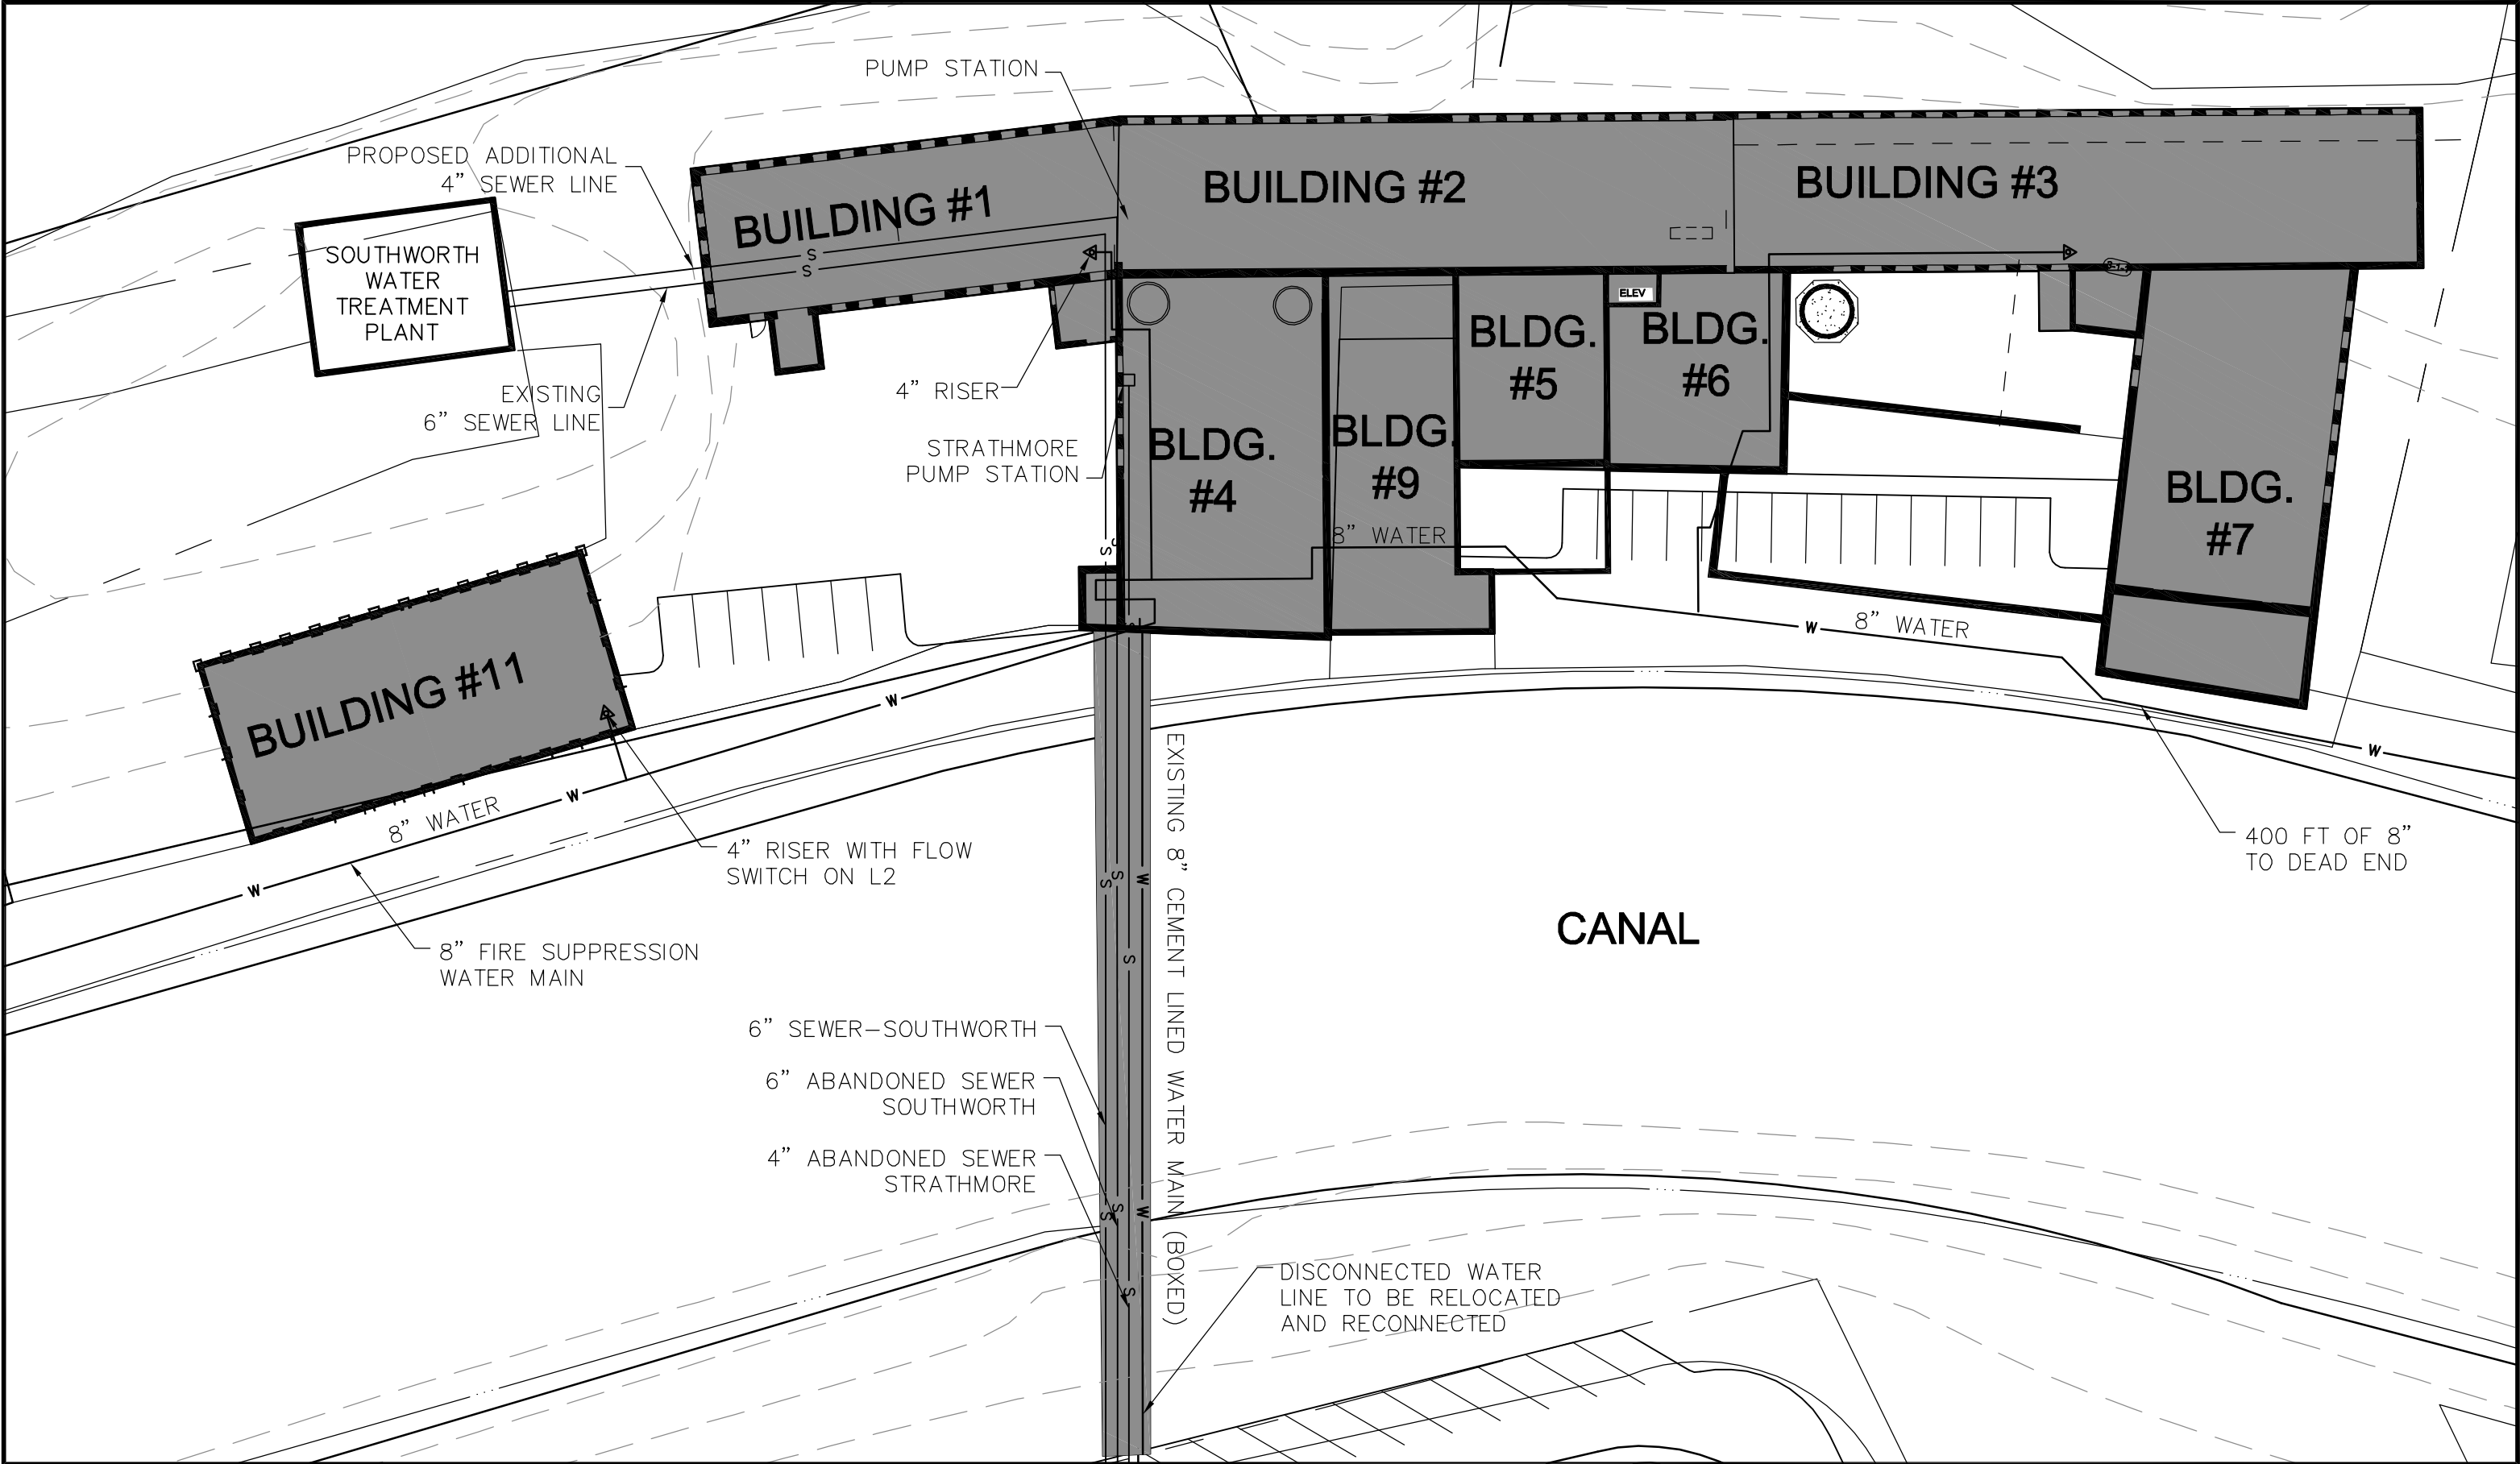
FIG 7

Three sewer lines cross on the west side of the bridge and will need to be maintained and relocated as required. As shown in [Figure 7](#), the Southworth Paper has two sewer lines, a 4 inch line and 6 inch line, running though the Strathmore buildings with rights to cross the bridge. The Strathmore Mill has a sewer ejector station located outside the northwest corner of Building 4 with a 4" sewer line running across the pedestrian bridge. All three of these lines terminate in a manhole on the south side of the bridge in Canal Road.

After the fire which destroyed Building 10, both operating lines from the Southworth Mill were destroyed. A new 6" insulated line was installed in the lower floor of Building 1 running along the south wall along building 4 and then across the pedestrian bridge. Southworth Paper will be looking to install an additional line parallel to this line to provide secondary service to its wastewater treatment plant. The Southworth Mill had a study performed to evaluate the feasibility of abandoning the sewer lines and installing a gravity line down the canal road to the west as recommended by Bob Tremblay of the town sewer department. This alternative was determined to be economically infeasible.

The proposed redevelopment can utilize the existing fire suppression water service lines as it is currently being maintained and kept in service. A new 6" water line to provide the mill with a domestic water supply will need to be installed across the pedestrian bridge. The Fire Dept will need to be contacted concerning an emergency cross connection to the fire line (RPZ interconnection). The utilities layout is shown in [Figure 7](#).
