Property Condition Assessment

**Sheffield Administration Building
35 Crocker Avenue**

Turners Falls, MA

November 5, 2020

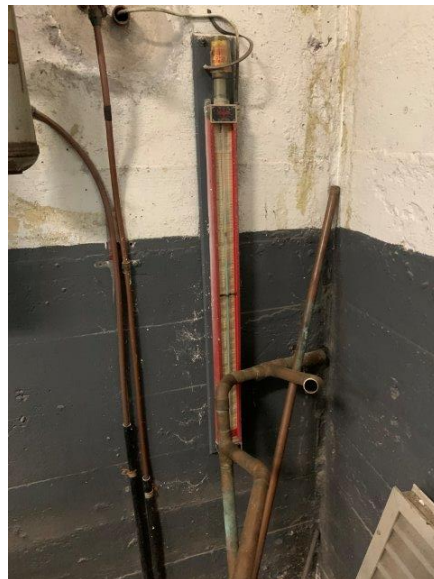
Gill-Montague
Facilities Management

ADMIN BUILDING OIL TANK
35 CROCKER AVE
5000 GALLON TANK 96" X 28" 50"

RED - MINIMUM OPERATING LEVEL
BLACK - OUT OF FUEL

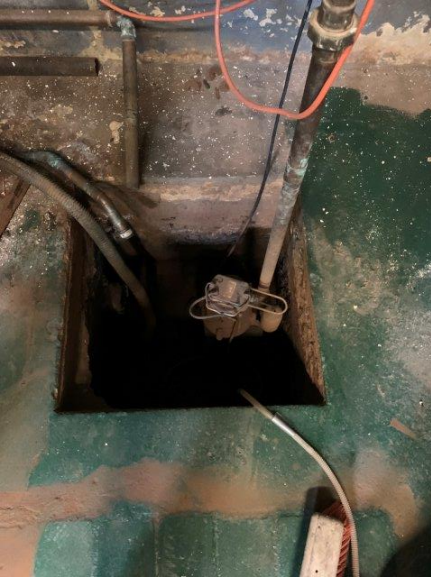
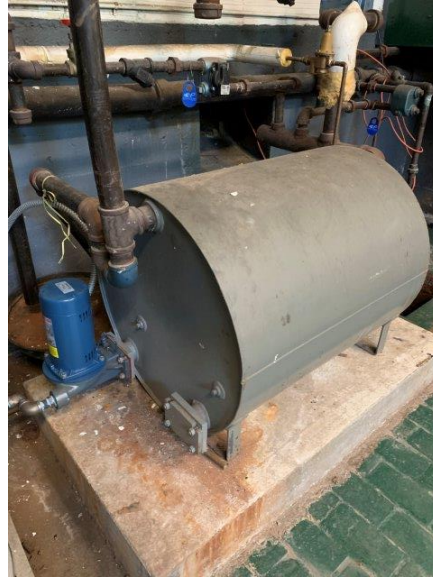
BOILER/FIRED PRESSURE VESSEL - REPORT OF INSPECTION
 The Hartford Steam Boiler Inspection and Insurance Co.
 Hartford, Connecticut 06182

NO ADVERSE CONDITIONS NOTED.
