MONTAGUE CAPITAL IMPROVEMENTS COMMITTEE

SPECIAL ARTICLE REQUEST – CAPITAL EXPENSE

Item/Project Title: Montague Center Pump Station Upgrades

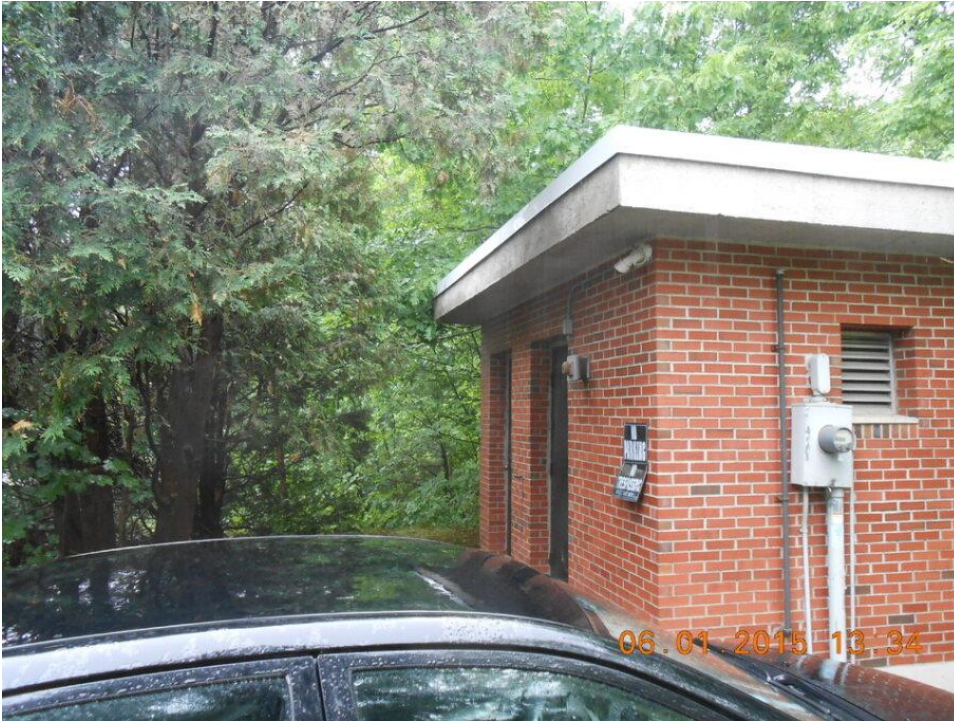
Station Exterior (2015)

The Montague Center Station is the Town's largest capacity station and is a multi-level structure with a very deep foundation, flat roof, and red brick masonry façade on the above ground level. This station was constructed adjacent to a waterway (the Sawmill River.) The structure is split into two major areas; wet well and dry well sides. The sides are divided by a concrete wall that extends from the base slab to the roof of the structure. The dry well is further divided into four levels.

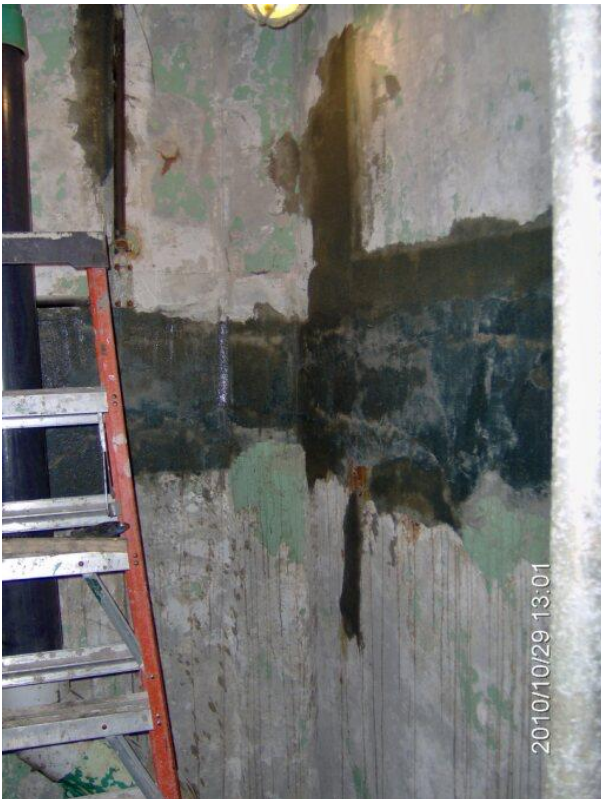
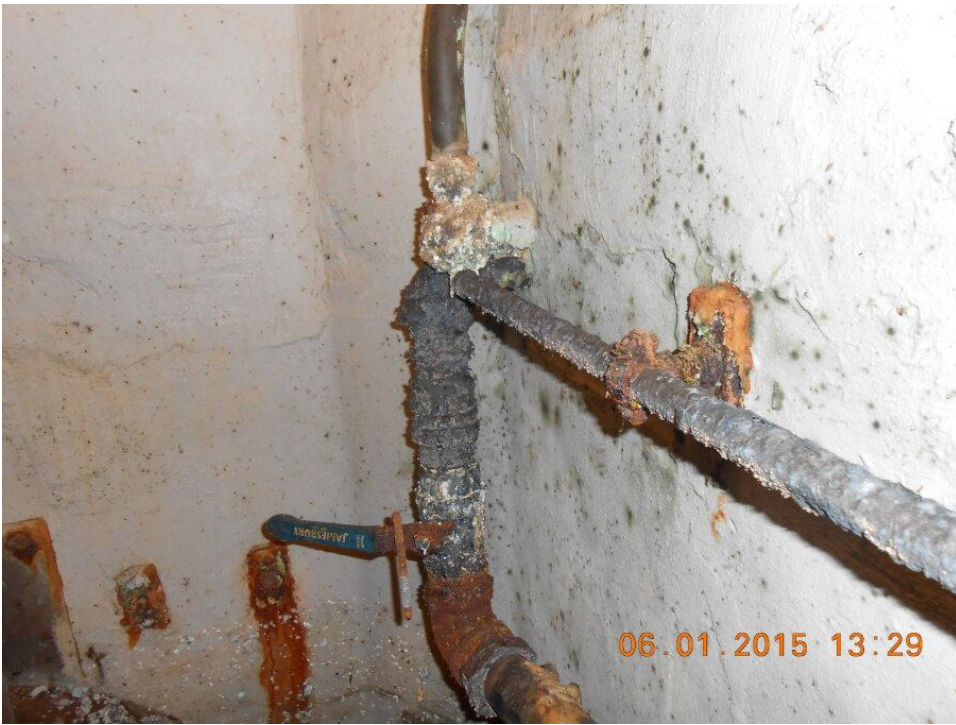
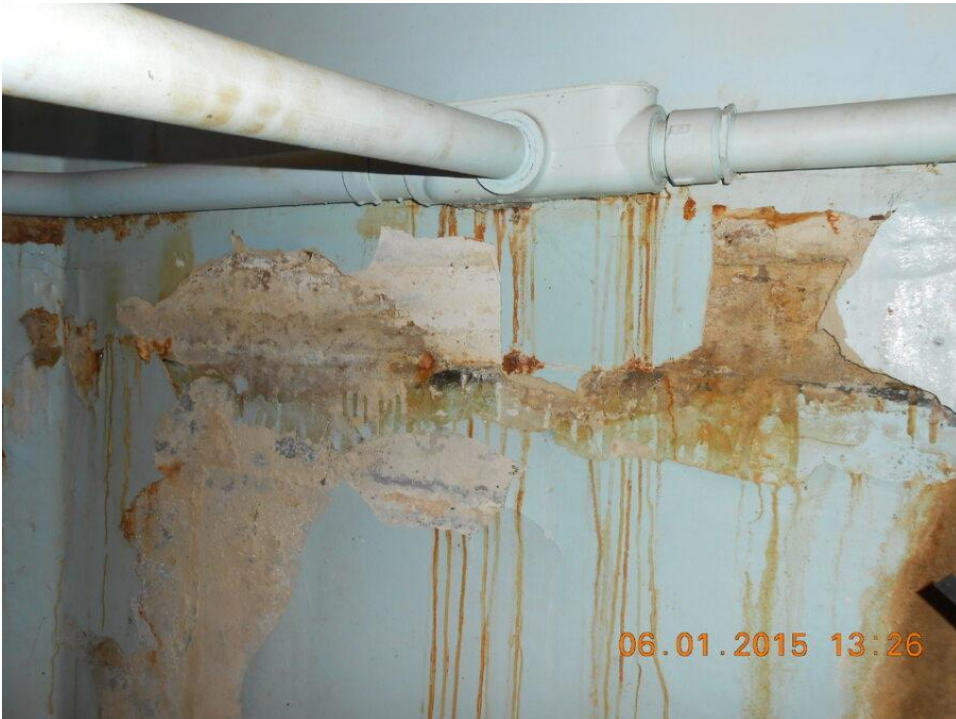
Dry Well (2010, 2015)

- No fence, puts station at risk for forced entry/vandalism to external generator and controls components
- Minor interior mortar deterioration, moisture damage to interior walls, need repairs on all levels, painting
- Exterior door replacement, brick and mortar needs re-pointing, painting
- Confined space entry is of significant concern relating to operator safety
- Due to age, risk of equipment failure is significant and increasing
- Capacity shortfall observed, larger pumps needed

Pumps x2 (Centrifugal)	\$60,000
Wet Well Rehab (concrete, coatings/sealer, paint)	\$30,000
Dry Well Rehab (concrete, coatings/sealer, paint)	\$10,000
Generator w/switch gear	\$28,000
Electrical Contractor	\$10,000
Controls, including level controls (bring up to grade out of confined space)	\$20,000
Bypass pumping connection (currently does not have one)	\$10,000
Bypass pumping	\$5,000
Building concrete/repointing/stabilization	\$20,000
Air relief valve and appurtenances	\$50,000
Fencing/gate for security (currently non-existent)	\$10,000
Dehumidification system	\$5,000
Total:	\$258,000
Contingency of 10%	\$25,800
Grand Total:	\$283,800

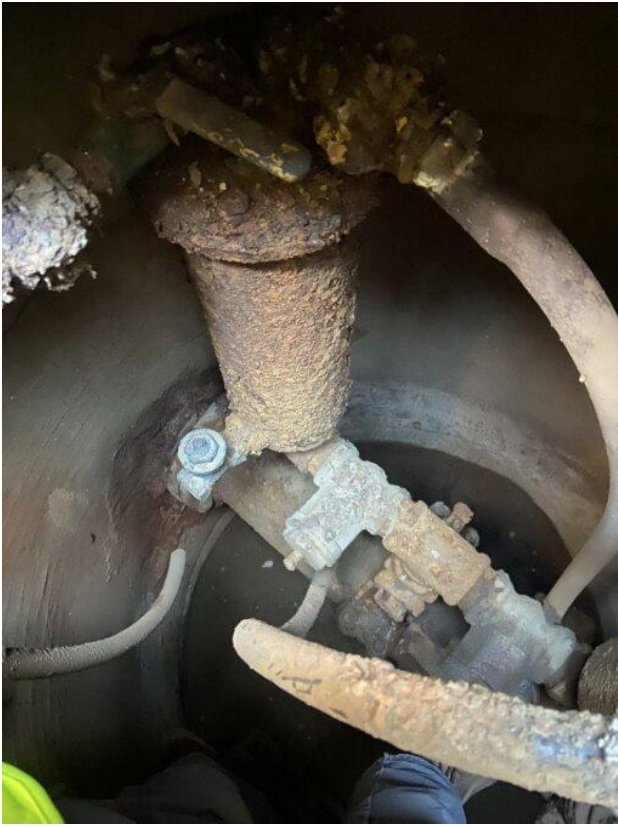
Air Relief Valve and Appurtenances (2022)

The corresponding air relief valve and appurtenances located in the force main (that stems from the station) are in dire need of repair, as they have experienced corrosion due to prolonged exposure to sewer gases such as hydrogen sulfide. (See photo) Due to the importance of the relief valve on the overall operation of the station, it is recommended to perform the replacement of the valve assembly at the same time as the bypass occurs during the upgrade of the station.
